DEPARTMENT OF HEALTH AND HUMAN SERVICES
DIVISION OF PUBLIC HEALTH, ENVIRONMENTAL HEALTH SECTION
ON-SITE WATER PROTECTION BRANCH

Sheet 1 of 1
PROPERTY ID #: 3783465147
COUNTY: Iredell

SOIL/SITE EVALUATION
for ON-SITE WASTEWATER SYSTEM
(Complete all fields in full)

OWNER: Martin Hendricks — APPLICATION DATE: 4-5-16
ADDRESS: 346 New Sterling Rd — DATE EVALUATED: 5-11-16
PROPOSED FACILITY: SFD — PROPOSED DESIGN FLOW (.1949): 240gpd — PROPERTY SIZE: 4.14 acres
LOCATION OF SITE: 374 Lookout Dam Rd — PROPERTY RECORDED: Yes
WATER SUPPLY: ☑ Private ☐ Public ☐ Well ☐ Spring ☐ Other N/A
EVALUATION METHOD: ☑ Auger Boring ☐ Pit ☐ Cut — TYPE OF WASTEWATER: ☑ Sewage ☐ Industrial Process ☐ Mixed

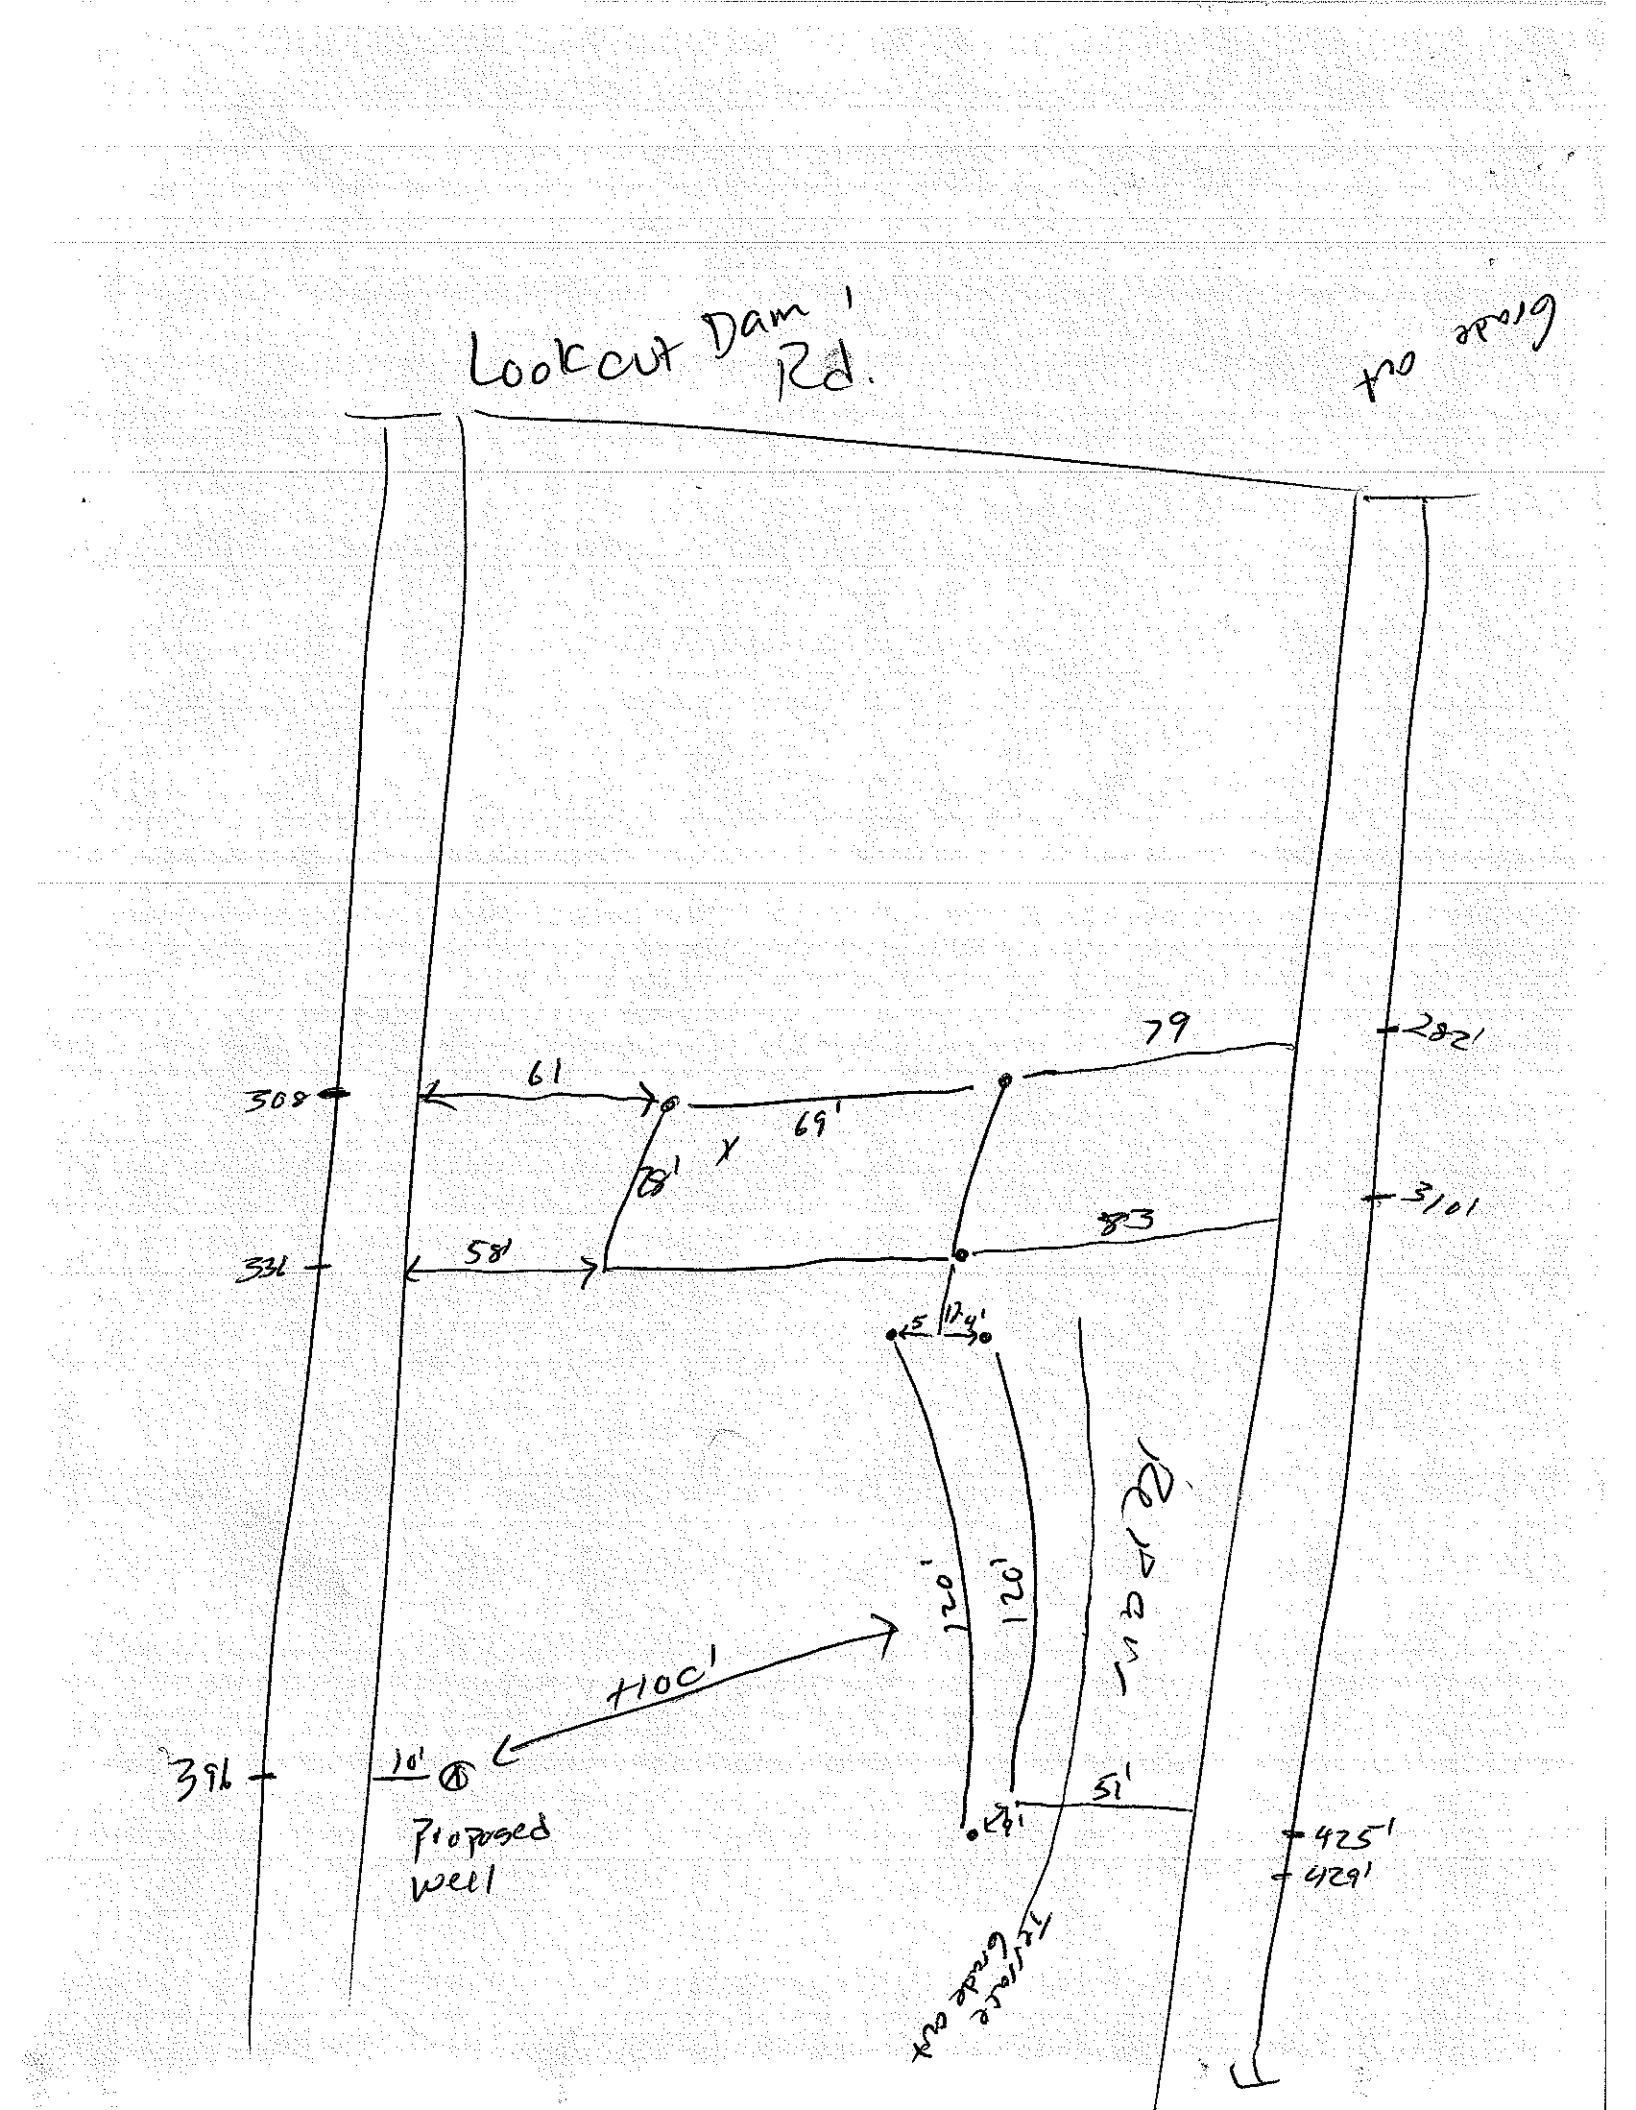
Show profile locations and other site features (dimensions, reference or benchmark, and North).

Lookout Dam Rd.
no grade
308
336
396
61
58'
69'
78'
X
79
83
282'
310'
425'
429'
5
17.4'
120'
120'
110C'
51'
10'
Proposed well
Existing Grade out
