ON-SITE WASTEWATER SECTION

SOIL/SITE EVALUATION
for ON-SITE WASTEWATER SYSTEM

OWNER: CRT
ADDRESS: ___ APPLICATION DATE ___
PROPOSED FACILITY: ___ PROPOSED DESIGN FLOW (.1949): 480gpd DATE EVALUATED: 1-7-03
LOCATION OF SITE: Lot 1104 adj 11 Tee Court PROPERTY SIZE: ___
WATER SUPPLY: ☐ Private ☒ Public ☒ Well ☐ Spring ☐ Other ___ PROPERTY RECORDED: ___
EVALUATION METHOD: ☐ Auger Boring ☒ Pit ☐ Cut
TYPE OF WASTEWATER: ☒ Sewage ☐ Industrial Process ☐ Mixed

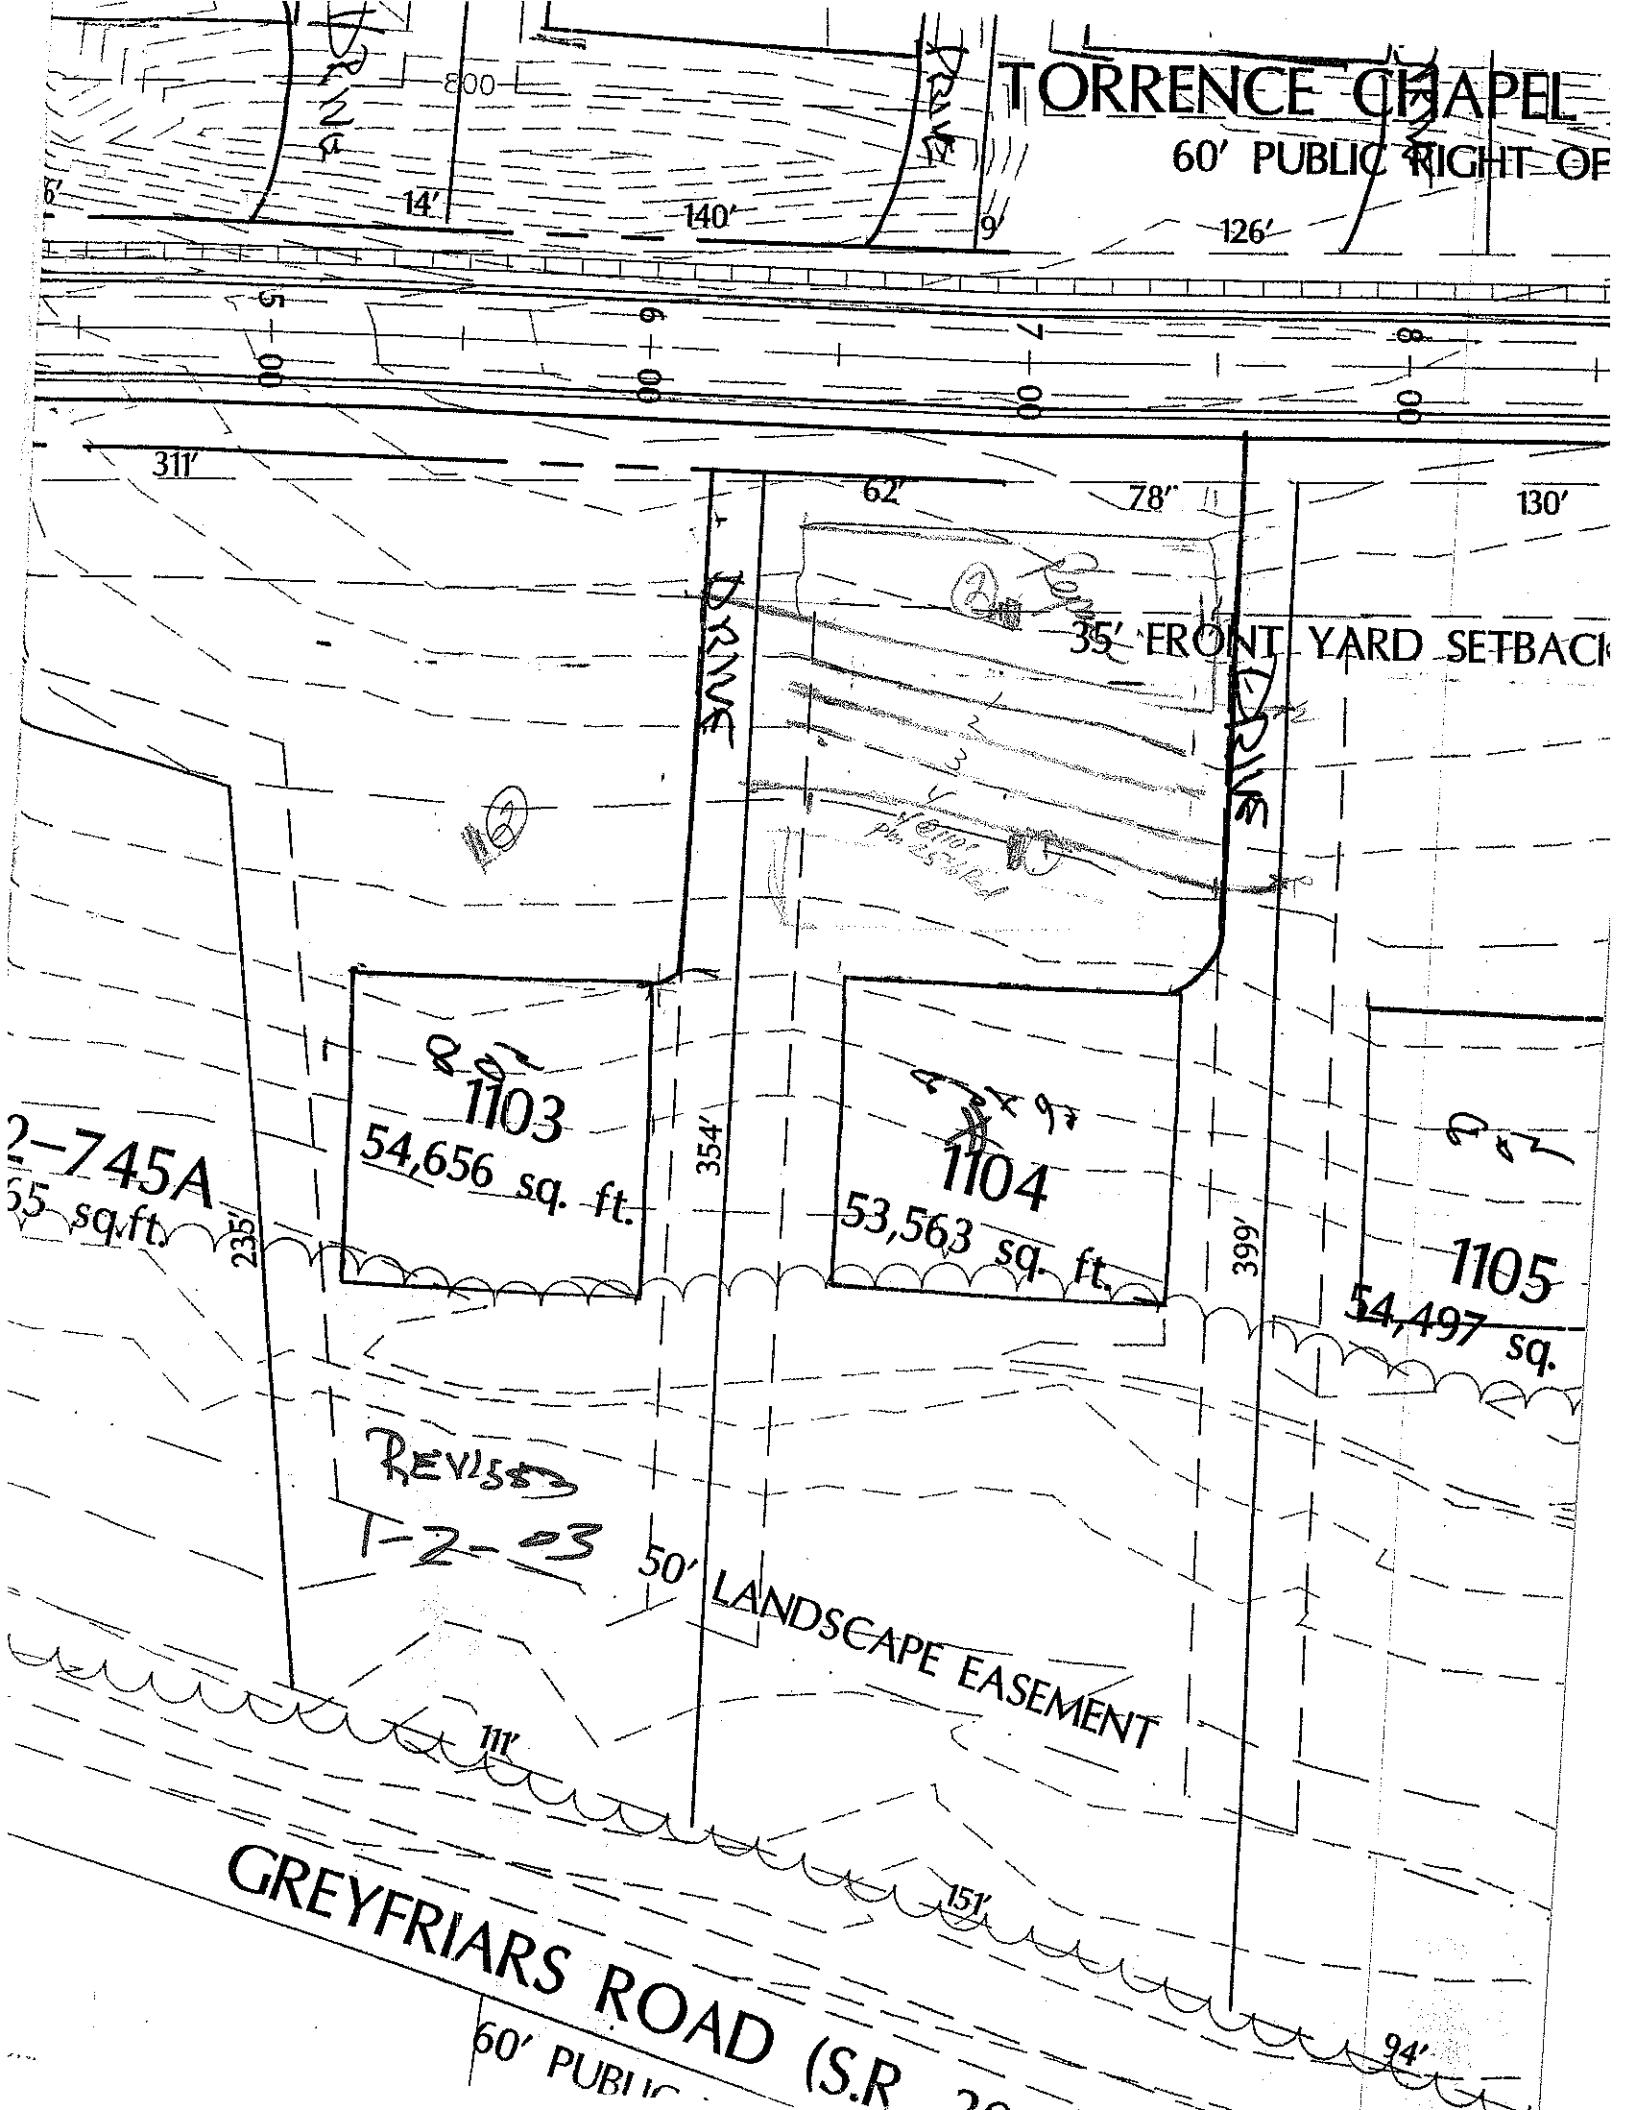
COMMENTS: Repair area not evaluated. CRT did not want to clear & dig pits there
