DIVISION OF ENVIRONMENTAL HEALTH
ON-SITE WASTEWATER SECTION

SOIL/SITE EVALUATION
for ON-SITE WASTEWATER SYSTEM

OWNER: CRI APPLICATION DATE ___
ADDRESS: ___
PROPOSED FACILITY: ___ PROPOSED DESIGN FLOW (.1949): 480gpd DATE EVALUATED: 1-703
LOCATION OF SITE: Lot 1107 PROPERTY SIZE: ___
WATER SUPPLY: ☐ Private ☒ Public ☒ Well ☐ Spring ☐ Other PROPERTY RECORDED: ___
EVALUATION METHOD: ☐ Auger Boring ☒ Pit ☐ Cut
TYPE OF WASTEWATER: ☒ Sewage ☐ Industrial Process ☐ Mixed

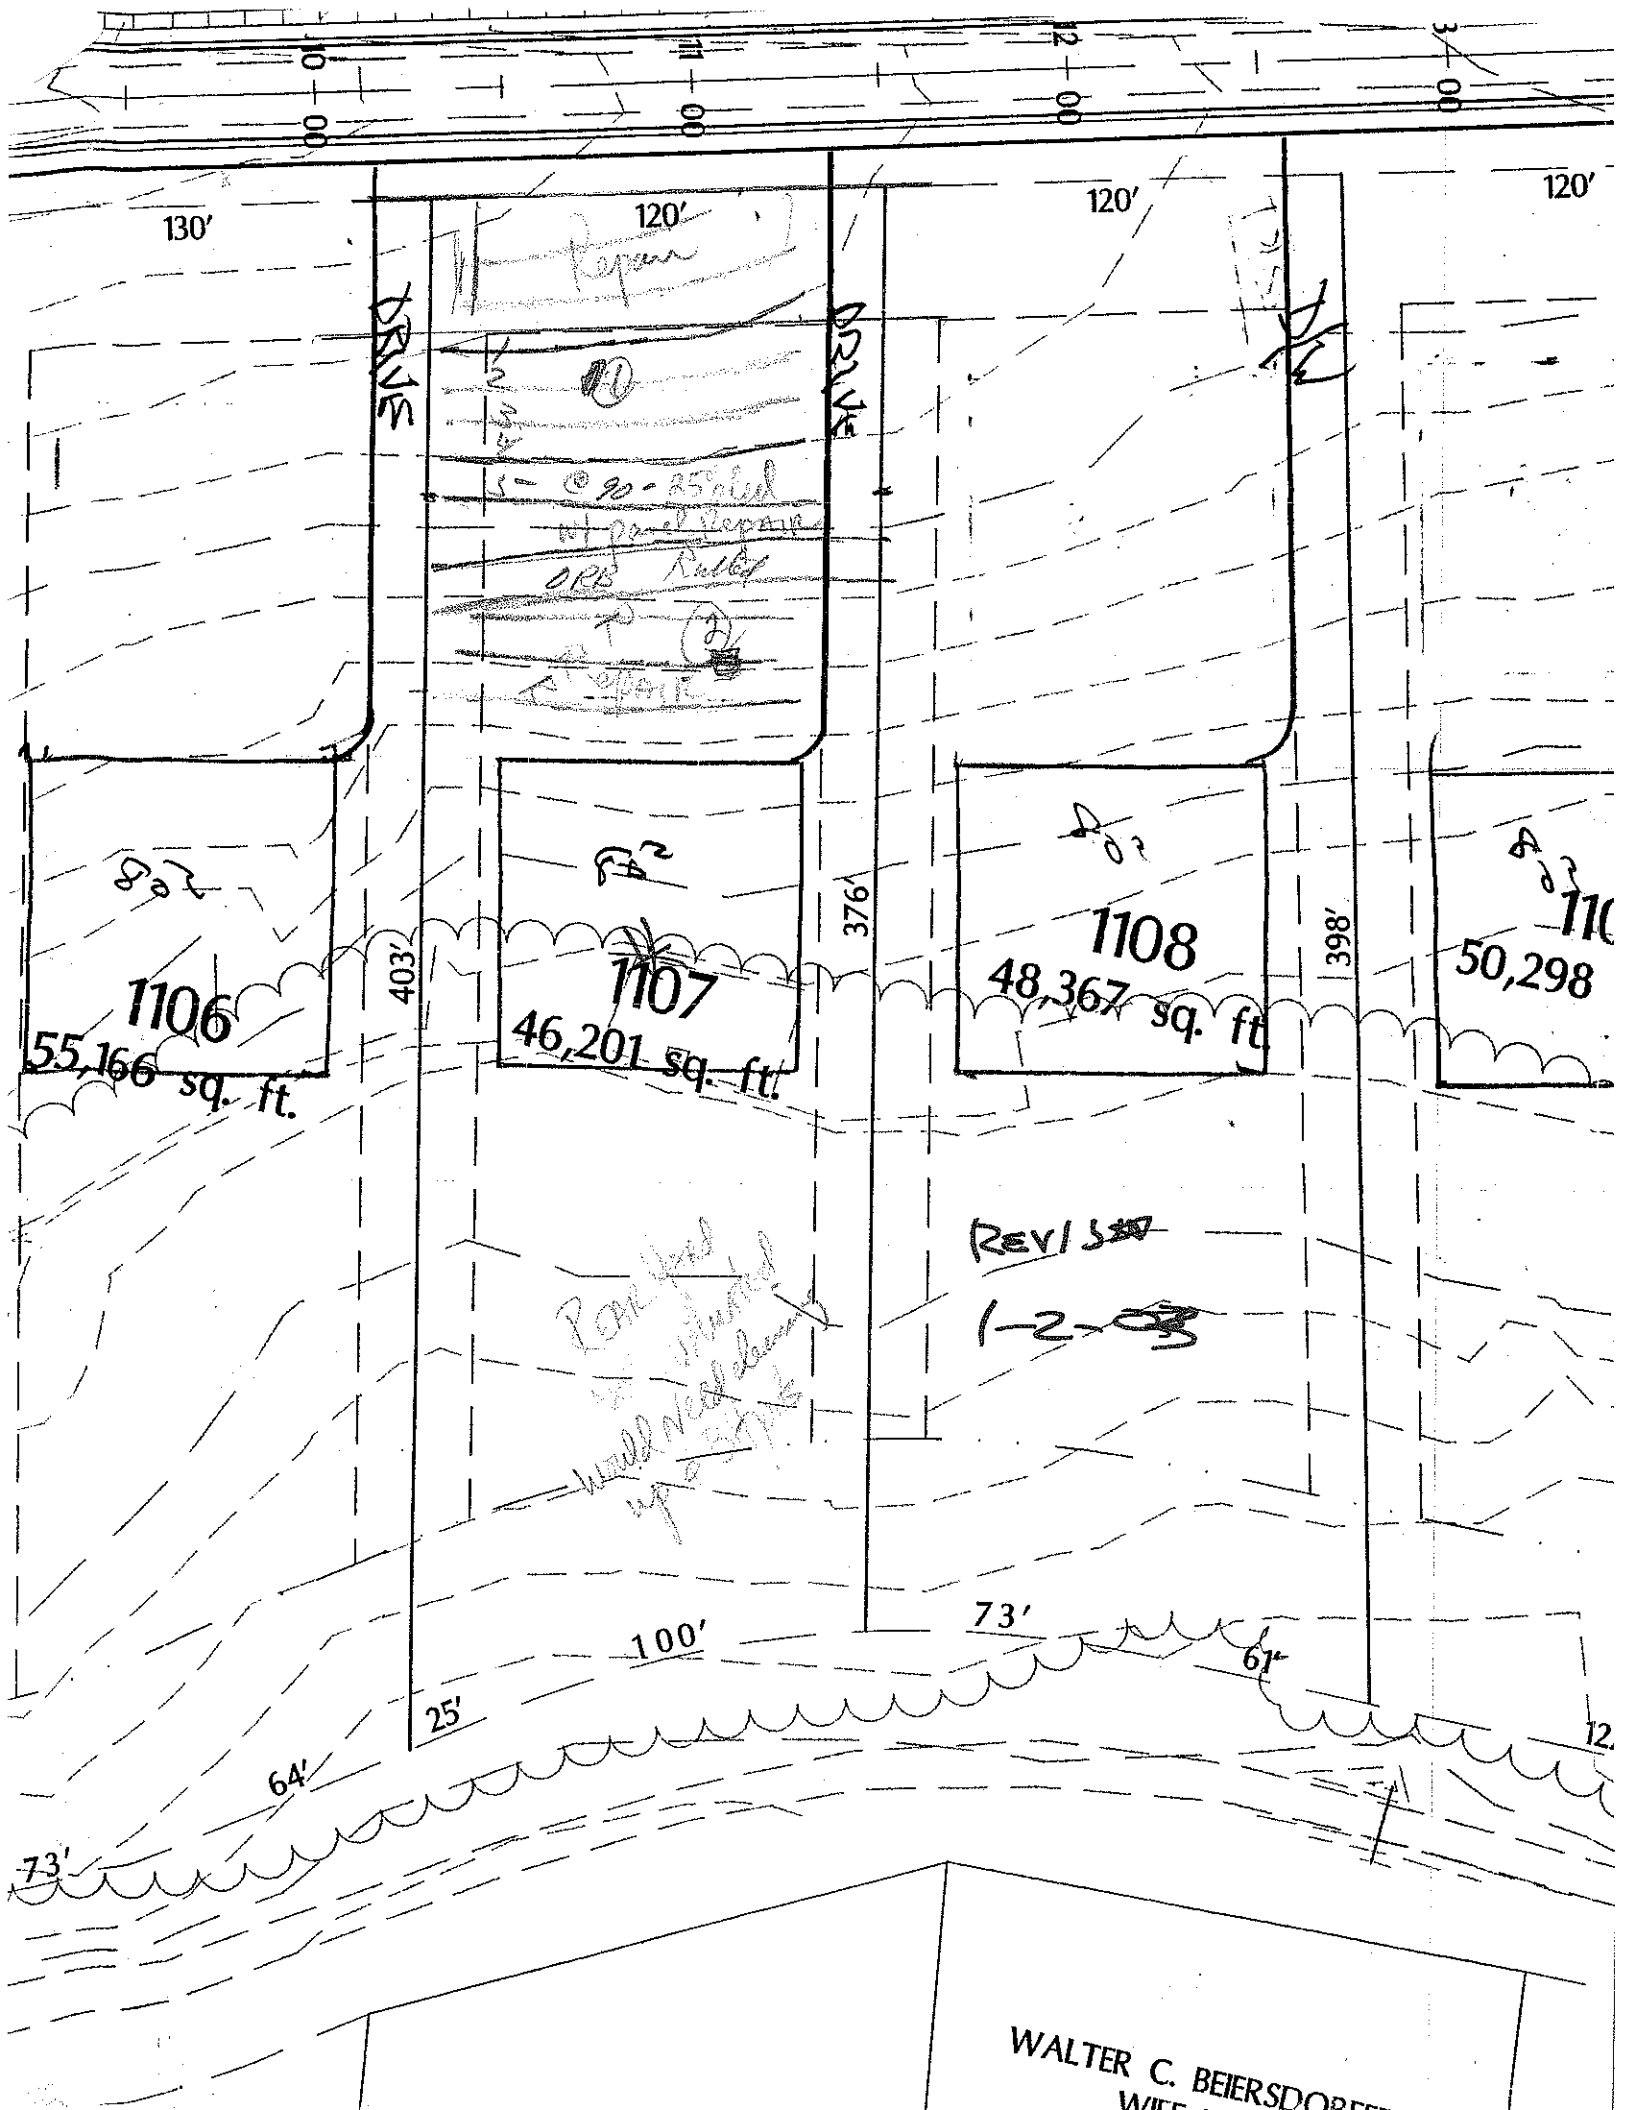
PROFILE #	.1940 LANDSCAPE POSITION/ SLOPE %	HORIZON DEPTH (IN.)	SOIL MORPHOLOGY (.1941) .1941 STRUCTURE/ TEXTURE	SOIL MORPHOLOGY (.1941) .1941 CONSISTENCE/ MINERALOGY	OTHER PROFILE FACTORS .1942 SOIL WETNESS/ COLOR	.1943 SOIL DEPTH	.1956 SAPRO CLASS	.1944 RESTR HORIZ	PROFILE CLASS & LTAR
1		0-7	Wsl brsl	fr ss sp					≤3
		7-38	m sbk	rc fr sp					
		38-58	m sbk	rc fr sp to vfr sp w/ sap					
2	4 6%	0-8	gr-wsl sbk	vfr ss sp	a little water coming out at horizon change				.25-.3
		8-36	m sbk	rc fr so					
		36-58	wk sbk	yel fr sp					
3									
4

COMMENTS: Repair yard not evaluated. CRI did not want to clear up and dig test pits.
