DIVISION OF ENVIRONMENTAL HEALTH
ON-SITE WASTEWATER SECTION

SOIL/SITE EVALUATION
for ON-SITE WASTEWATER SYSTEM

OWNER: CRI APPLICATION DATE _____
ADDRESS: _____
PROPOSED FACILITY: _____ PROPOSED DESIGN FLOW (.1949): 450 gpd DATE EVALUATED: 1-7-03
LOCATION OF SITE: Lot 119 phase 2 PROPERTY SIZE: _____
WATER SUPPLY: ☐ Private ☒ Public ☒ Well ☐ Spring ☐ Other _____ PROPERTY RECORDED: _____
EVALUATION METHOD: ☐ Auger Boring ☒ Pit ☐ Cut
TYPE OF WASTEWATER: ☒ Sewage ☐ Industrial Process ☐ Mixed

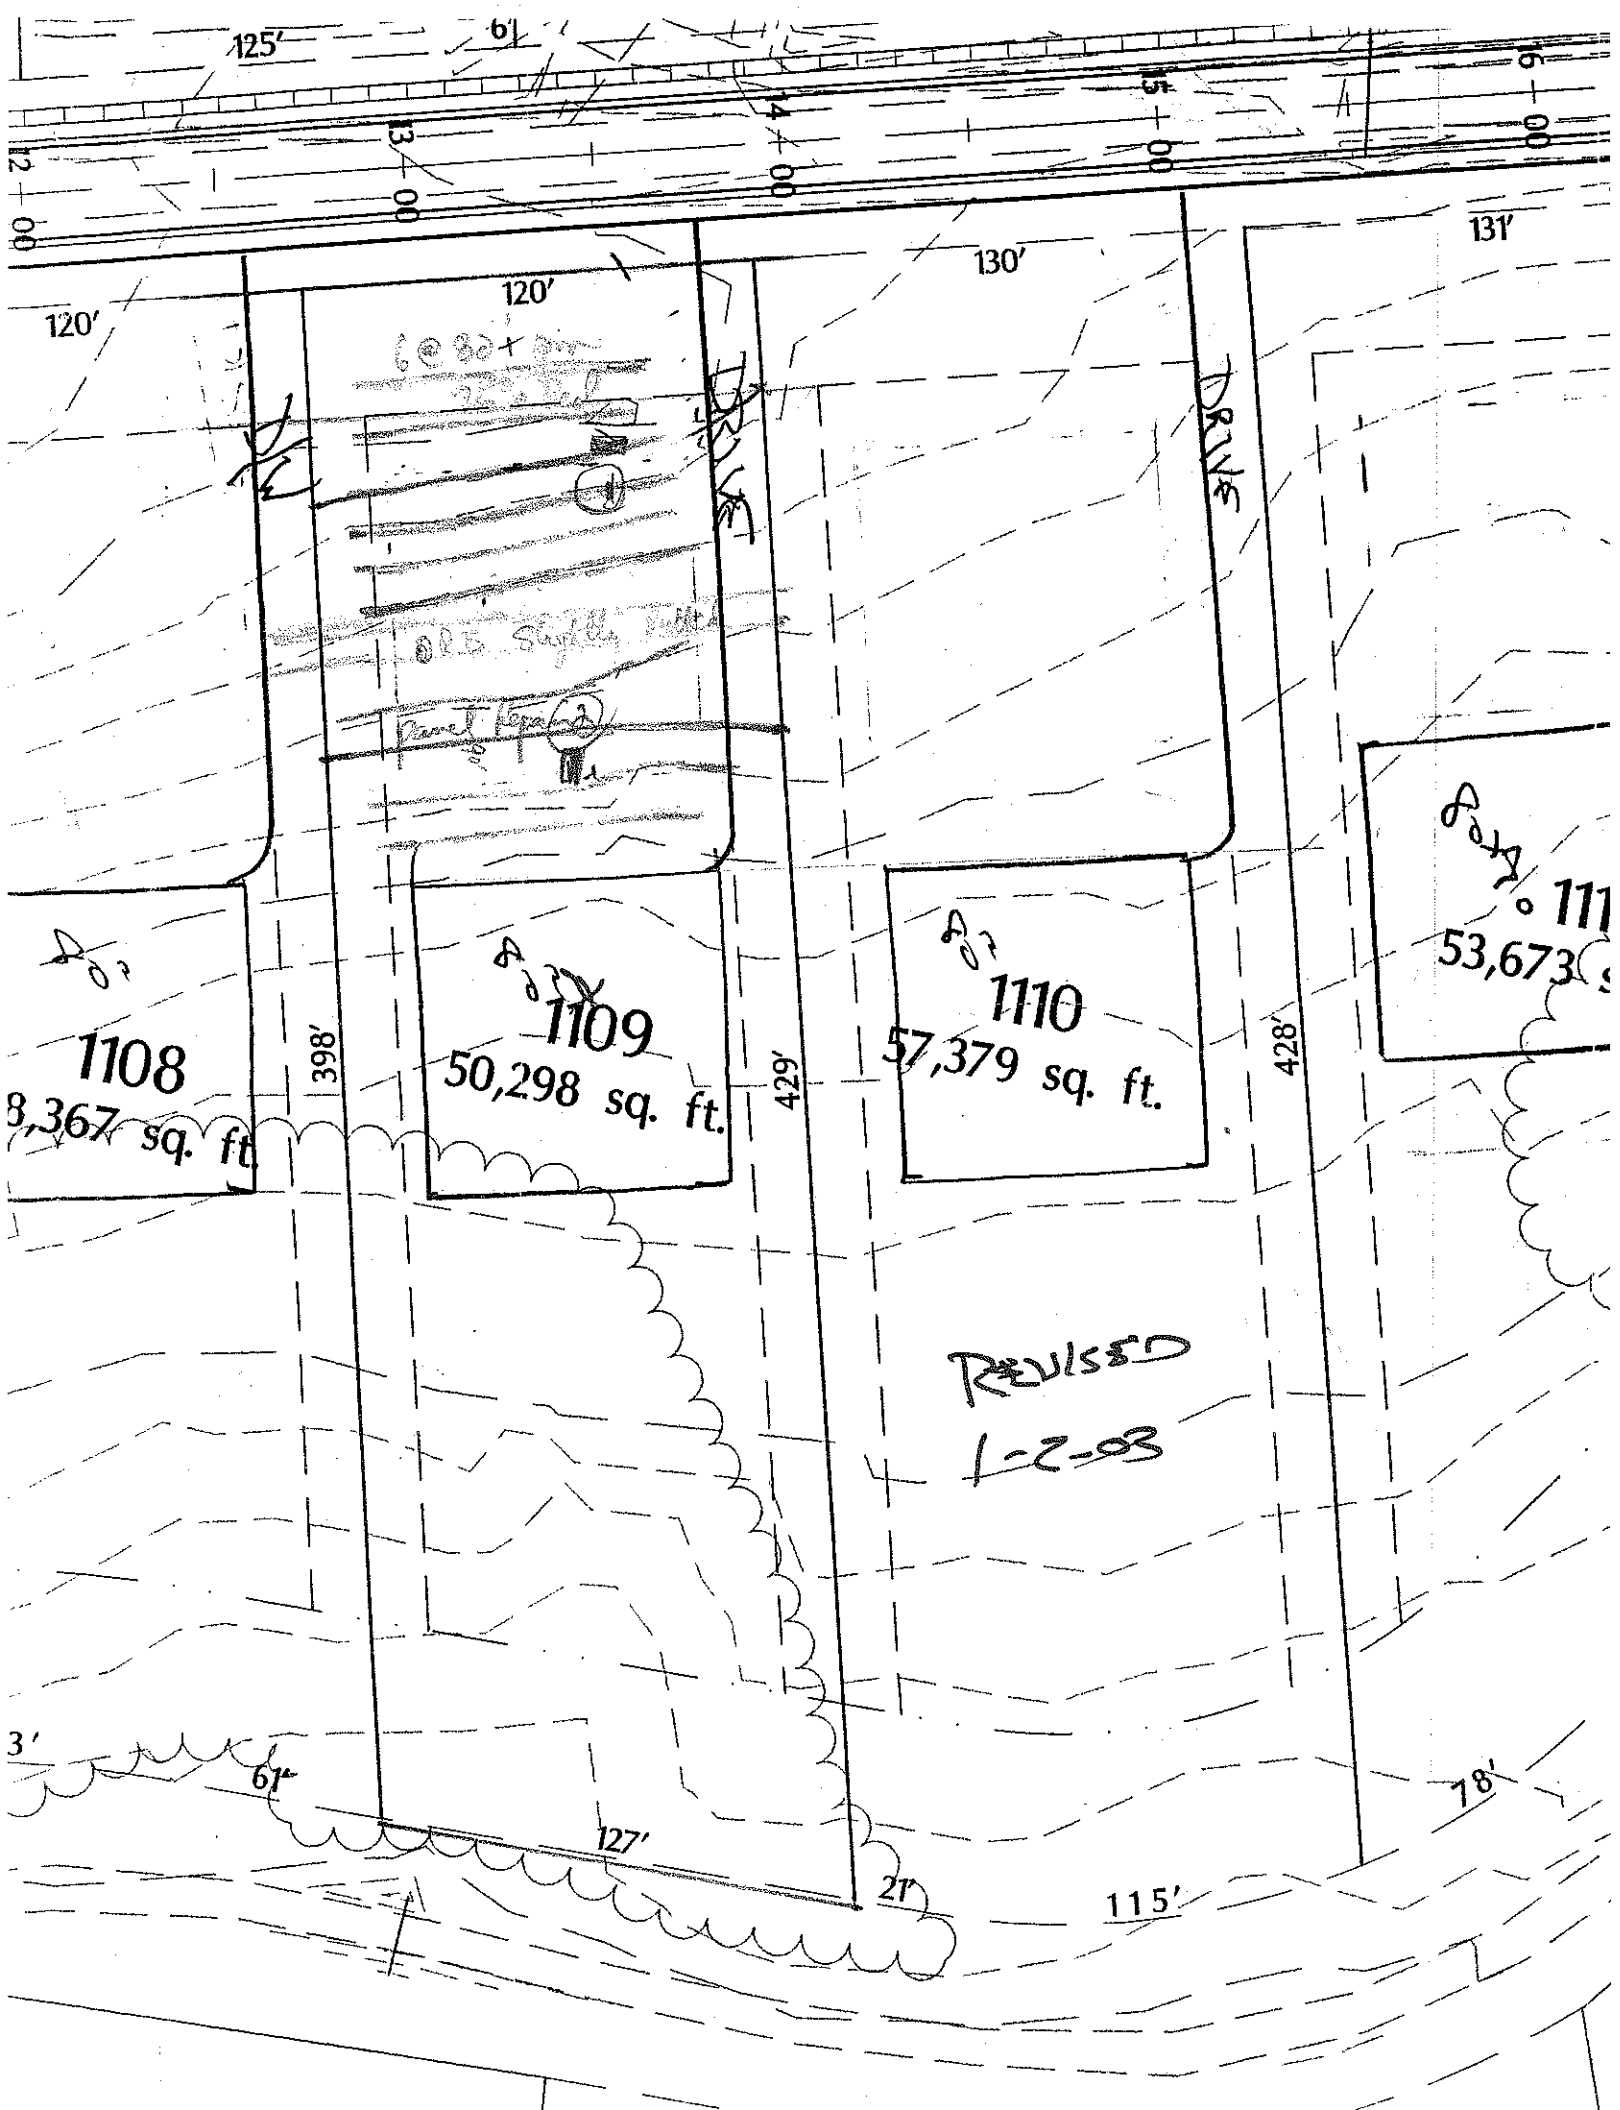
PROFILE #	.1940 LANDSCAPE POSITION/ SLOPE %	HORIZON DEPTH (IN.)	SOIL MORPHOLOGY (.1941) .1941 STRUCTURE/ TEXTURE	SOIL MORPHOLOGY (.1941) .1941 CONSISTENCE/ MINERALOGY	OTHER PROFILE FACTORS .1942 SOIL WETNESS/ COLOR	.1943 SOIL DEPTH	.1956 SAPRO CLASS	.1944 RESTR HORIZ	PROFILE CLASS & LTAR
1		0-8	wk sbk loamy sd	fri ss p					.3
		8-41	mod sbk RC	fri ss p					
		41-60	mod sbk gyel	fri ss p for common mid sap					
2	4-6%	0-11	gr-wk sbk loamy sd	fri ss sp	a little water seeping from this horizon				.35 .3
		11-24	wk sbk fsa clc	fri sp					
		24-60	m sbk R-yel	fri ss sp					
3									
4

COMMENTS: NOTE: Upper not evaluated. CRI did not want to clean up until this point.

DESCRIPTION	INITIAL SYSTEM	REPAIR SYSTEM
Available Space (.1945)		
System Type(s)	Pm 25% Red	LPP60S
Site LTAR	.25-.3	.25-.3
