DIVISION OF ENVIRONMENTAL HEALTH
ON-SITE WASTEWATER SECTION

SOIL/SITE EVALUATION
for ON-SITE WASTEWATER SYSTEM

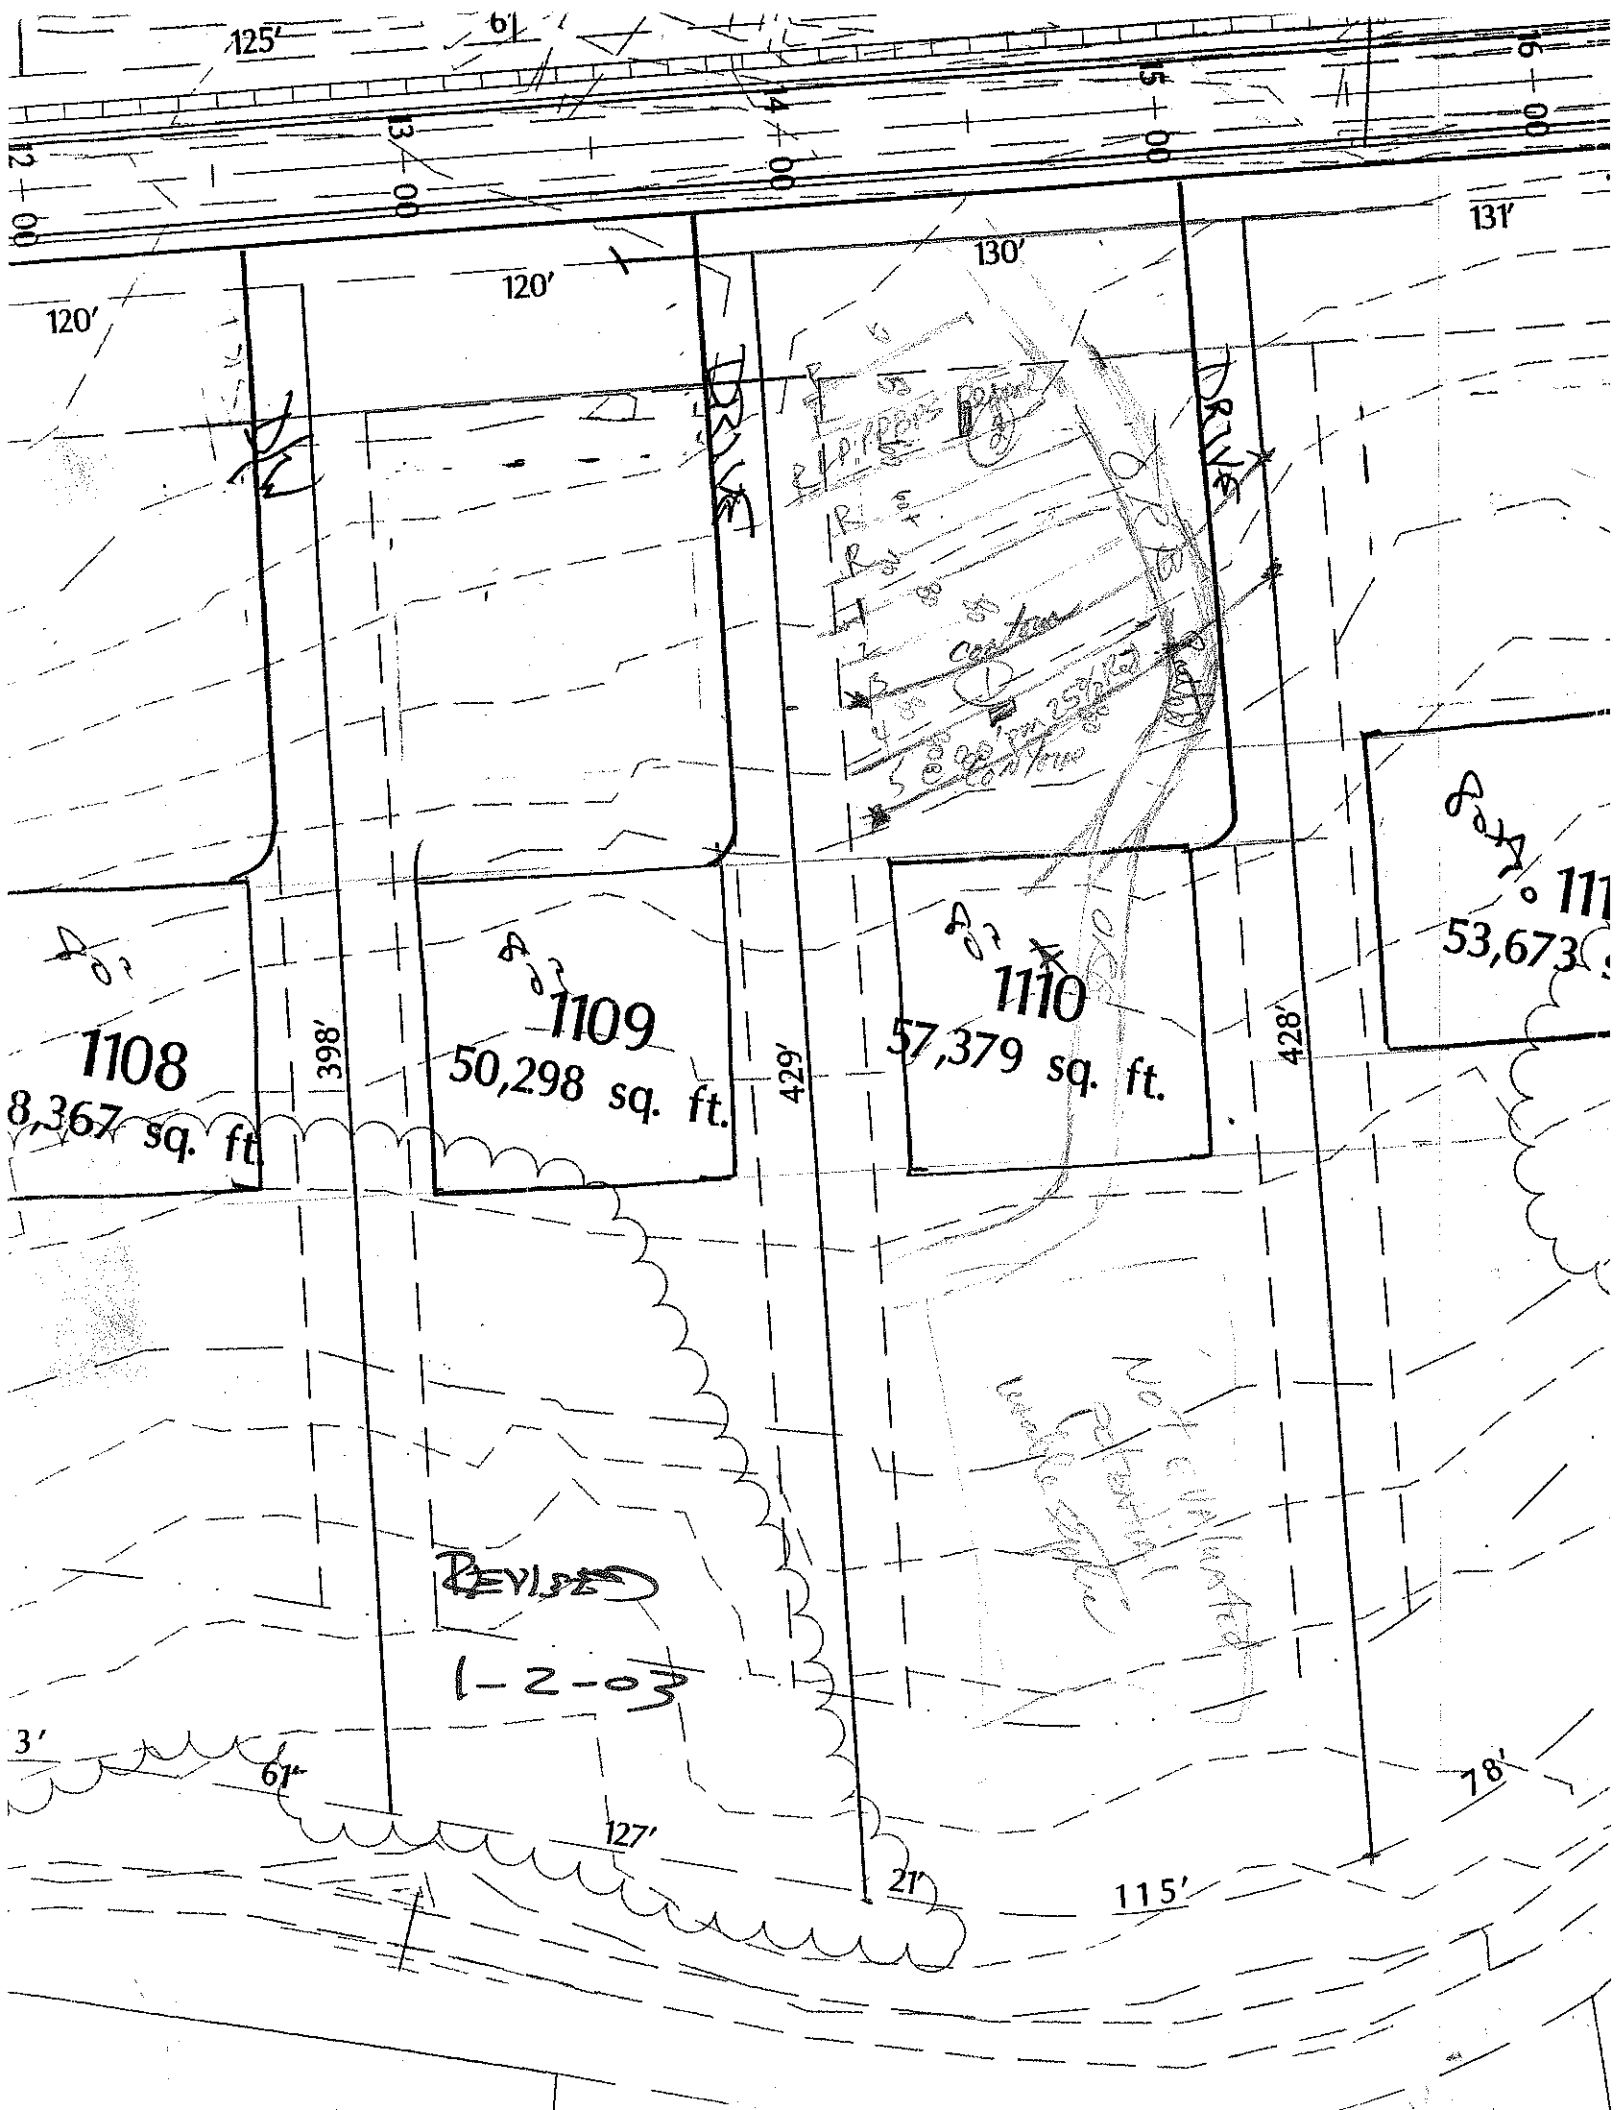
PROFILE #	.1940 LANDSCAPE POSITION/ SLOPE %	HORIZON DEPTH (IN.)	SOIL MORPHOLOGY (.1941) .1941 STRUCTURE/ TEXTURE	SOIL MORPHOLOGY (.1941) .1941 CONSISTENCE/ MINERALOGY	OTHER PROFILE FACTORS .1942 SOIL WETNESS/ COLOR	.1943 SOIL DEPTH	.1956 SAPRO CLASS	.1944 RESTR HORIZ	PROFILE CLASS & LTAR
1		0-8	wk sbk brn sl sy	fr sso					3
		8-31	m-wk sbk R sl sy	fr sso					
		31-53	m-wk sbk yl cl	fi sso sp	for common mi sp				
2	4 to 8%	0-4	wk sbk sandy l	fr sso sp					.37 23"
		4-23	wk sbk lms RBNC	fi sp					
		23-50	m Pmk Rd	fr sso sp					
		50-60	LSAP	fr sso sp					
3									
4

COMMENTS: NEW yard Not Disturbed. CRL did not want to clean up and dig Bitches.

DESCRIPTION	INITIAL SYSTEM	REPAIR SYSTEM
Available Space (.1945)		
System Type(s)	pm 25% Red	LPPPBPS
Site LTAR	.3	.3
