DEPARTMENT OF ENVIRONMENT AND NATURAL RESOURCES
DIVISION OF ENVIRONMENTAL HEALTH
ON-SITE WASTEWATER SECTION

SOIL/SITE EVALUATION
for ON-SITE WASTEWATER SYSTEM

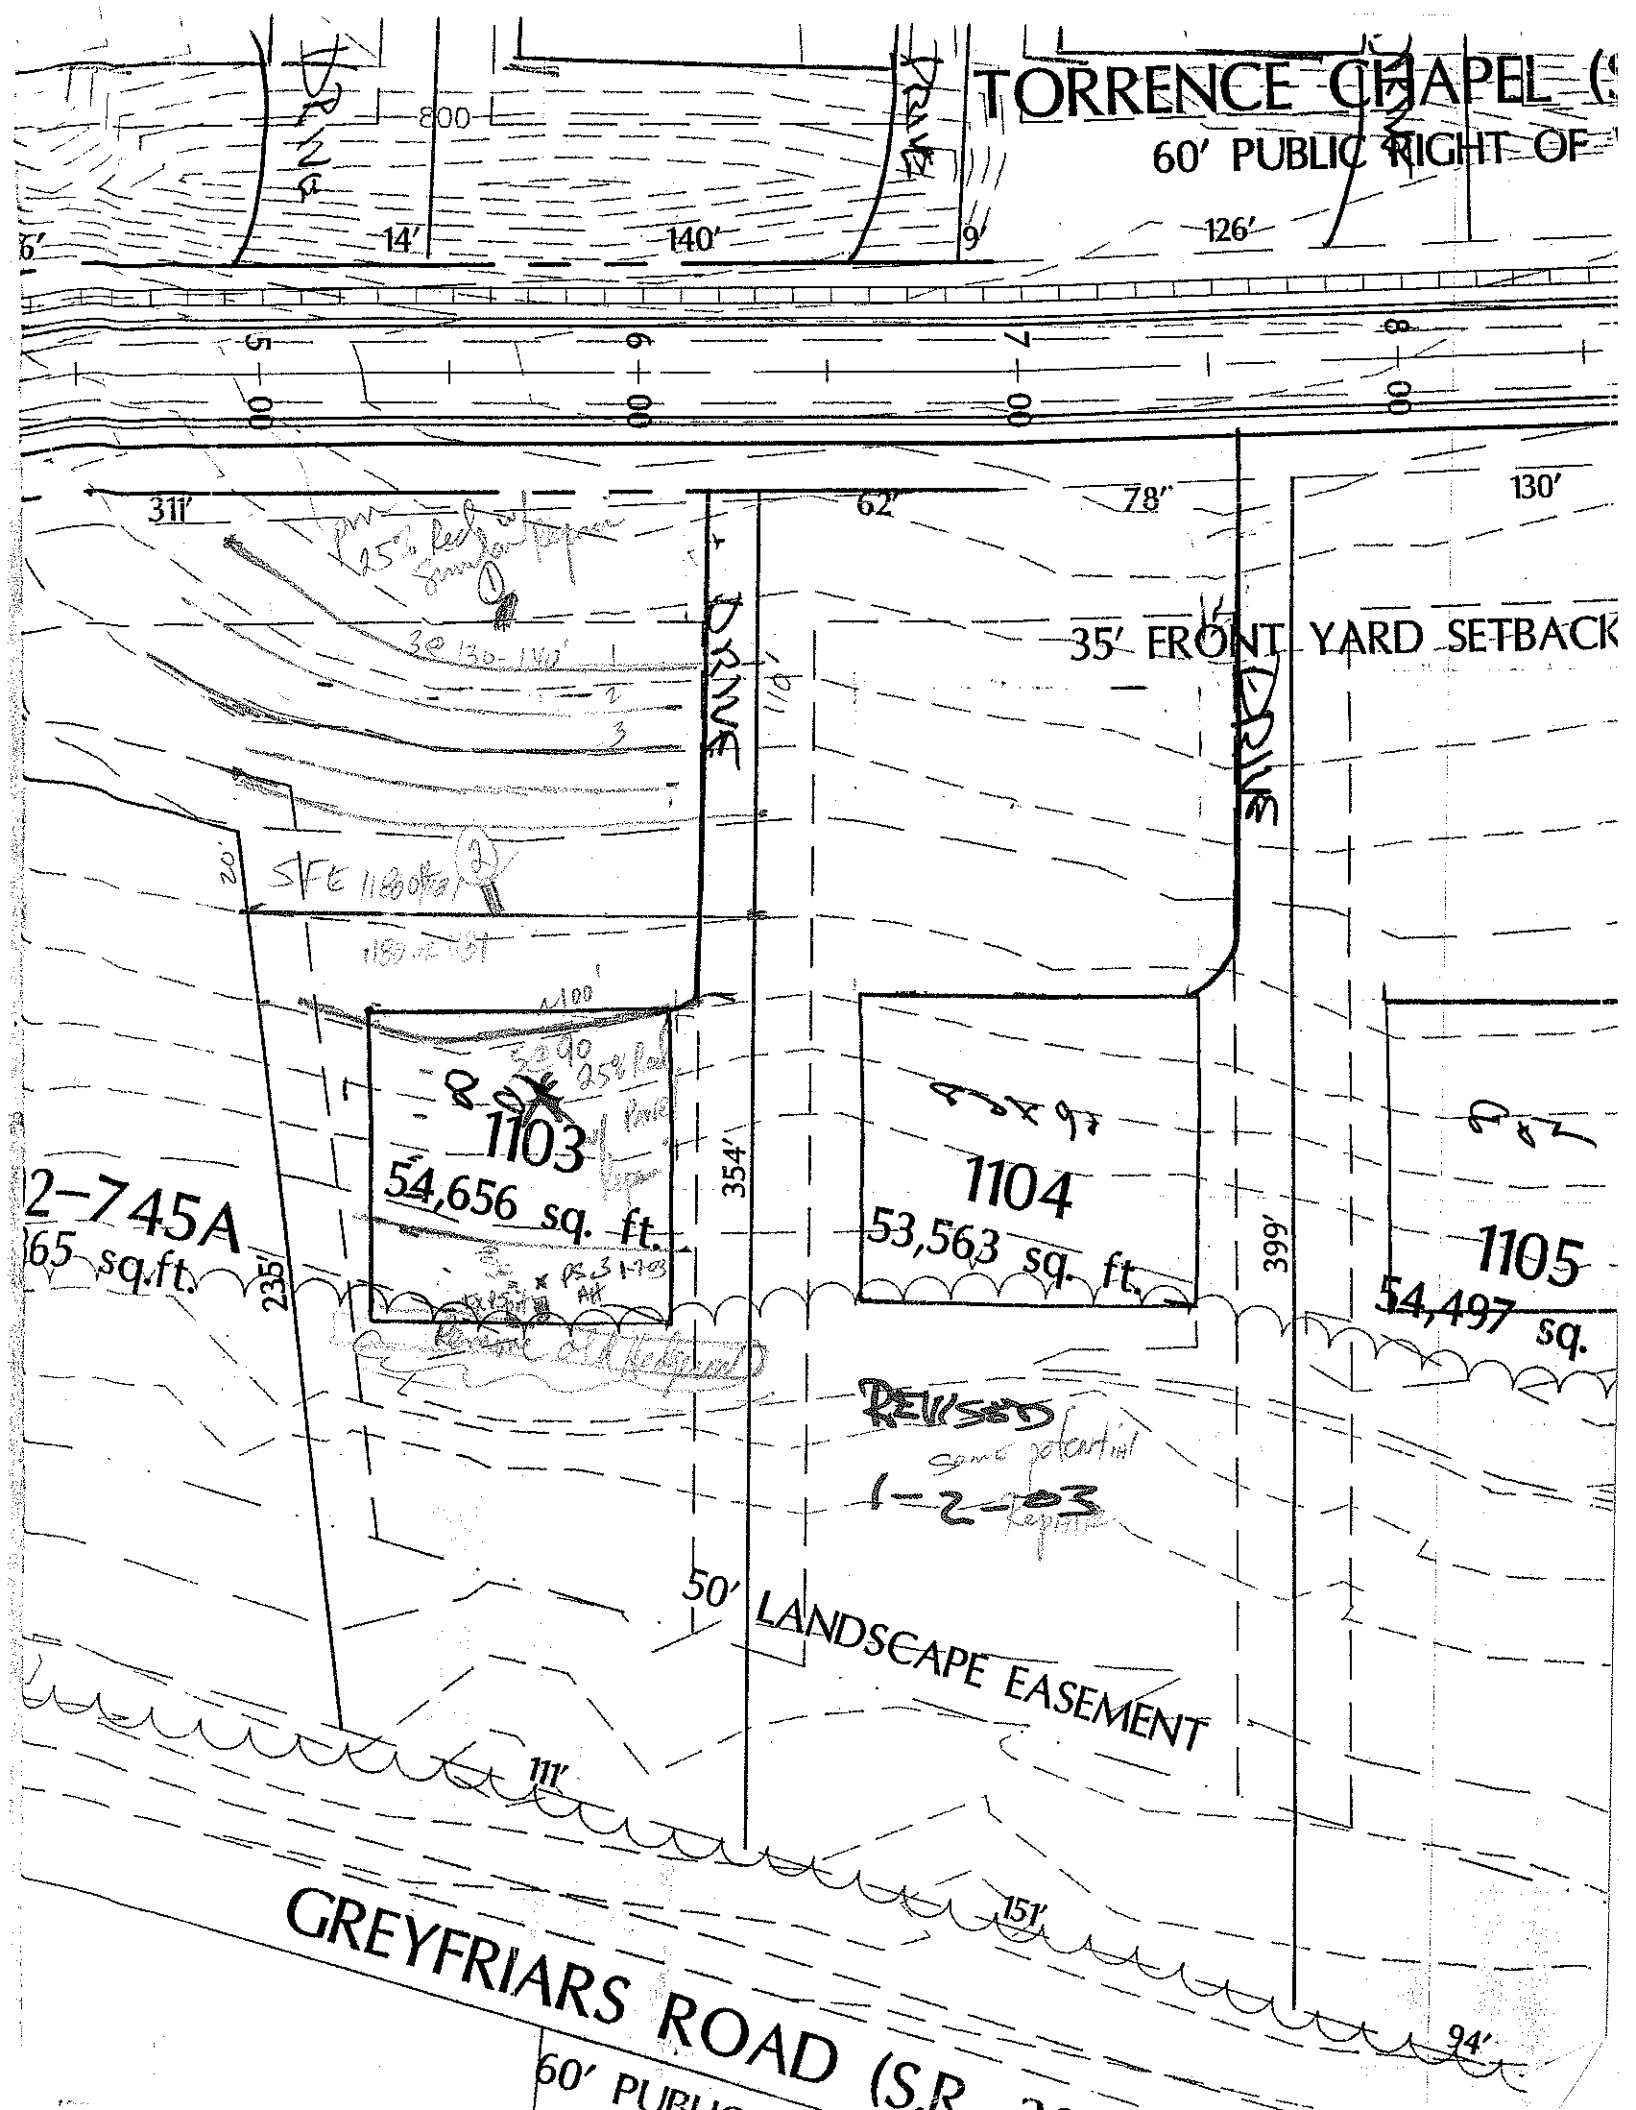
PROFILE #	.1940 LANDSCAPE POSITION/ SLOPE %	HORIZON DEPTH (IN.)	SOIL MORPHOLOGY (.1941) .1941 STRUCTURE/ TEXTURE	.1941 CONSISTENCE/ MINERALOGY	OTHER PROFILE FACTORS .1942 SOIL WETNESS/ COLOR	.1943 SOIL DEPTH	.1956 SAPRO CLASS	.1944 RESTR HORIZ	PROFILE CLASS & LTAR
1		0-17	SiL low-plas subsoil						
		17-54	wk mas ybr wk L-fksp		common manganese concr. ? No distinct color zone definite lateral water movement			maybe deep	
2			c-L		21-27"				4
3		0-10	wk mk c	fksp					
		10-22	m lam rd	fksp few common manganese concretions					4
		22-52	m lam rd	fksp definite lateral water movement					
				ssbg ybr wk	n20" - rocks & fragments				
4		0-8	comp sandy		Seeping out of bank				
		8-21	m lam sgr c	fksp					
		21-38	mix rd/ybr	common ybr fksp					4a, 2
		38-50	wh/gy rd	common mica sand

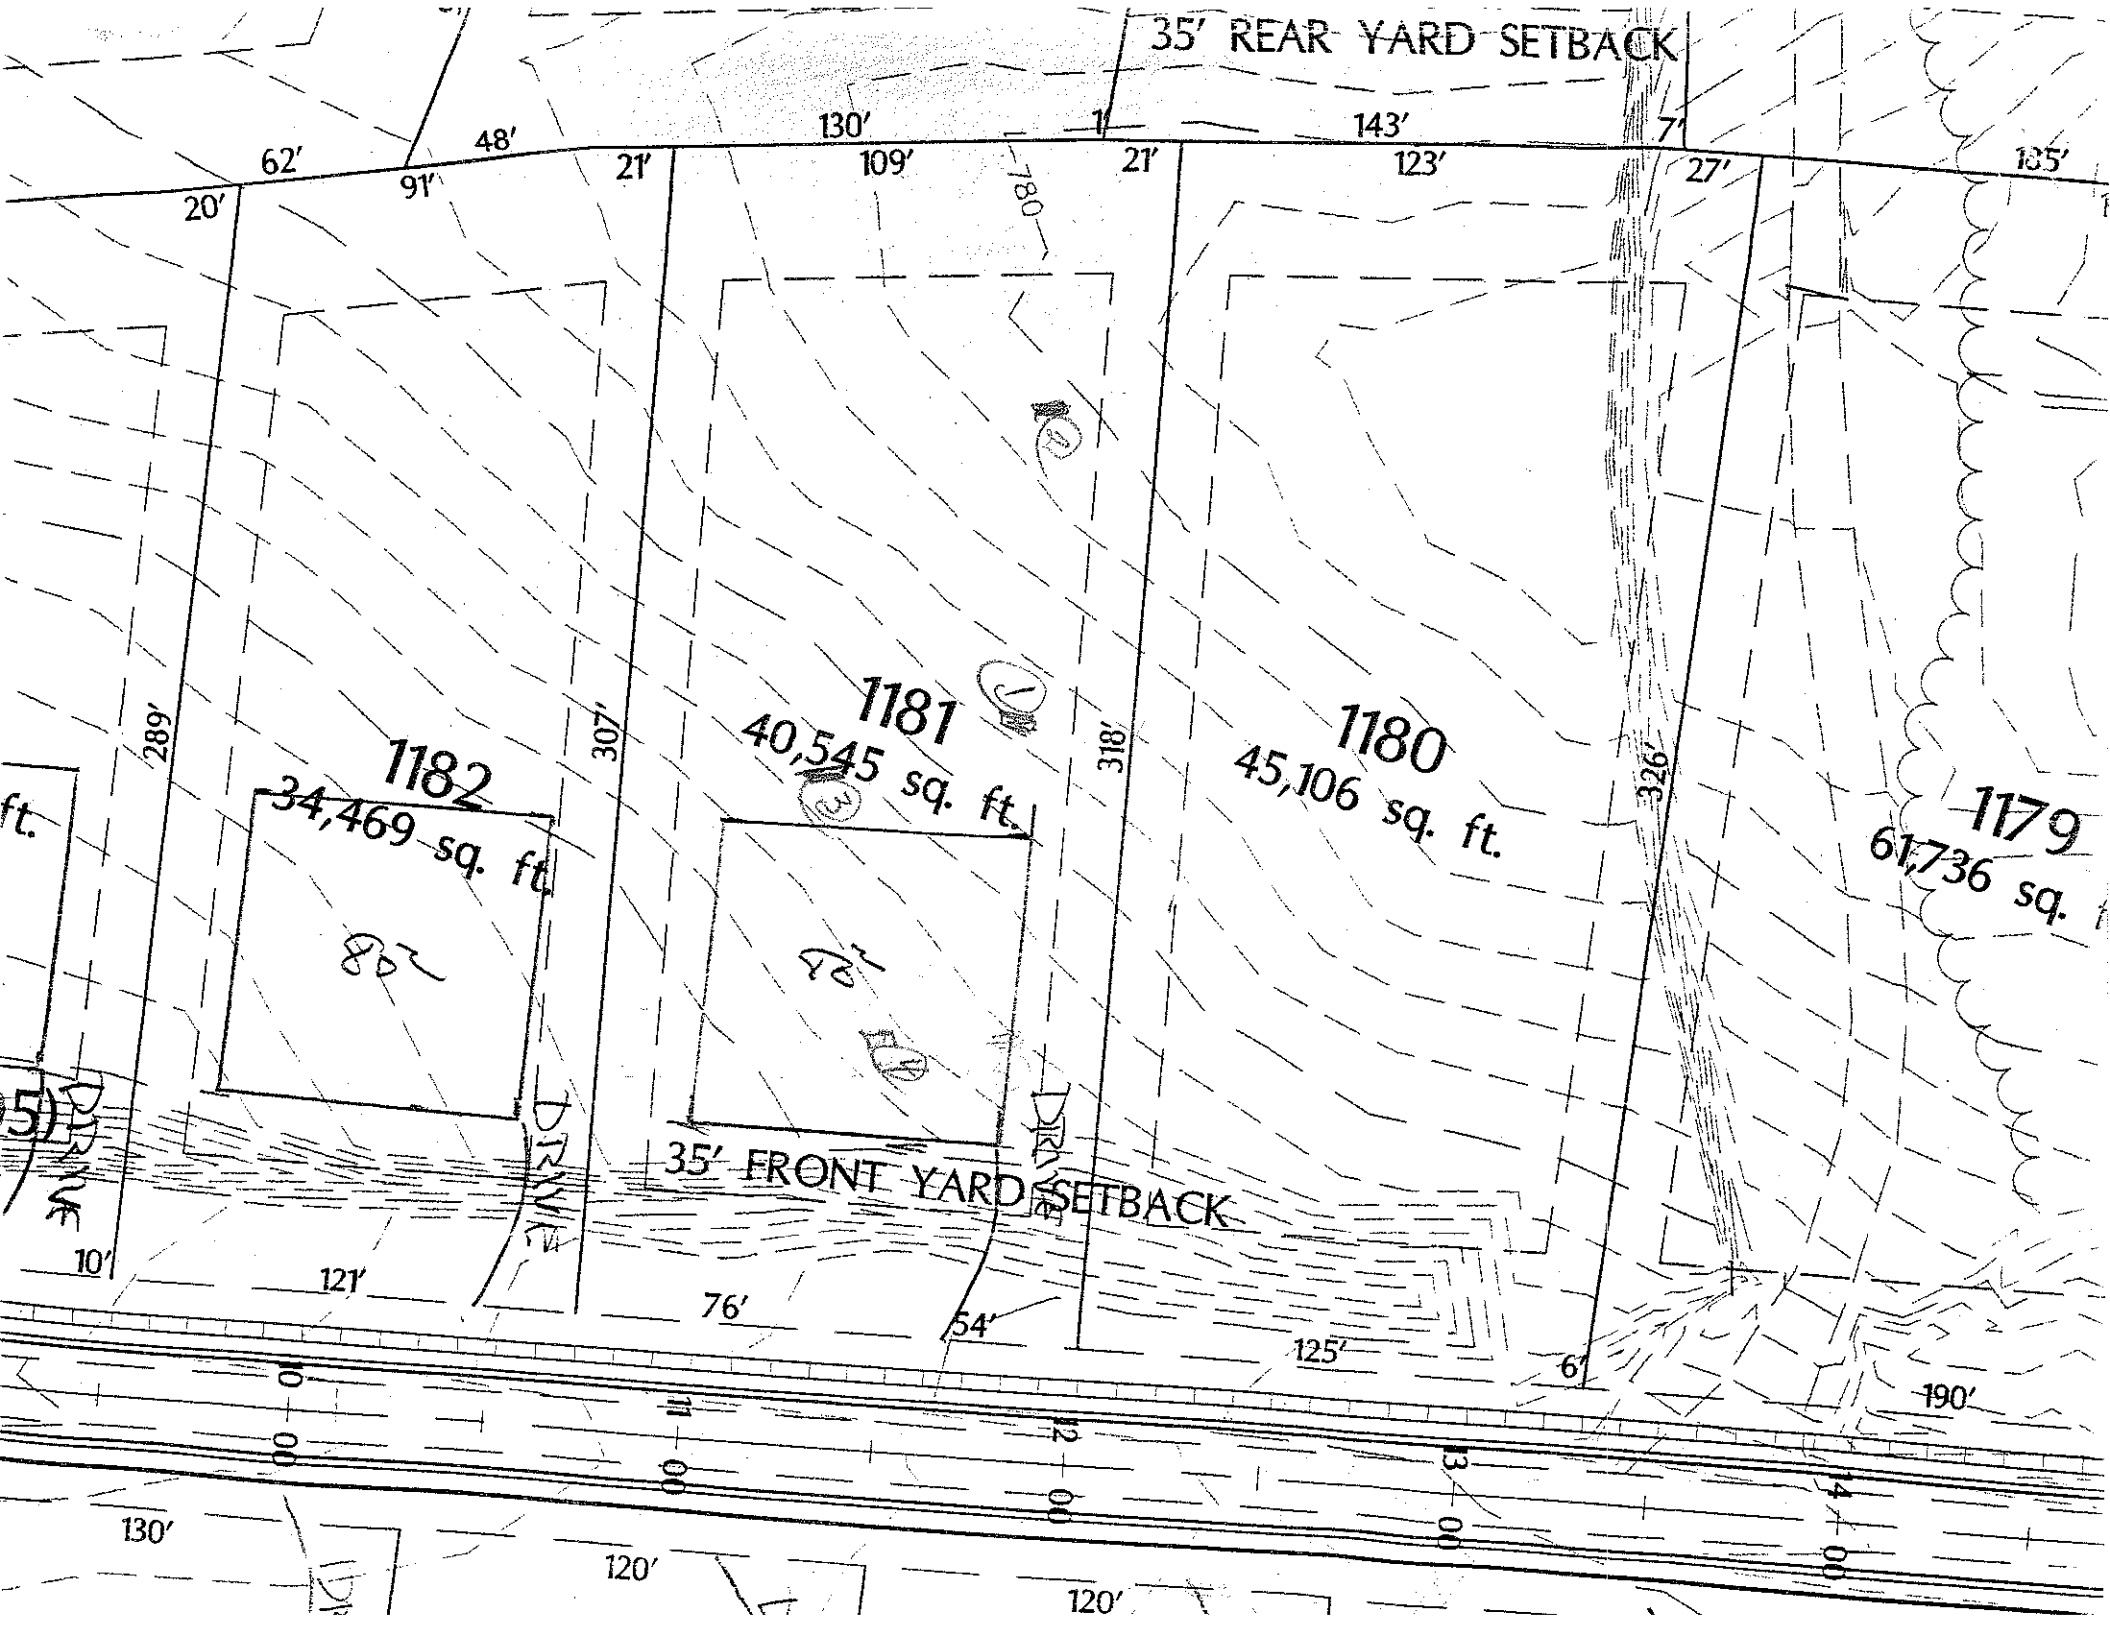
PROFILE #	.1940 LANDSCAPE POSITION/ SLOPE %	HORIZON DEPTH (IN.)	SOIL MORPHOLOGY (.1941) .1941 STRUCTURE/ TEXTURE	.1941 CONSISTENCE/ MINERALOGY	OTHER PROFILE FACTORS .1942 SOIL WETNESS/ COLOR	.1943 SOIL DEPTH	.1956 SAPRO CLASS	.1944 RESTR HORIZ	PROFILE CLASS & LTAR
1		0-6	gr sl cl/sandy	fr/ss/p					
		6-33	f sl blk RC	fr/sp					
		33-52	m sl blk gycl	fr/ss/p	for/fine sand/sp				.3
2	~5%	0-6	vf sdy sl/sandy	fr/ss/p					
		6-30	m/sdy sl RC	fr/sp					
		30-59	vk mott gycl	fr/ss/p	for/med sand/sp				.3
3	AW 1-7-03	0-48	RC/cl	fr/sp-ss/p					.3
4

COMMENTS: This lot NOW used for 2 SFE's for lots 1180 & 1181
