VISION OF ENVIRONMENTAL HEALTH
N-SITE WASTEWATER SECTION

SOIL/SITE EVALUATION
for ON-SITE WASTEWATER SYSTEM

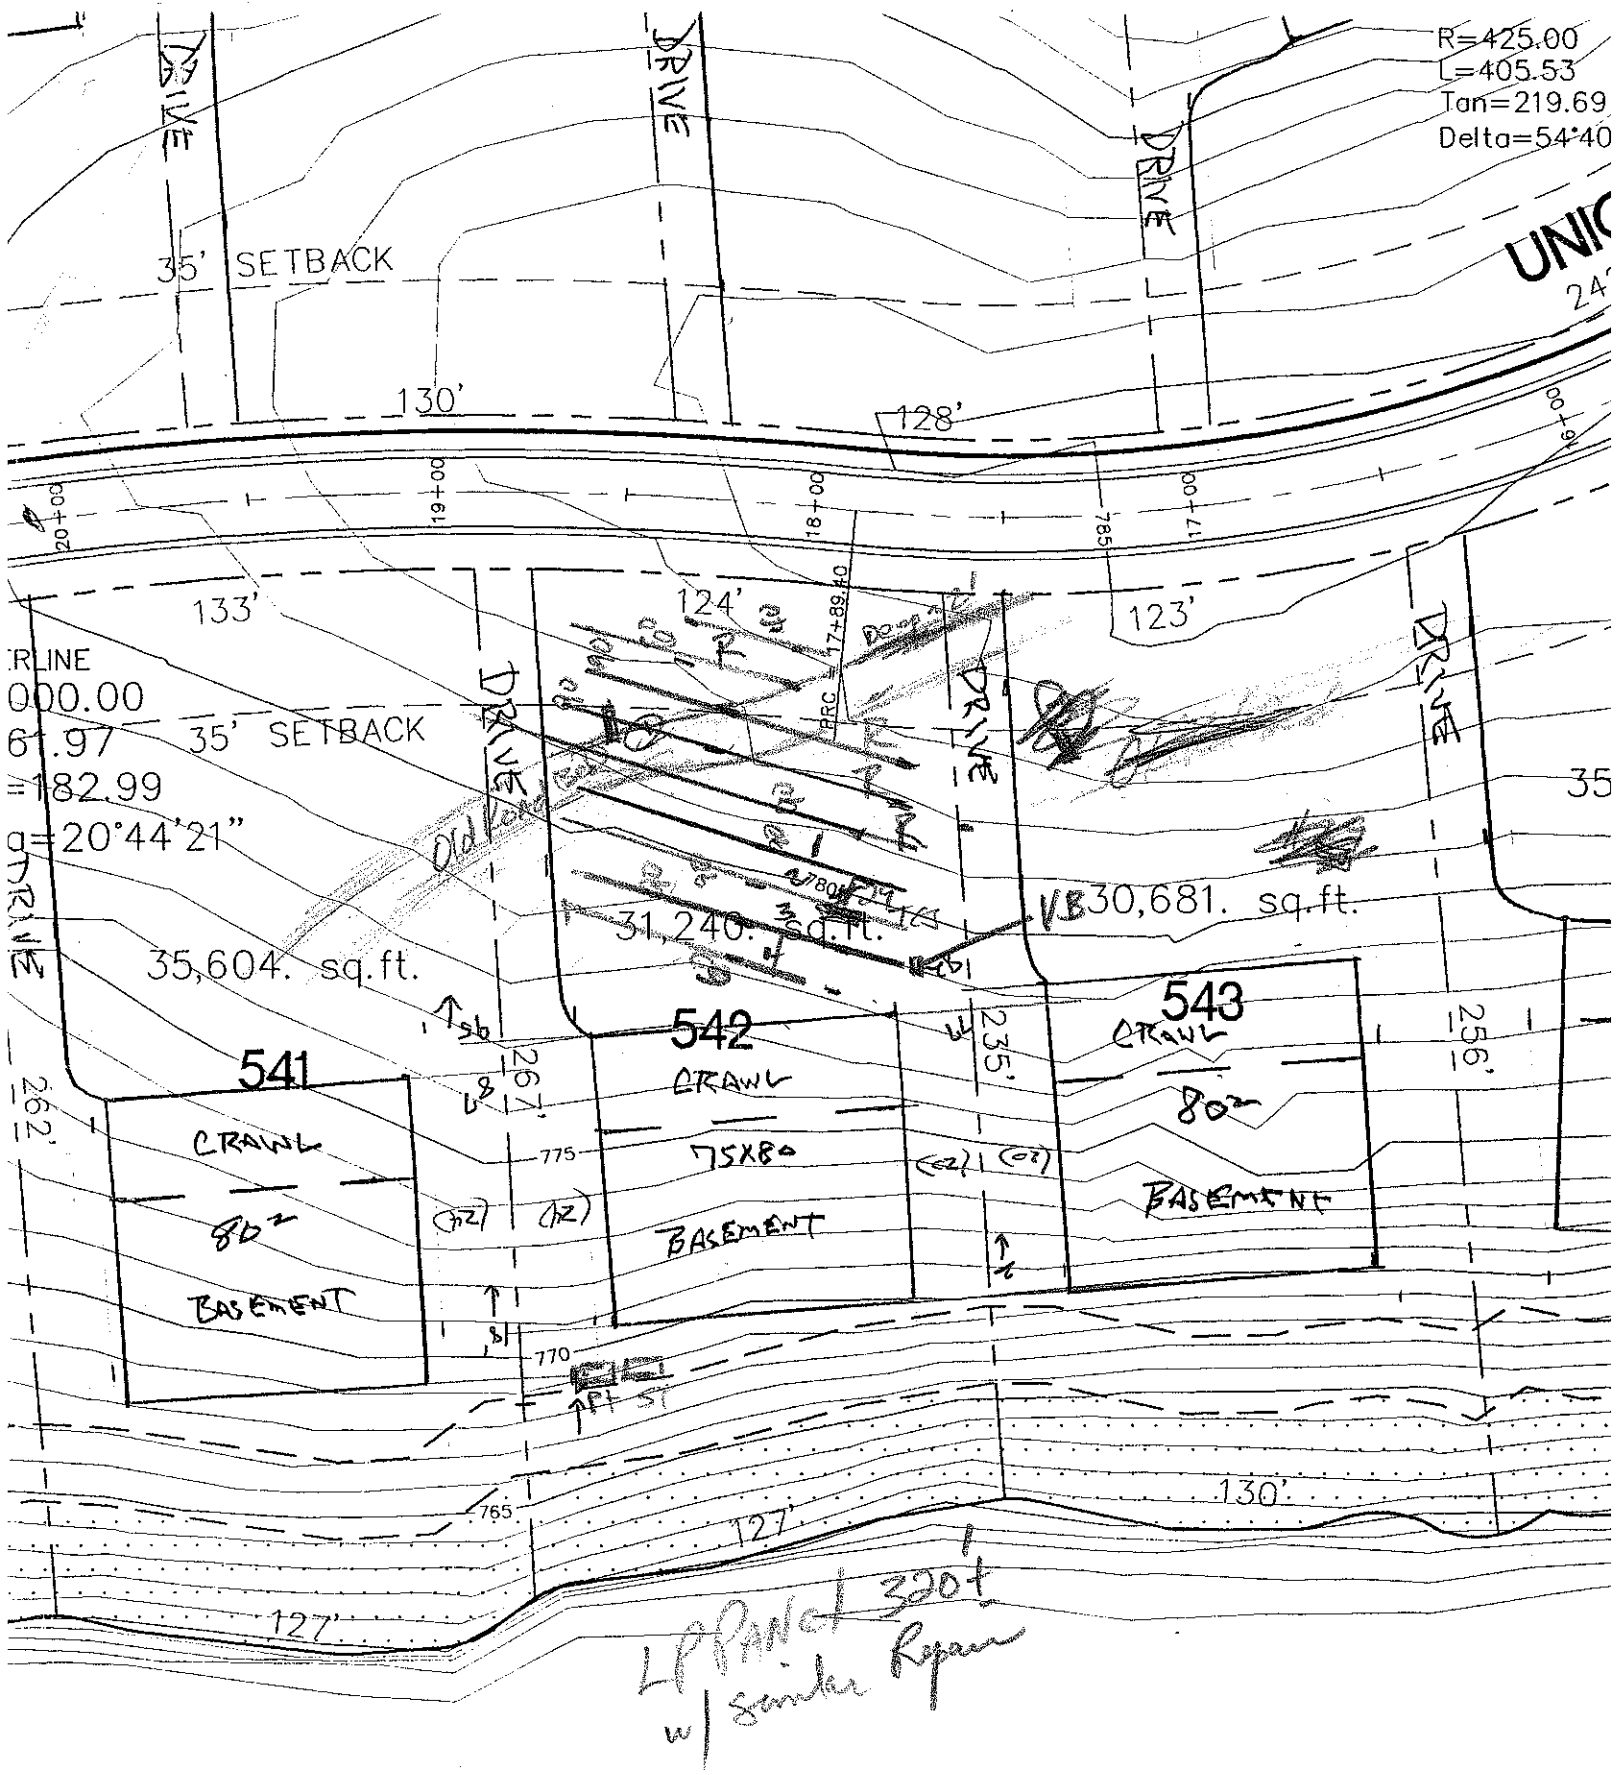
.1940 LAND-SCAPE POSITION/ SLOPE %	HORI-ZON DEPTH (IN.)	SOIL MORPHOLOGY (.1941) .1941 STRUCTURE/ TEXTURE	.1941 CONSISTENCE/ MINERALOGY	OTHER PROFILE FACTORS .1942 SOIL WETNESS/ COLOR	.1943 SOIL DEPTH	.1956 SAPRO CLASS	.1944 RESTR HORIZ	PROFILE CLASS & LTAR
	0-11	massive brn sl						
	11-25	wk sbk ec	LFSP	common y-brn mottles				.2-.25
	25-53	wk sbk gpcl	FR SSSP	few y-brn mottles				=3
#109 TCS	0-7	g brn sl	fr					P5
	7-15	m brn ec	FSP					=3
	15-50	m sbk gpcl	FR SSSP	common med y spp/brn mottles

R=425.00
L=405.53
Tan=219.69
Delta=54°40
DRIVE
DRIVE
DRIVE
35' SETBACK
130'
128'
133'
124'
123'
35' SETBACK
35,604. sq.ft.
31,240. sq.ft.
30,681. sq.ft.
541
542
543
CRAWL
80²
BASEMENT
75X80
256'
235'
262'
130'
127'
127'
LF Panel 320±
Sewer Repair
