DIVISION OF ENVIRONMENTAL HEALTH
ON-SITE WASTEWATER SECTION

SOIL/SITE EVALUATION
for ON-SITE WASTEWATER SYSTEM

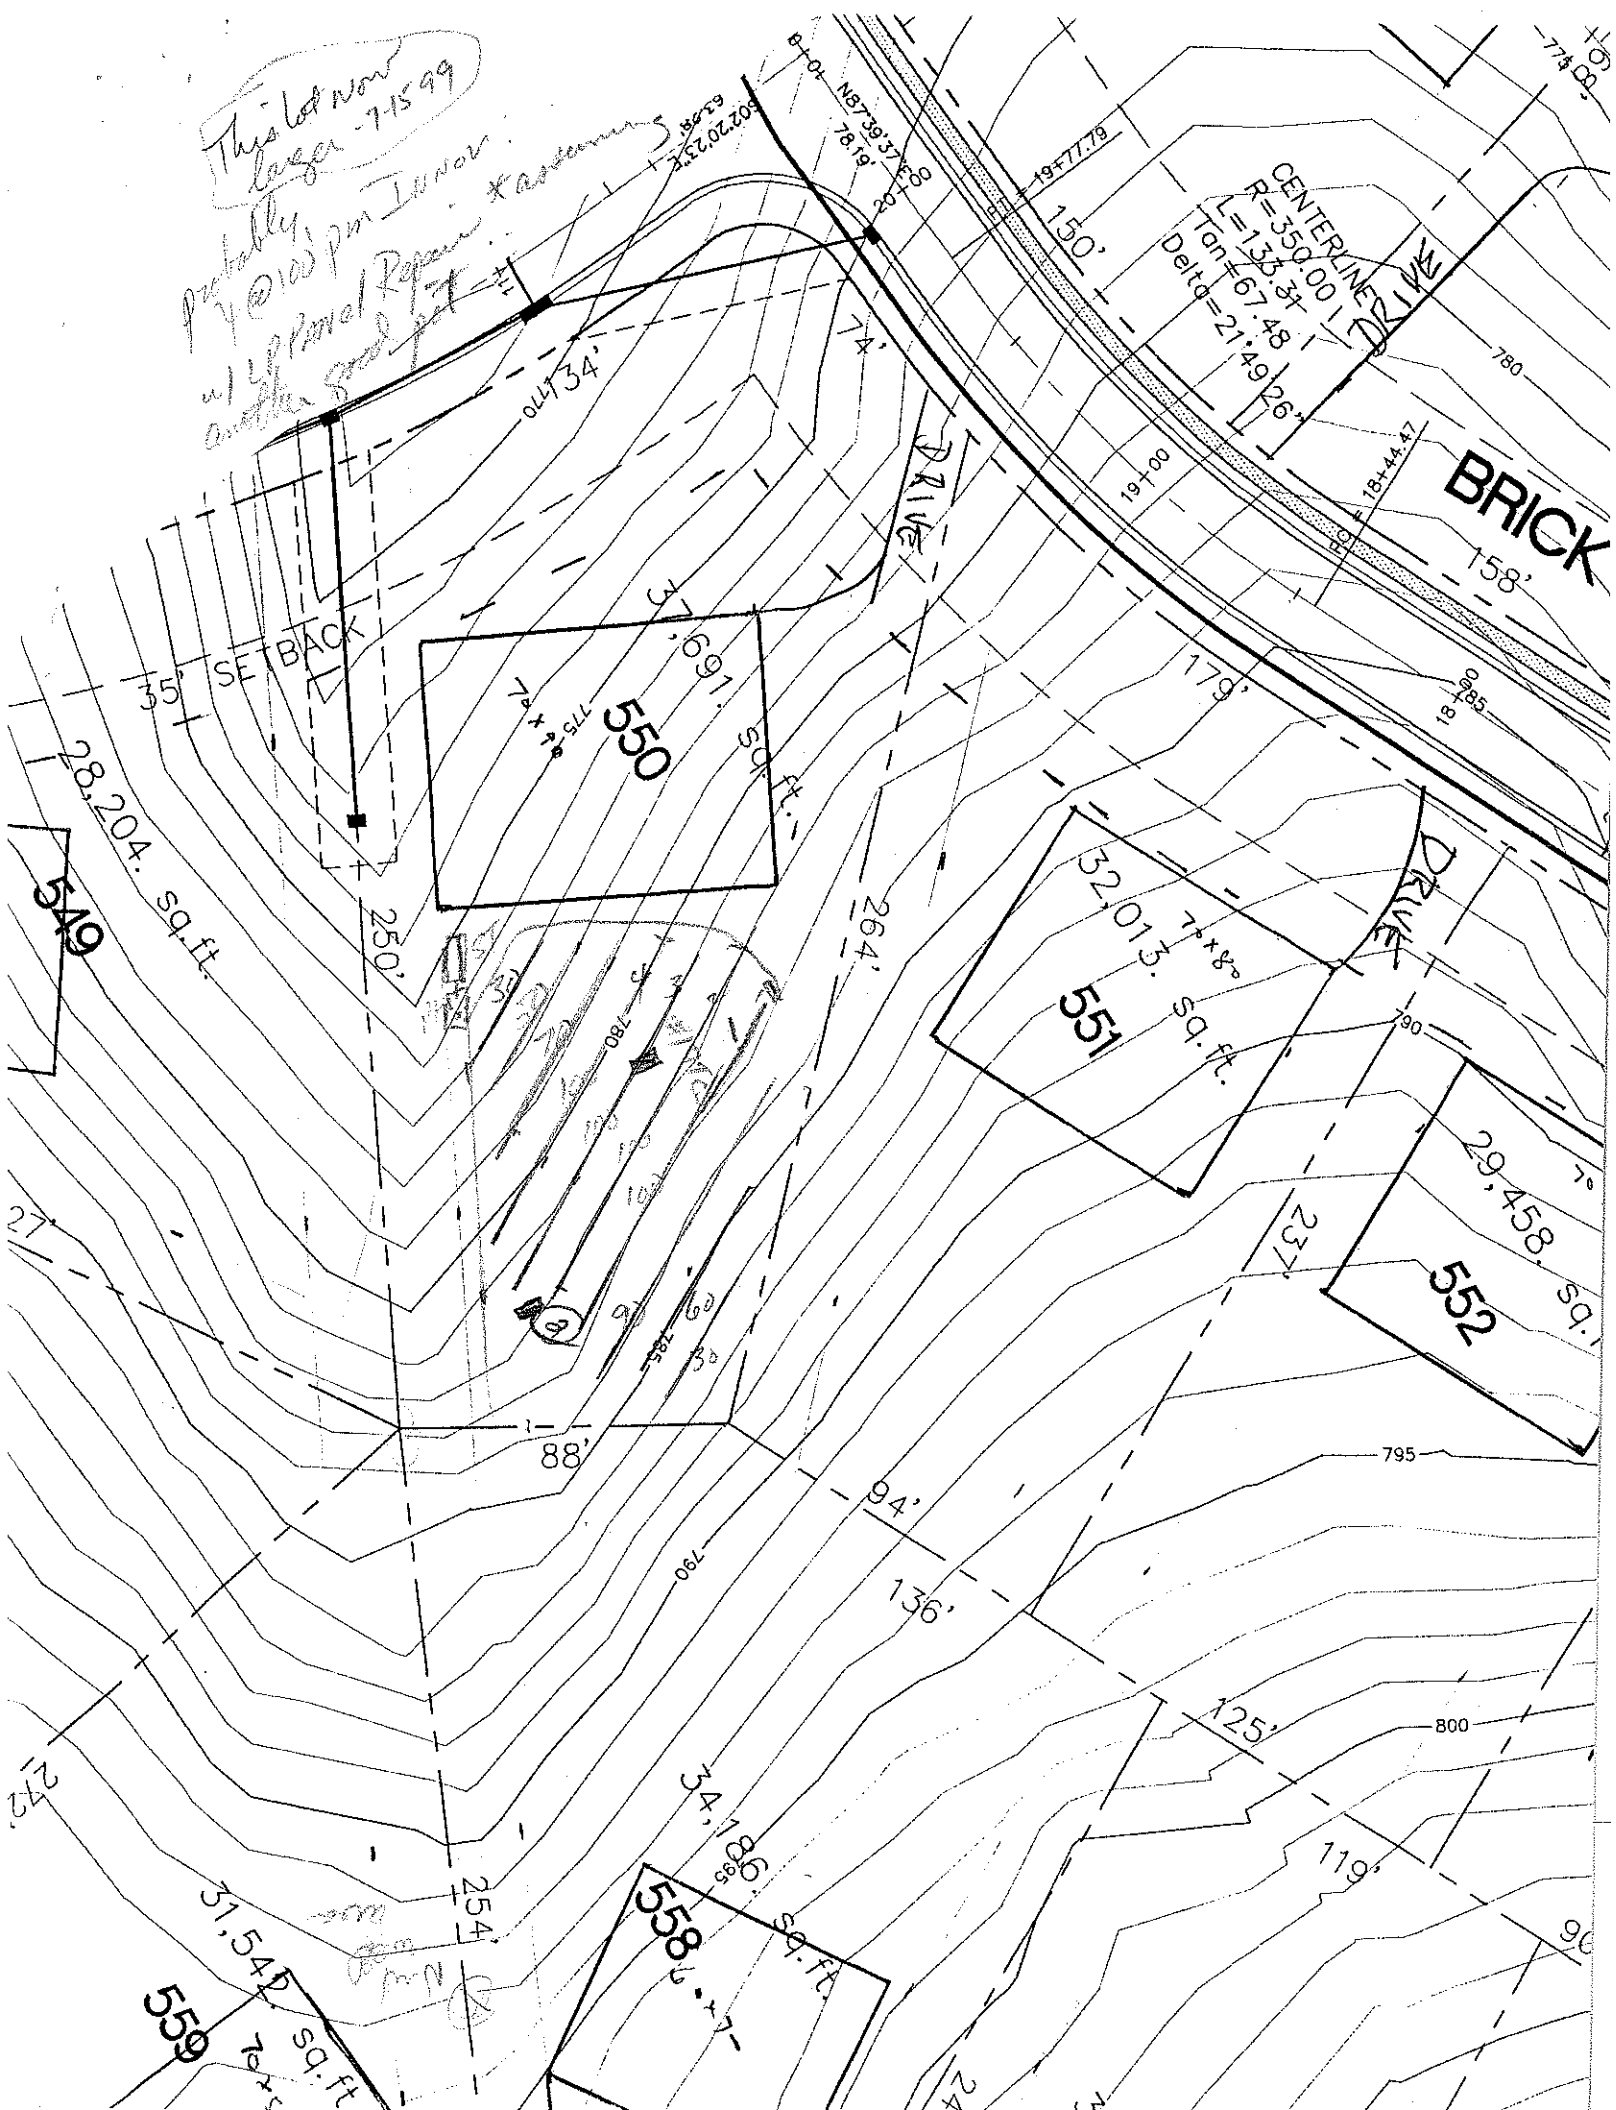
PROFILE #	.1940 LANDSCAPE POSITION/ SLOPE %	HORIZON DEPTH (IN.)	SOIL MORPHOLOGY (.1941) .1941 STRUCTURE/ TEXTURE	.1941 CONSISTENCE/ MINERALOGY	OTHER PROFILE FACTORS .1942 SOIL WETNESS/ COLOR	.1943 SOIL DEPTH	.1956 SAPRO CLASS	.1944 RESTR HORIZ	PROFILE CLASS & LTAR
1	#17 LCJ	0-10	sg brnsl/sdl fr						PS .3
		10-26	Mf sbk R [illegible] fr sp						
		26-55	Mf sbk yscl fr ss sp common mot cg						
2	6-4-99	0-10	gr-vfsb sl brn sdl fr sp						PS .3
		10-35	Mf sbk RCL fr sp						
		35-48	wk sbk RY scl fr ss sp common mot cg						
		48-57	gl hard ss sp w/mid hardware

This lot now
larger - 7-15-99
probably
4 @ 150 per Linear
w/ 2 Corner Repair + Extension
another Small Lot
CENTERLINE
R=350.00'
L=133.31'
Tan=67.48'
Delta=21°49'26"
DRIVE
BRICK
35' SETBACK
550
28,204. sq.ft.
549
32,013. sq.ft.
551
29,458. sq.ft.
552
31,542. sq.ft.
559
558
34,186. sq.ft.
N87°39'37"E
78.19'
S02°20'23"E
63.58'
74'
170'
264'
179'
158'
88'
94'
136'
125'
119'
254'
150'
780
785
790
795
800
