DIVISION OF ENVIRONMENTAL HEALTH
ON-SITE WASTEWATER SECTION

SOIL/SITE EVALUATION
for ON-SITE WASTEWATER SYSTEM

OWNER: Lot 526 APPLICANT: _____
ADDRESS: _____ APPLICATION DATE: _____ DATE EVALUATED: 5-27-99
PROPOSED FACILITY: _____ PROPOSED DESIGN FLOW (.1949): _____ PROPERTY SIZE: _____
LOCATION OF SITE: Lot 526 Shute Rd. PROPERTY RECORDED: _____
WATER SUPPLY: ☐ Private ☐ Public ☐ Well ☐ Spring ☐ Other _____
EVALUATION METHOD: ☐ Auger Boring ☐ Pit ☐ Cut
TYPE OF WASTEWATER: ☐ Sewage ☐ Industrial Process ☐ Mixed

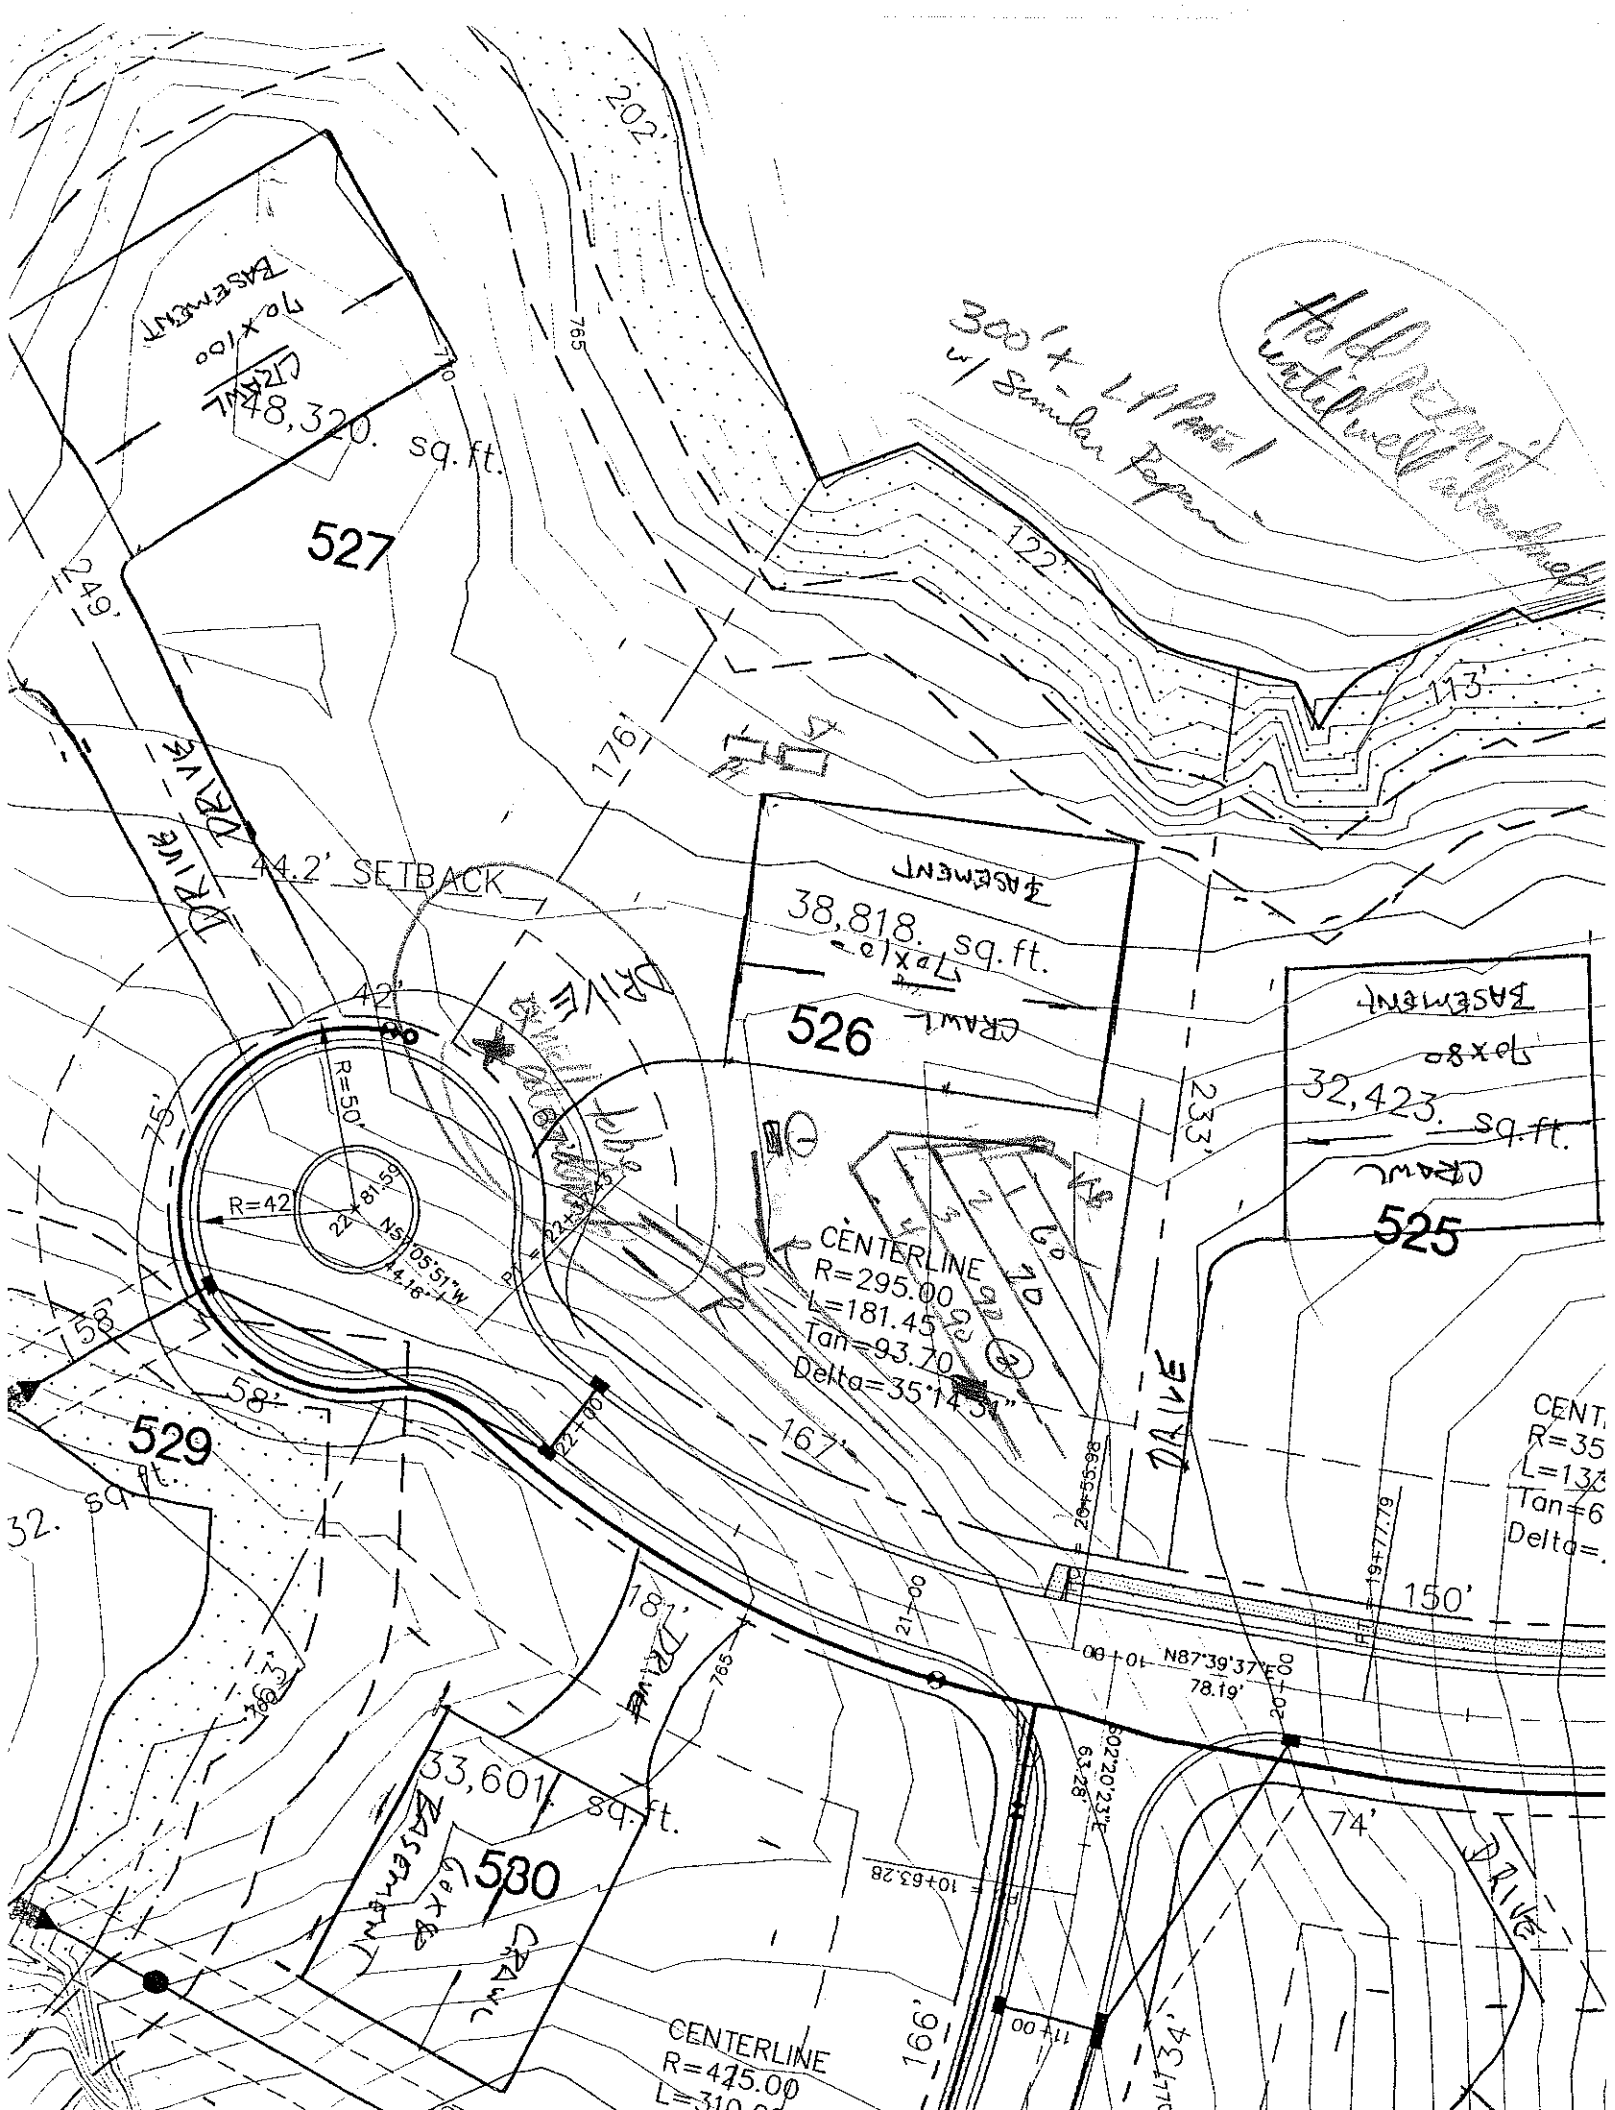
PROFILE #	.1940 LANDSCAPE POSITION/ SLOPE %	HORIZON DEPTH (IN.)	SOIL MORPHOLOGY (.1941) .1941 STRUCTURE/ TEXTURE	.1941 CONSISTENCE/ MINERALOGY	OTHER PROFILE FACTORS .1942 SOIL WETNESS/ COLOR	.1943 SOIL DEPTH	.1956 SAPRO CLASS	.1944 RESTR HORIZ	PROFILE CLASS & LTAR
1		0-7	mucky brsl	fr ssp					PS .3
		7-24	mfsab RC	fr sl sp					
		24-56	mfsab Rg CL	fr ssp common mi ssp					
2		0-7	mucky silt brsl						PS .3
		7-28	SiCl RC	fr sp					
		28-58	wk sab gr sil CL	w/ common mi ssp					
3									
4

527
48,320. sq.ft.
526
38,818. sq.ft.
525
32,423. sq.ft.
529
580
33,601 sq.ft.
44.2' SETBACK
CENTERLINE
R=295.00
L=181.45
Tan=93.70
Delta=35°14'31"
CENTERLINE
R=425.00
L=310.0
R=50'
R=42
N5°05'51"W
44.16'
N87°39'37"E
78.19'
S22°20'23"E
63.28'
DRIVE
COURT
150'
167'
74'
34'
202'
249'
176'
122'
113'
233'
100'
160'
181'
63'
58'
75'
42'
30'
21'
20'
765'
Basement
Clear
70'x100'
90'x80'
30'± Level
w/ Garden Repair
to Owner's Discretion
