SOIL/SITE EVALUATION
for ON-SITE WASTEWATER SYSTEM

OWNER: CRT APPLICANT: _____
ADDRESS: _____ APPLICATION DATE: _____ DATE EVALUATED: 3-18-04
PROPOSED FACILITY: _____ PROPOSED DESIGN FLOW (.1949): 4 Bdrm PROPERTY SIZE: _____
LOCATION OF SITE: lot 1362 Phs 13 The Pt. PROPERTY RECORDED: _____
WATER SUPPLY: ☐ Private ☐ Public ☑ Well ☐ Spring ☐ Other _____
EVALUATION METHOD: ☐ Auger Boring ☑ Pit ☐ Cut
TYPE OF WASTEWATER: ☑ Sewage ☐ Industrial Process ☐ Mixed

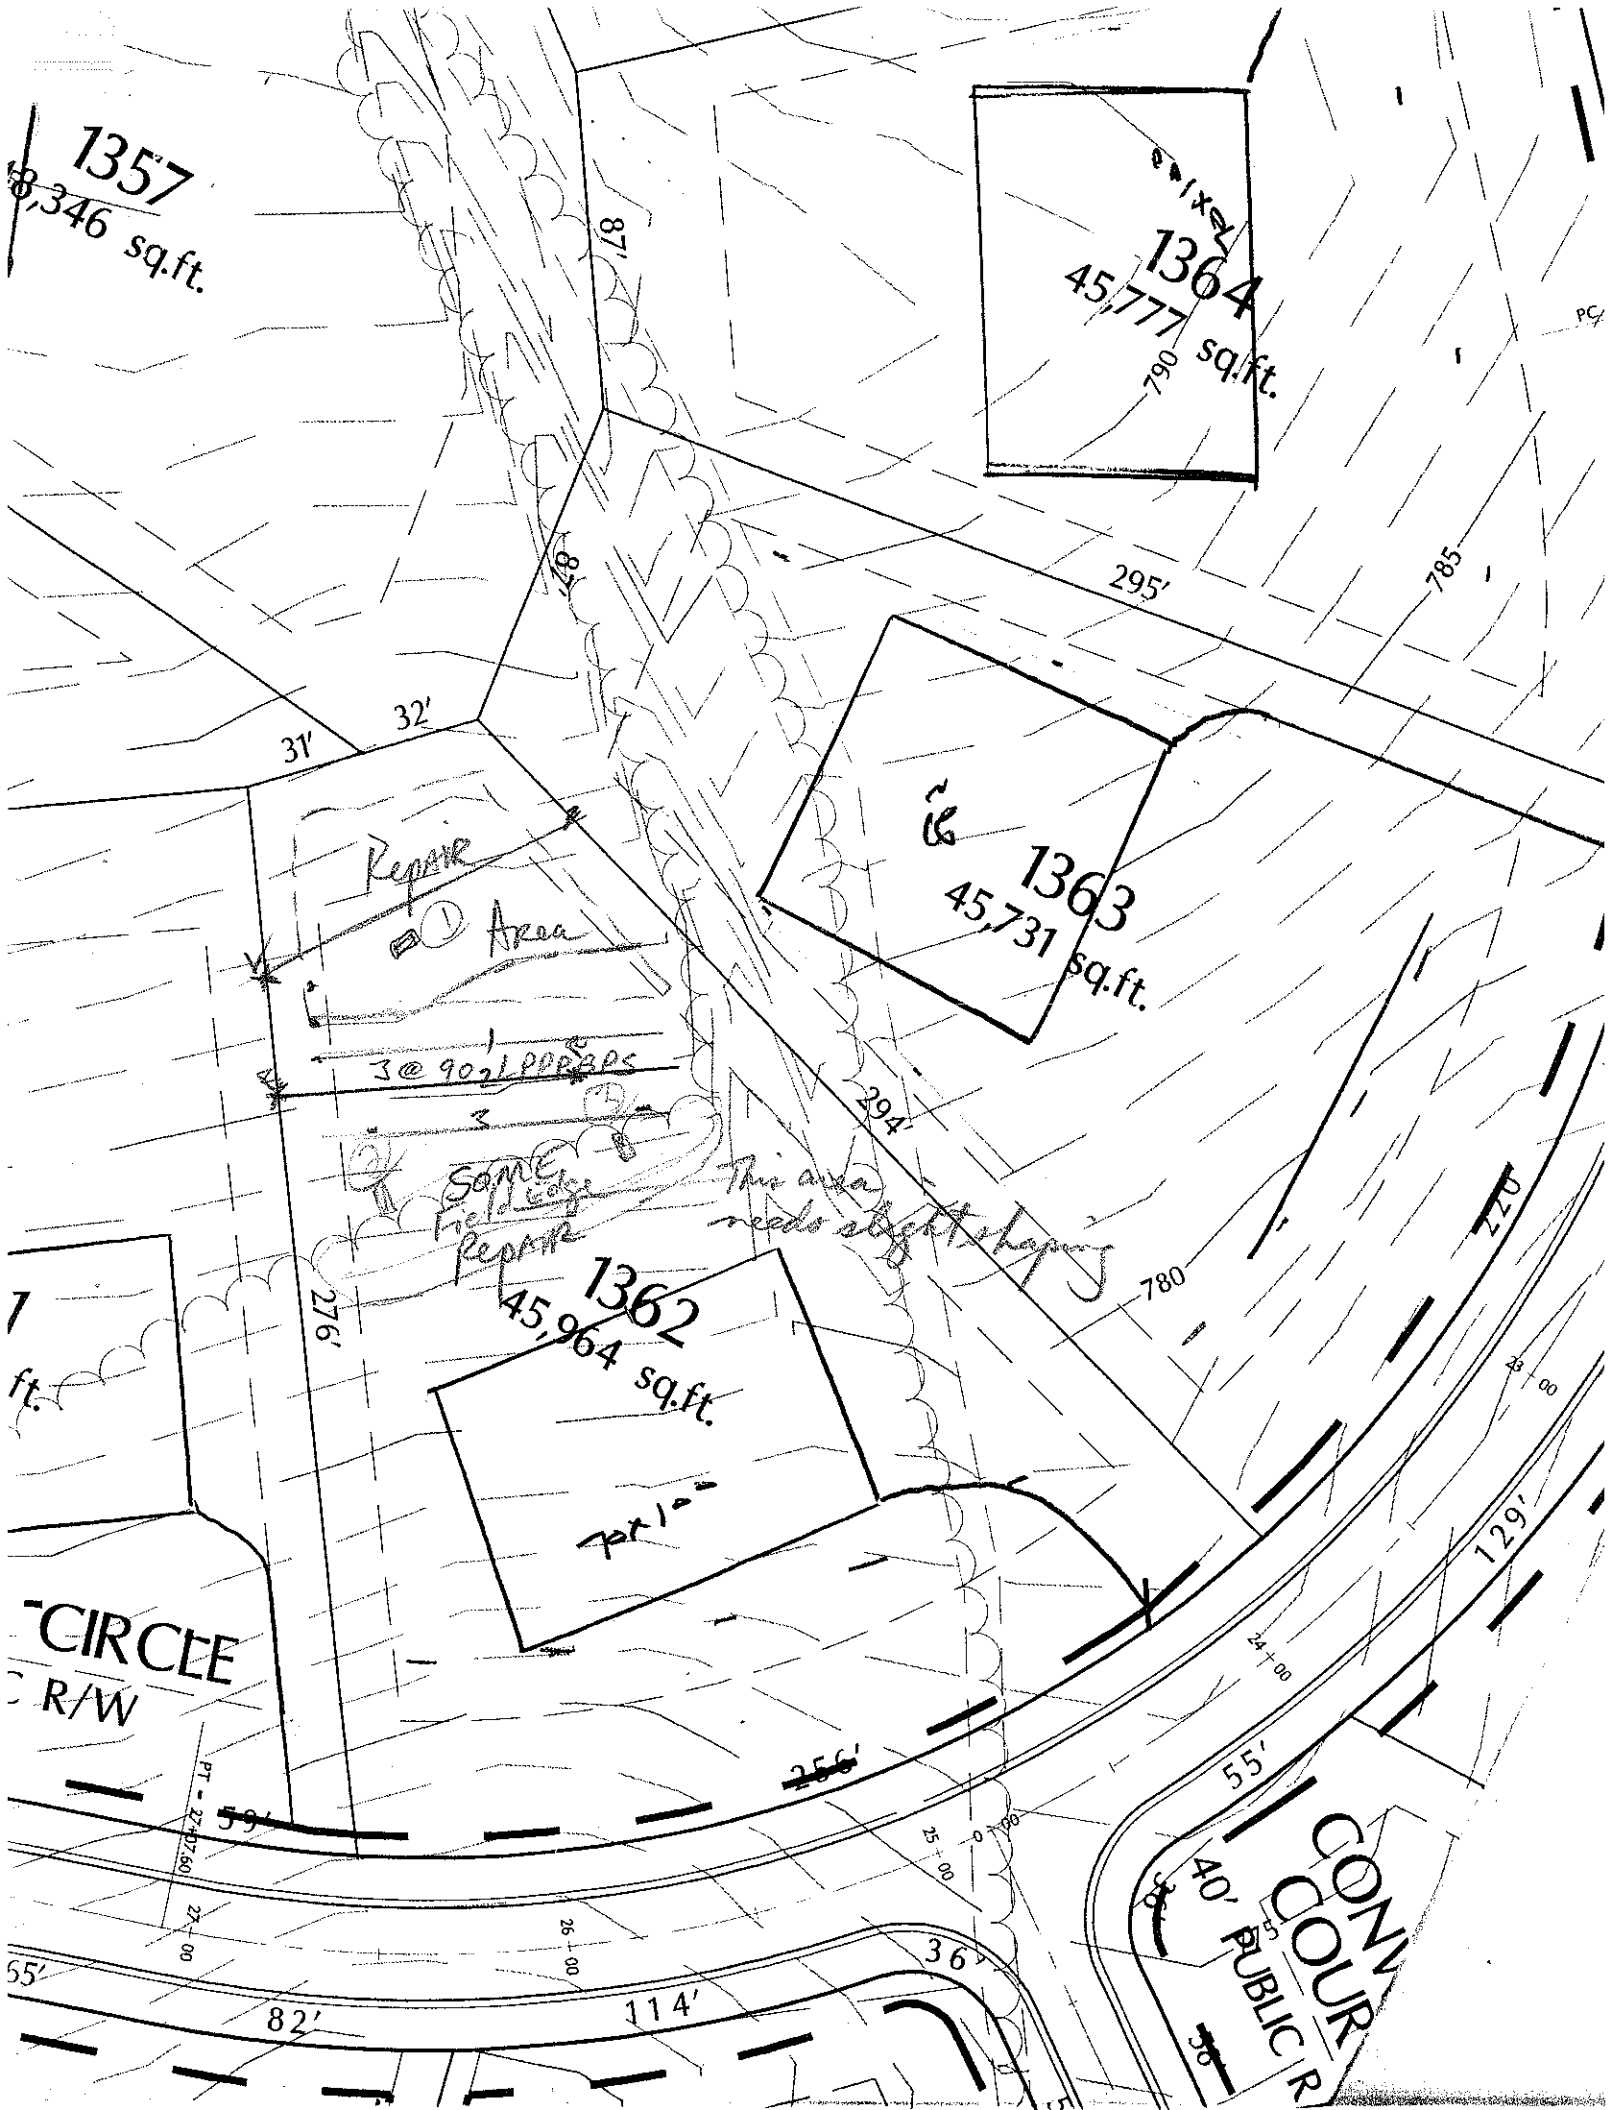
1357
8,346 sq.ft.
87'
1364
45,777 sq.ft.
790
785
295'
287'
32'
31'
Repair
Area
3@ 90° Lpgs
SOME Repair
This area needs slight Leveling
1363
45,731 sq.ft.
294'
1362
45,964 sq.ft.
276'
780
220
129'
55'
CIRCLE
R/W
59'
256'
82'
114'
36'
40'
PUBLIC
COURT
