DIVISION OF ENVIRONMENTAL HEALTH:
ON-SITE WASTEWATER SECTION

SOIL/SITE EVALUATION
for ON-SITE WASTEWATER SYSTEM

OWNER: CRI APPLICANT: _____
ADDRESS: _____ APPLICATION DATE: _____ DATE EVALUATED: 3-23-99
PROPOSED FACILITY: _____ PROPOSED DESIGN FLOW (.1949): _____ PROPERTY SIZE: _____
LOCATION OF SITE: Lot 302 phase III Hoke PROPERTY RECORDED: _____
WATER SUPPLY: ☐ Private ☐ Public ☐ Well ☐ Spring ☐ Other _____
EVALUATION METHOD: ☐ Auger Boring ☐ Pit ☐ Cut
TYPE OF WASTEWATER: ☐ Sewage ☐ Industrial Process ☐ Mixed

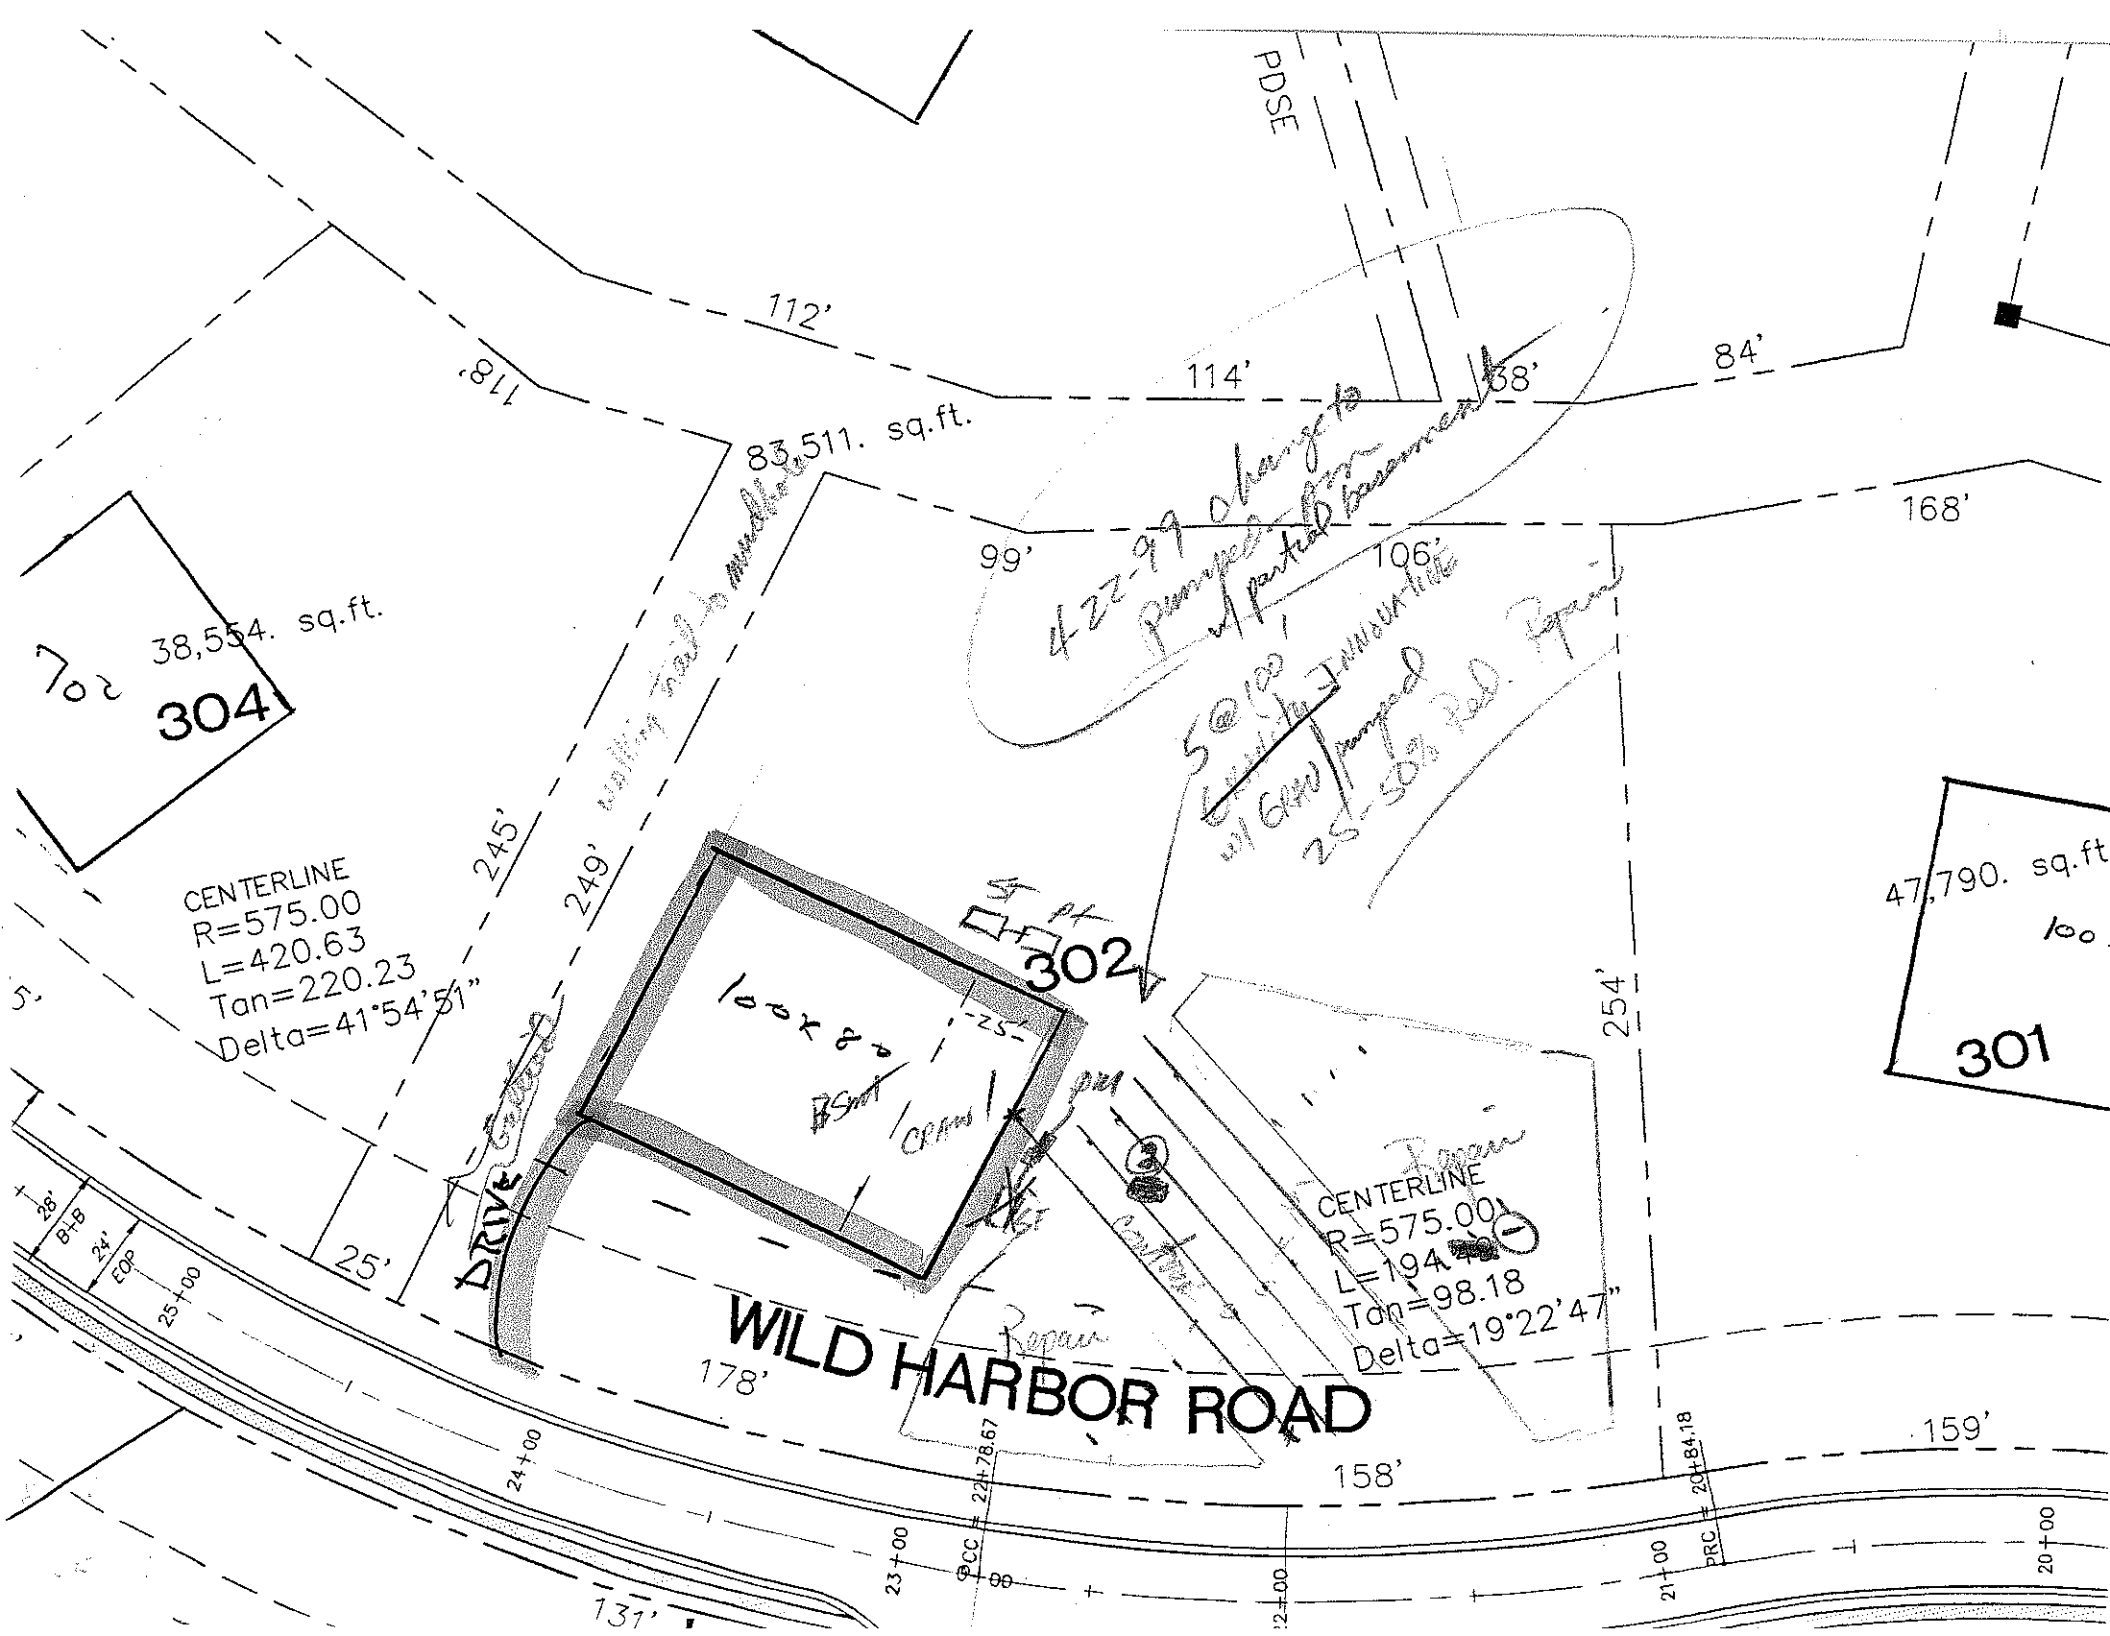
PDSE
112'
114'
38'
84'
118'
83,511. sq.ft.
168'
99'
106'
4-22-97 change to pumped from partial basement
5@100 w/ 6HW pumped
25-50 Pad Repair
38,554. sq.ft.
702
304
CENTERLINE
R=575.00
L=420.63
Tan=220.23
Delta=41°54'51"
245'
249'
walking trail to mailbox
5 ft
302
looks
BSMT
1 CRAWL
-25-
Repair
Repair
Repair
47,790. sq.ft
100
301
254'
DRIVE
25'
28'
B-B
24'
EOP
25+00
CENTERLINE
R=575.00
L=194.40
Tan=98.18
Delta=19°22'47"
WILD HARBOR ROAD
178'
158'
159'
24+00
23+00
PCC # 22+78.67
22+00
21+00
PRC # 20+84.18
20+00
131'
