DIVISION OF ENVIRONMENTAL HEALTH

APPLICANT: Ashley Rollins Wendell Overby (Rollins Env)

DATE OF EVALUATION: 11/6/15

143 Asbury Cir. (PIN) 4627841909

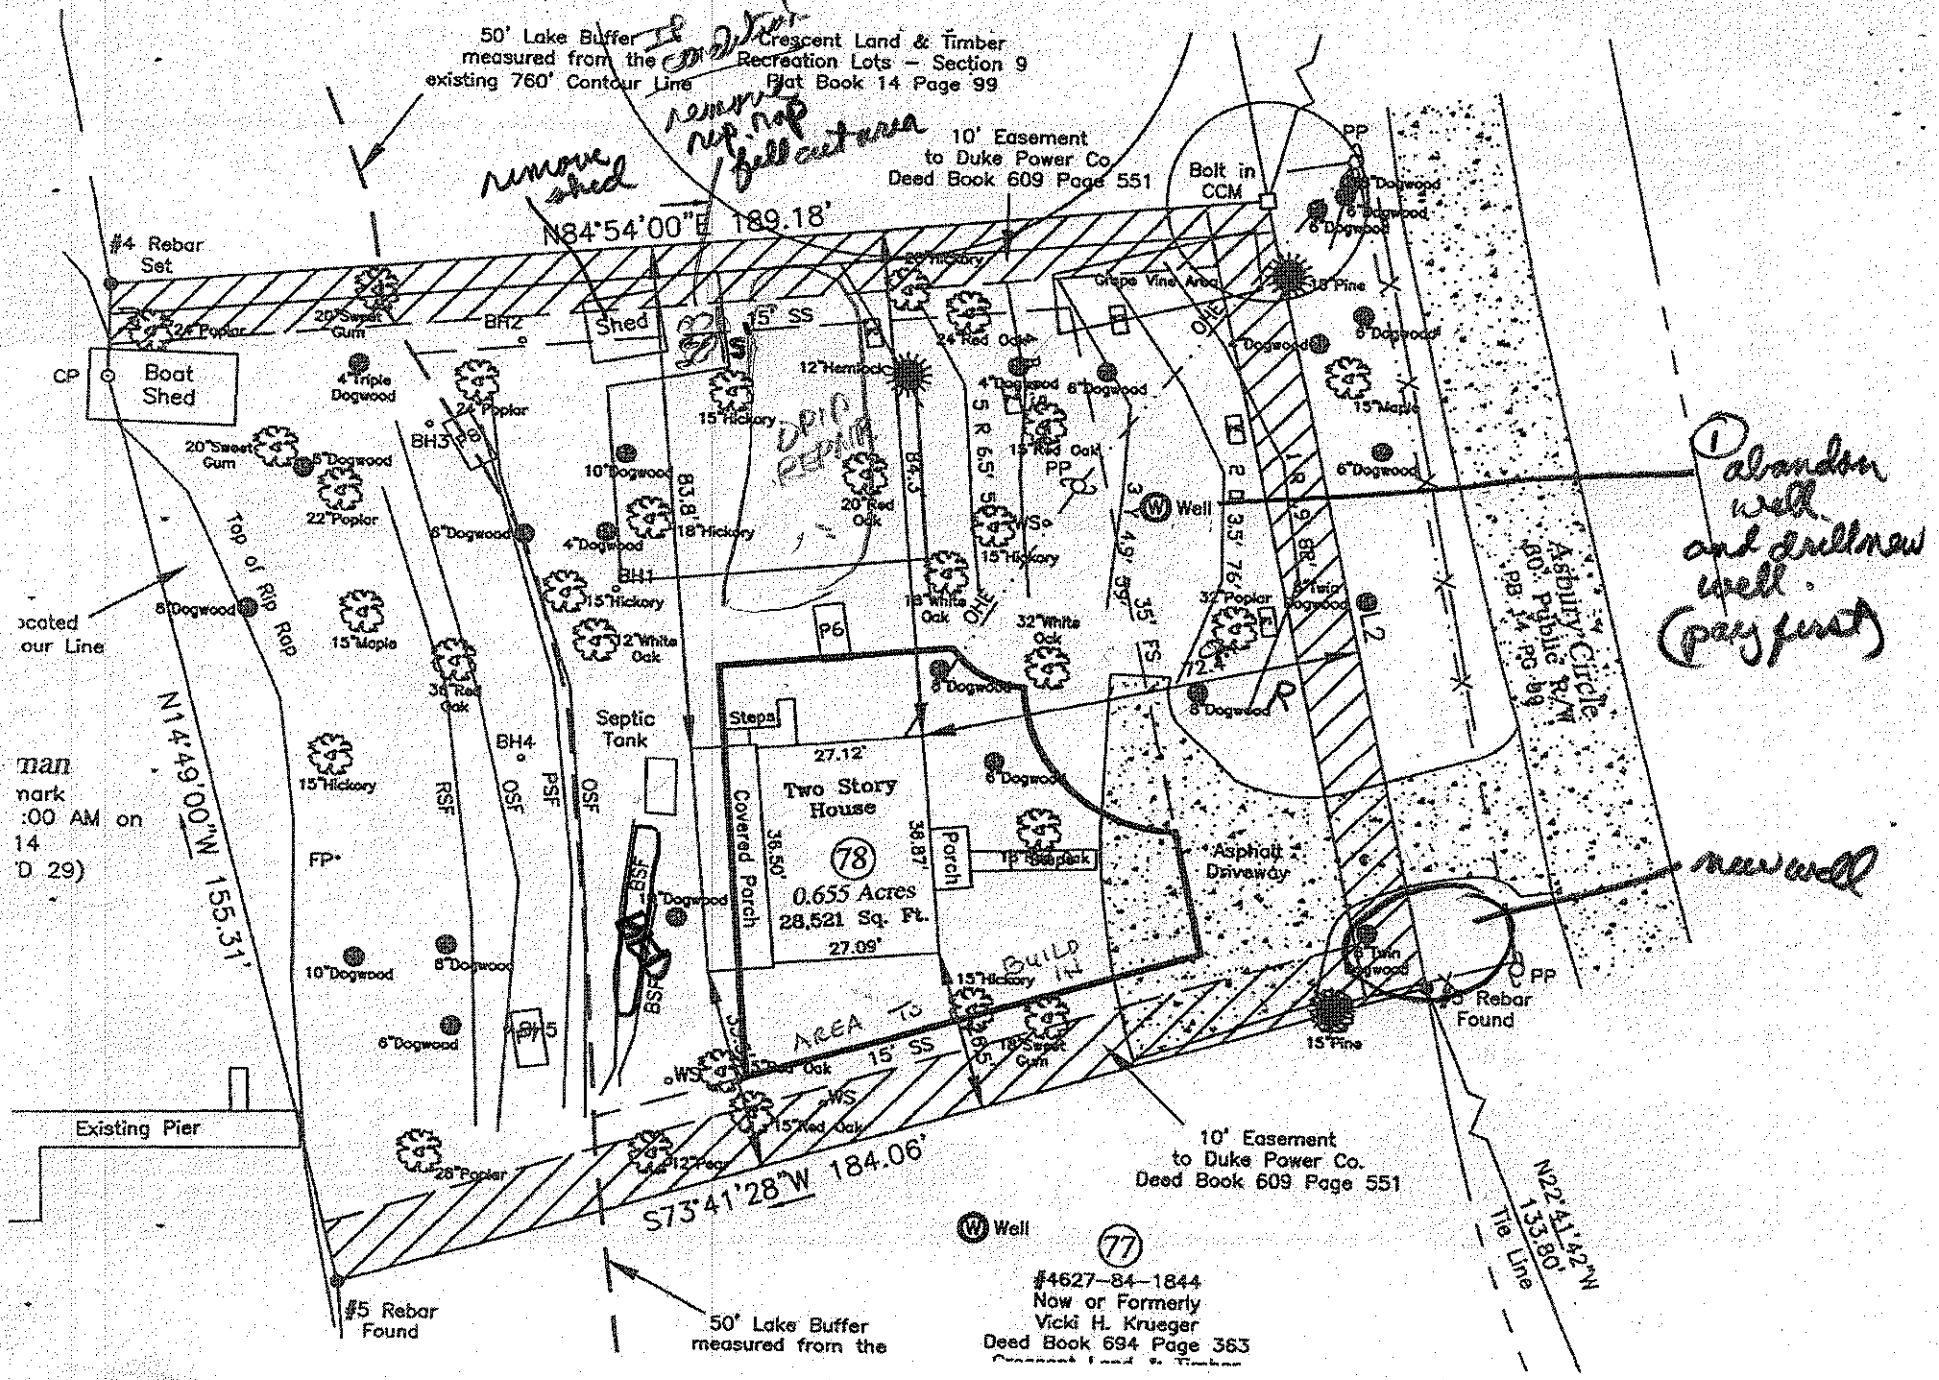
SITE PLAN

PROFILE #	.1940 LANDSCP POS. (%)	HORIZON DEPTH (IN.)	.1941 STRUCTURE/TEXTURE	.1941 MINERALOGY/ CONSISTENCE	.1942 WETNESS COND.	.1944 RESTRICT HORIZONS	.1948 CLASS OF HORIZ	1943/ 1956 SAPRLT CLASS.	HORIZON LTAR
1	side	0-18	SL gr	fr nsnp SE					.3
		18-28	L wSBk	fr sssp SE					
		28-48	SCL WAB	sssp SE					
2	side	0-22	SL gr	fr nsnp SE					.275
		22-28	C SB	ss+p SE					
		28-33	C AB	fr SE					
		33-36	C+SAP PL→AB	fr SE					
		36-48	C+SAP WAB	fr SE					
3	side	0-12	SL gr	fr SE					.3
		12-20	L wSB	fr SE					
		20-26	CL SB	fr SE					
		26-48	CL+SAP + core stone	fr SE					
4	side	0-60	SL gr	vfr SE					.8 conv .4 drip on LPP
5	side	0-8	CL wSB	sssp SE					.35 conv .175 drip LPP
		8-15	CL wSB	sssp SE					
		15-48	CL+SAP WAB	sssp SE					
6	side	0-10	L gr	fr SE					.3 conv .15 drip on LPP
		10-30/33	CL+SAP wSBk/WAB	fr SE					
		30/33-48	SAP(L) m	vfr acid

COMMENTS: LPP panel block .275 initial drip repair .2 mark P/L stake house evaluate layout revision and well site area. Needs well abandonment

#5 Rebar Found
N22°41'42"W 133.80'
Tie Line
Asbury Circle 40' Public R/W PB 14 PG 99
1 abandon well and drill new well (pay first)
new well
AREA 13
BUILD IN
DRIP REPAIR
Grape Vine Arbor
Twin Dogwood
Triple Dogwood
Dogwood
Poplar
Sweet Gum
Maple
Hickory
Red Oak
White Oak
Hemlock
Pine
Beech
Gatepost
Rebar Found
