DIVISION OF ENVIRONMENTAL HEALTH
ON-SITE WASTEWATER SECTION

SOIL/SITE EVALUATION
for ON-SITE WASTEWATER SYSTEM

OWNER: ORL APPLICANT: _____
ADDRESS: _____ APPLICATION DATE: _____ DATE EVALUATED: 3-23-98
PROPOSED FACILITY: _____ PROPOSED DESIGN FLOW (.1949): _____ PROPERTY SIZE: _____
LOCATION OF SITE: lot 68 The Peak PROPERTY RECORDED: _____
WATER SUPPLY: ☐ Private ☐ Public ☐ Well ☐ Spring ☐ Other _____
EVALUATION METHOD: ☐ Auger Boring ☐ Pit ☐ Cut
TYPE OF WASTEWATER: ☐ Sewage ☐ Industrial Process ☐ Mixed

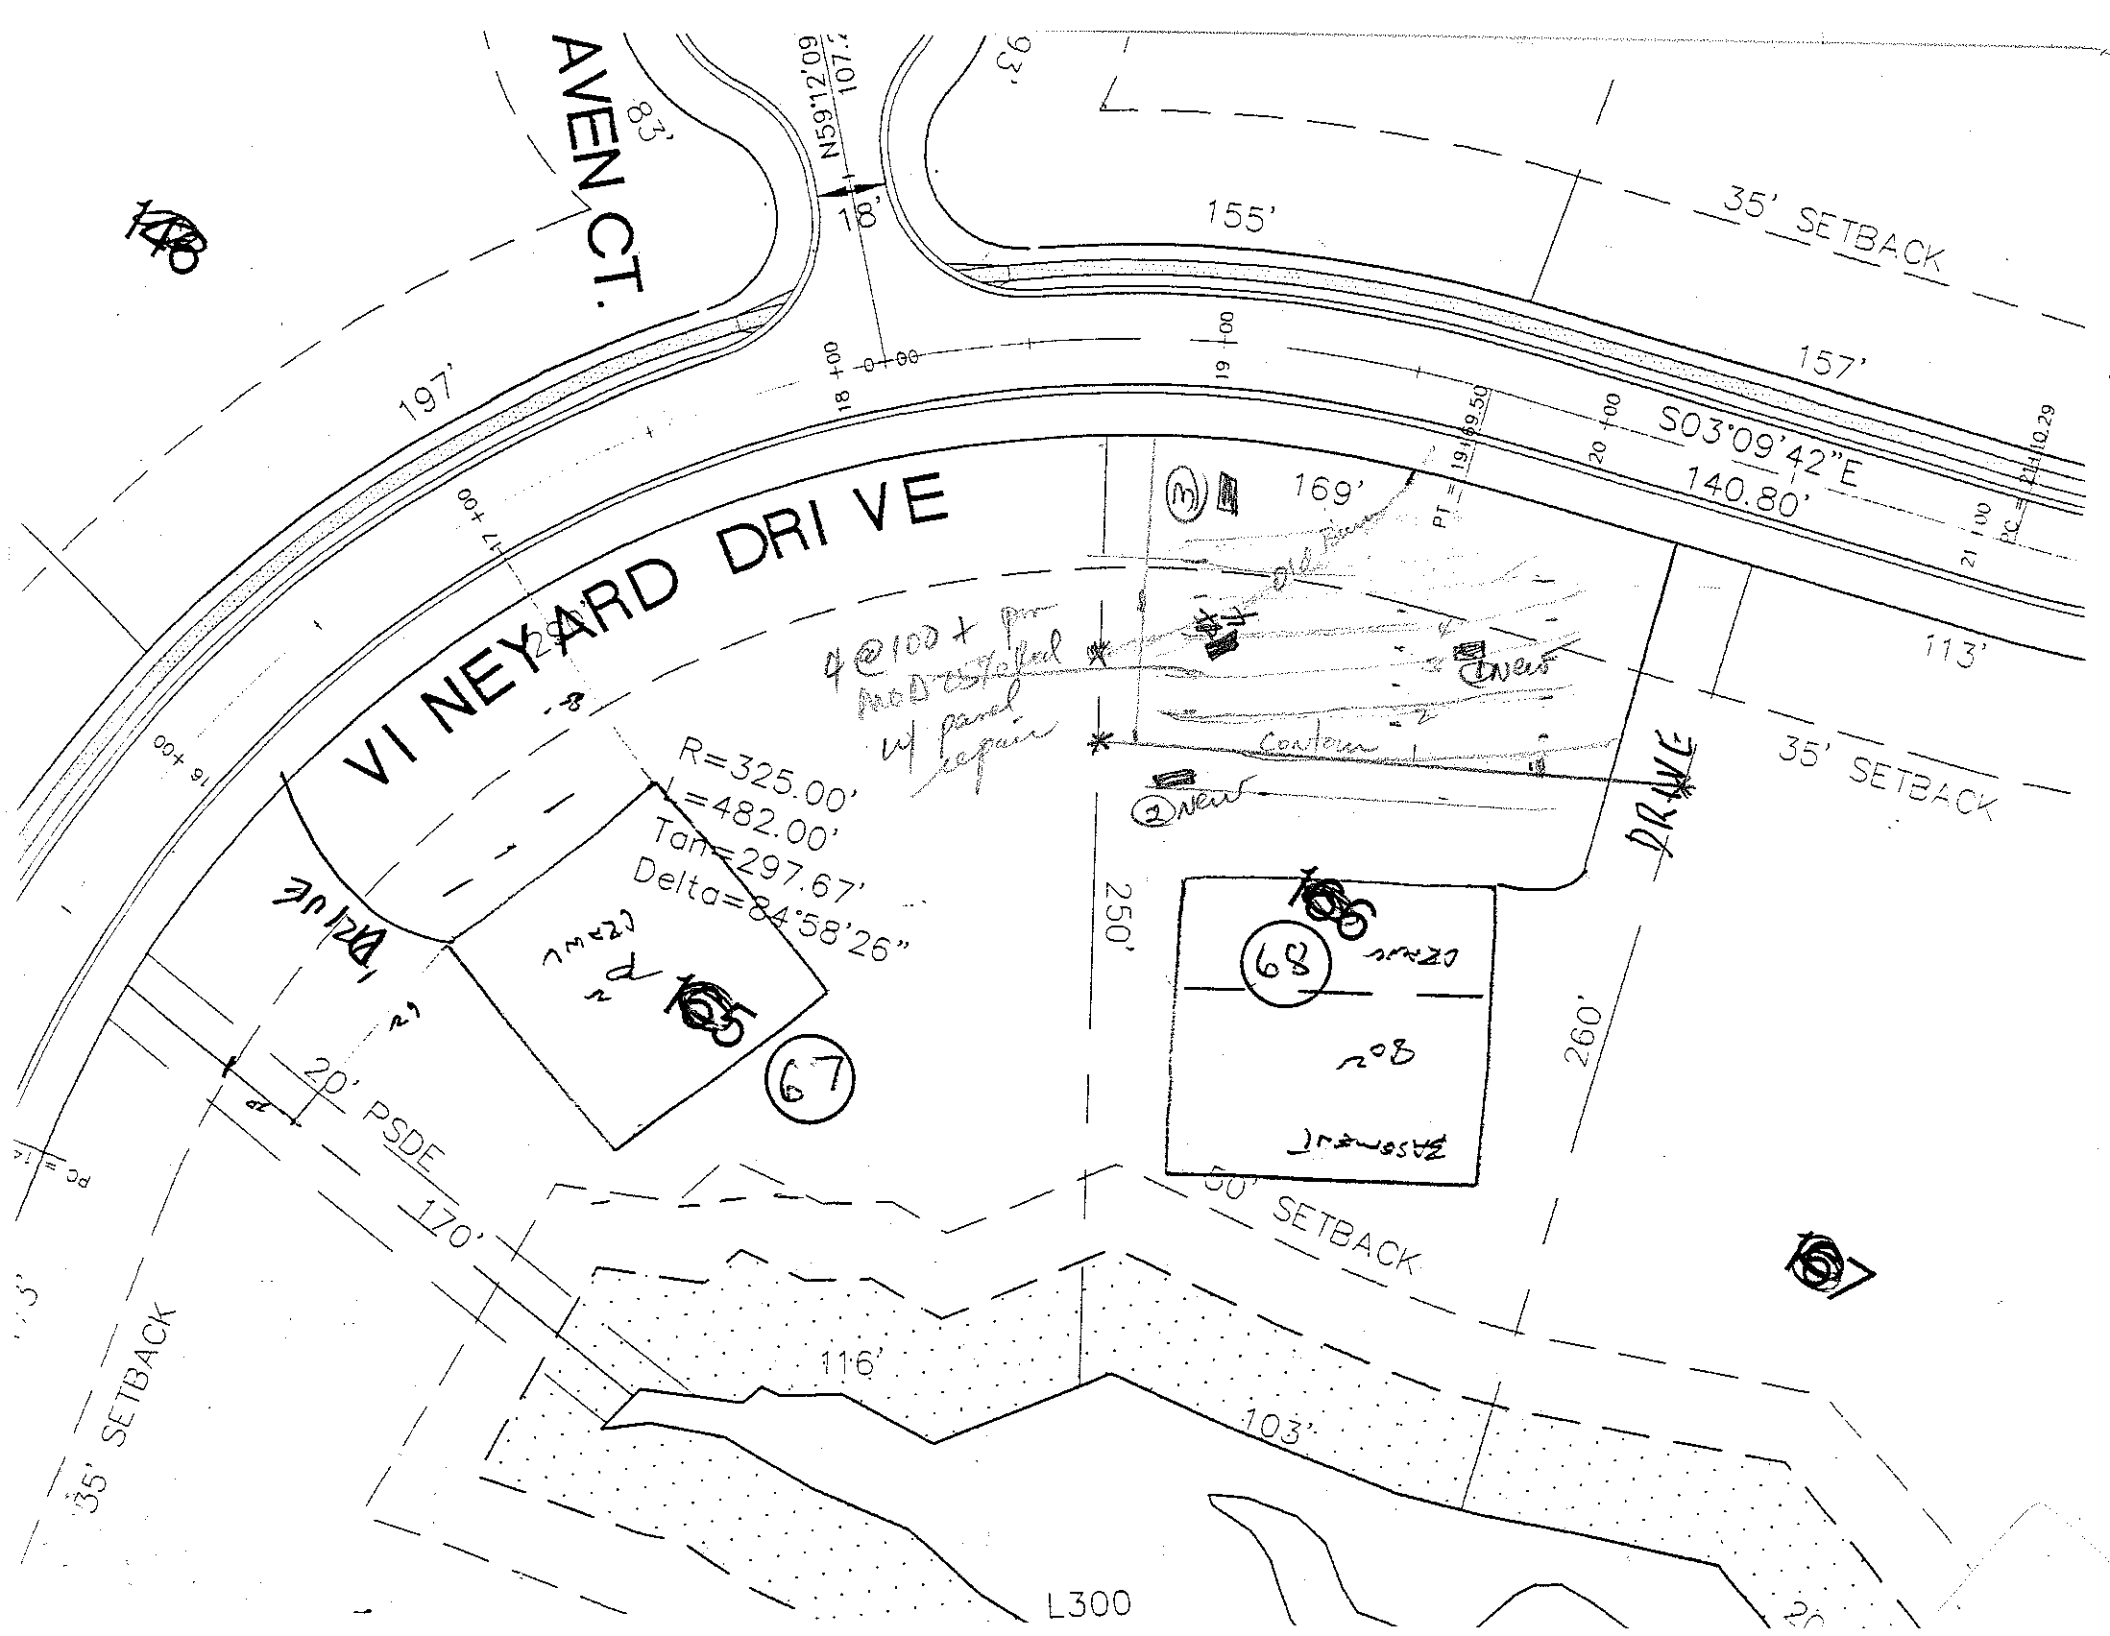
Now Lot 67

Dig another pit 2 pits down hill from 8 Go down 4-21-98 this is 8 with landscape

PROFILE #	1940 LANDSCAPE POSITION/ SLOPE %	HORIZON DEPTH (IN.)	SOIL MORPHOLOGY (1941) 1941 STRUCTURE/ TEXTURE	1941 CONSISTENCE/ MINERALOGY	OTHER PROFILE FACTORS 1942 SOIL WETNESS/ COLOR	1943 SOIL DEPTH	1956 SAPRO CLASS	1944 RESTR. HORIZ	PROFILE CLASS & LTAR
1	4-21-98	0-5	gr-slb brwsd fr						PS -3 @ 23"
		5-23	slb rc/cl	fr soapstone					
		23-32	wk sbk rcl	fr soapstone					
		32-49	wk sbk rcl	fr soapstone					
		49-60	Same	micaceous soapstone bedrock					
2		0-21	wk sbk rc	fr sp					PS 13 @ 23"
		21-31	wk sbk gr scl	fr soapstone					
		31-40	Channer Stone Layer						
3		0-7	gr brwsd l	fr					B .3
		7-45	slb rc/cl	fr soapstone					
4	4-21-98	0-8	gr-slb Brwsd	fr					R .3 @ 45"
		8-48	slb rc/cl	fr-fi soapstone					
		48-51	hard soapstone bedrock
