DIVISION OF ENVIRONMENTAL HEALTH
ON-SITE WASTEWATER SECTION

SOIL/SITE EVALUATION
for ON-SITE WASTEWATER SYSTEM

OWNER: _____ APPLICANT: _____
ADDRESS: _____ APPLICATION DATE: _____ DATE EVALUATED: 3-26-18
PROPOSED FACILITY: _____ PROPOSED DESIGN FLOW (.1949): _____ PROPERTY SIZE: _____
LOCATION OF SITE: Lot 56 The Pointe PROPERTY RECORDED: _____
WATER SUPPLY: ☐ Private ☐ Public ☐ Well ☐ Spring ☐ Other _____
EVALUATION METHOD: ☐ Auger Boring ☐ Pit ☐ Cut
TYPE OF WASTEWATER: ☐ Sewage ☐ Industrial Process ☐ Mixed

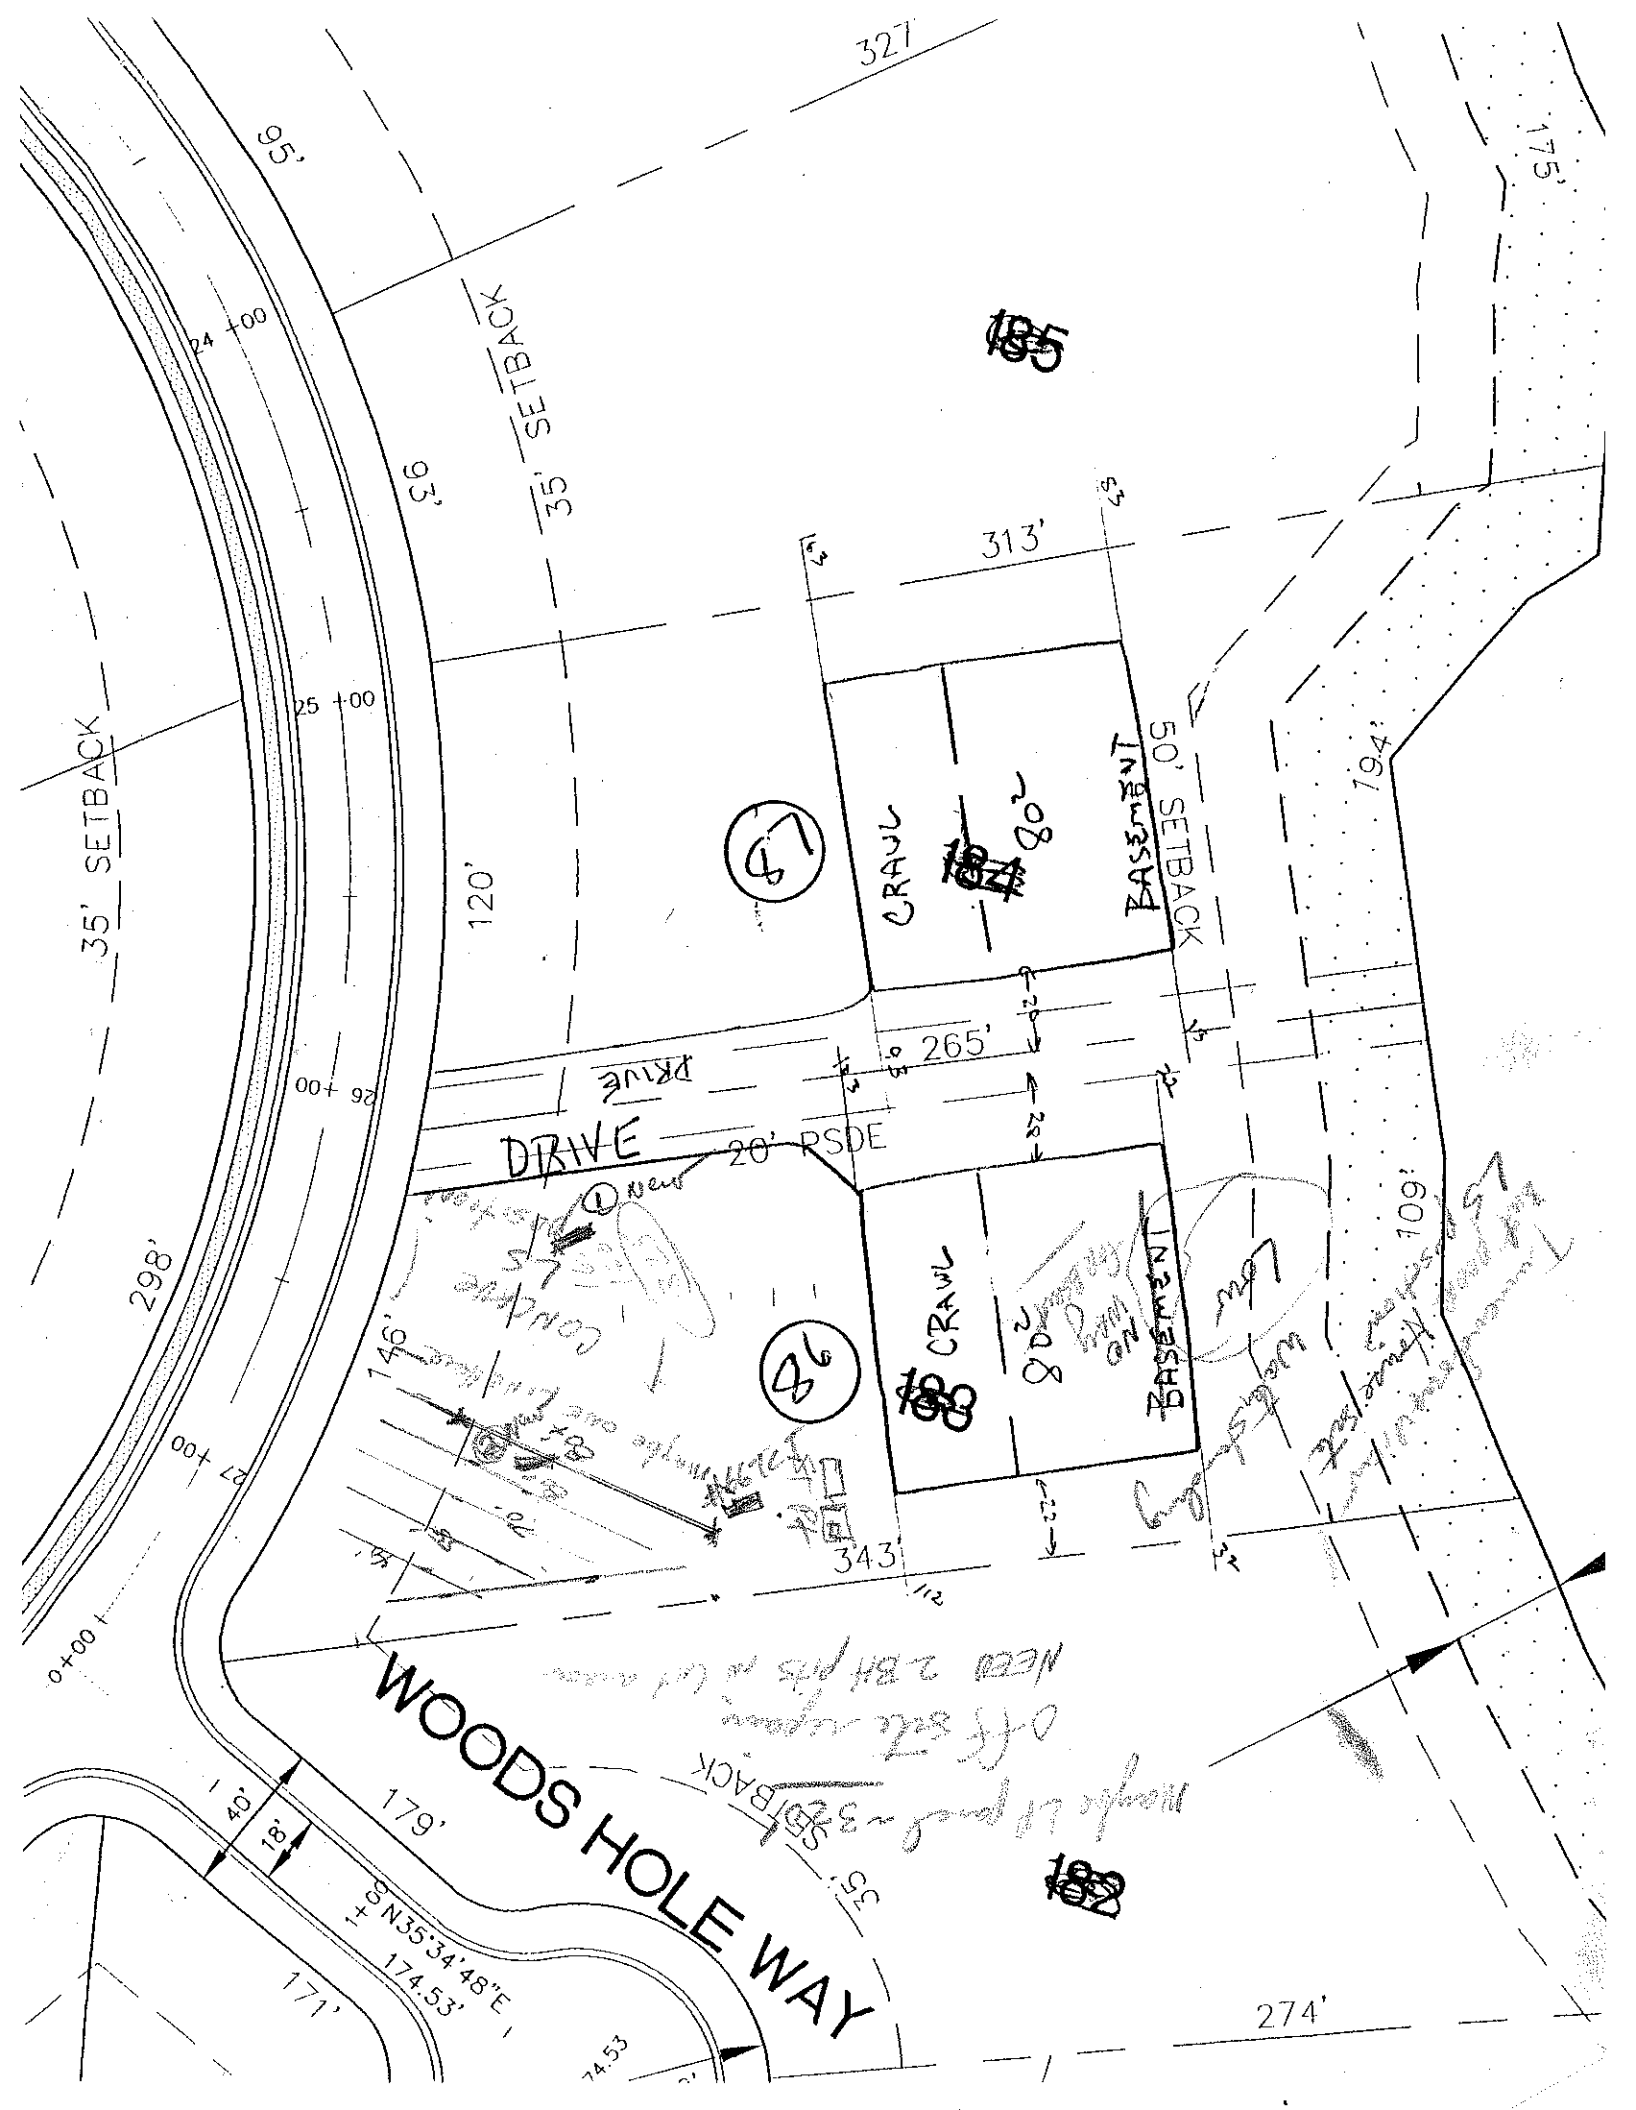
Now Lot 85

PROFILE #	1940 LAND SCAPE POSITION/ SLOPE %	HORIZON DEPTH (IN)	SOIL MORPHOLOGY (1941) 1941 STRUCTURE/ TEXTURE	1941 CONSISTENCE/ MINERALOGY	OTHER PROFILE FACTORS 1942 SOIL WETNESS/ COLOR	1943 SOIL DEPTH	1956 SAPRO CLASS	1944 RESTR HORIZ	PROFILE CLASS & LTAR
1	Shoulder Slope	0-12	SiL, moderate fine sub						LS
			water Sample Taken						
2		0-22							
		22-42							
		42-48							
3		0-32							
		32-50							
4

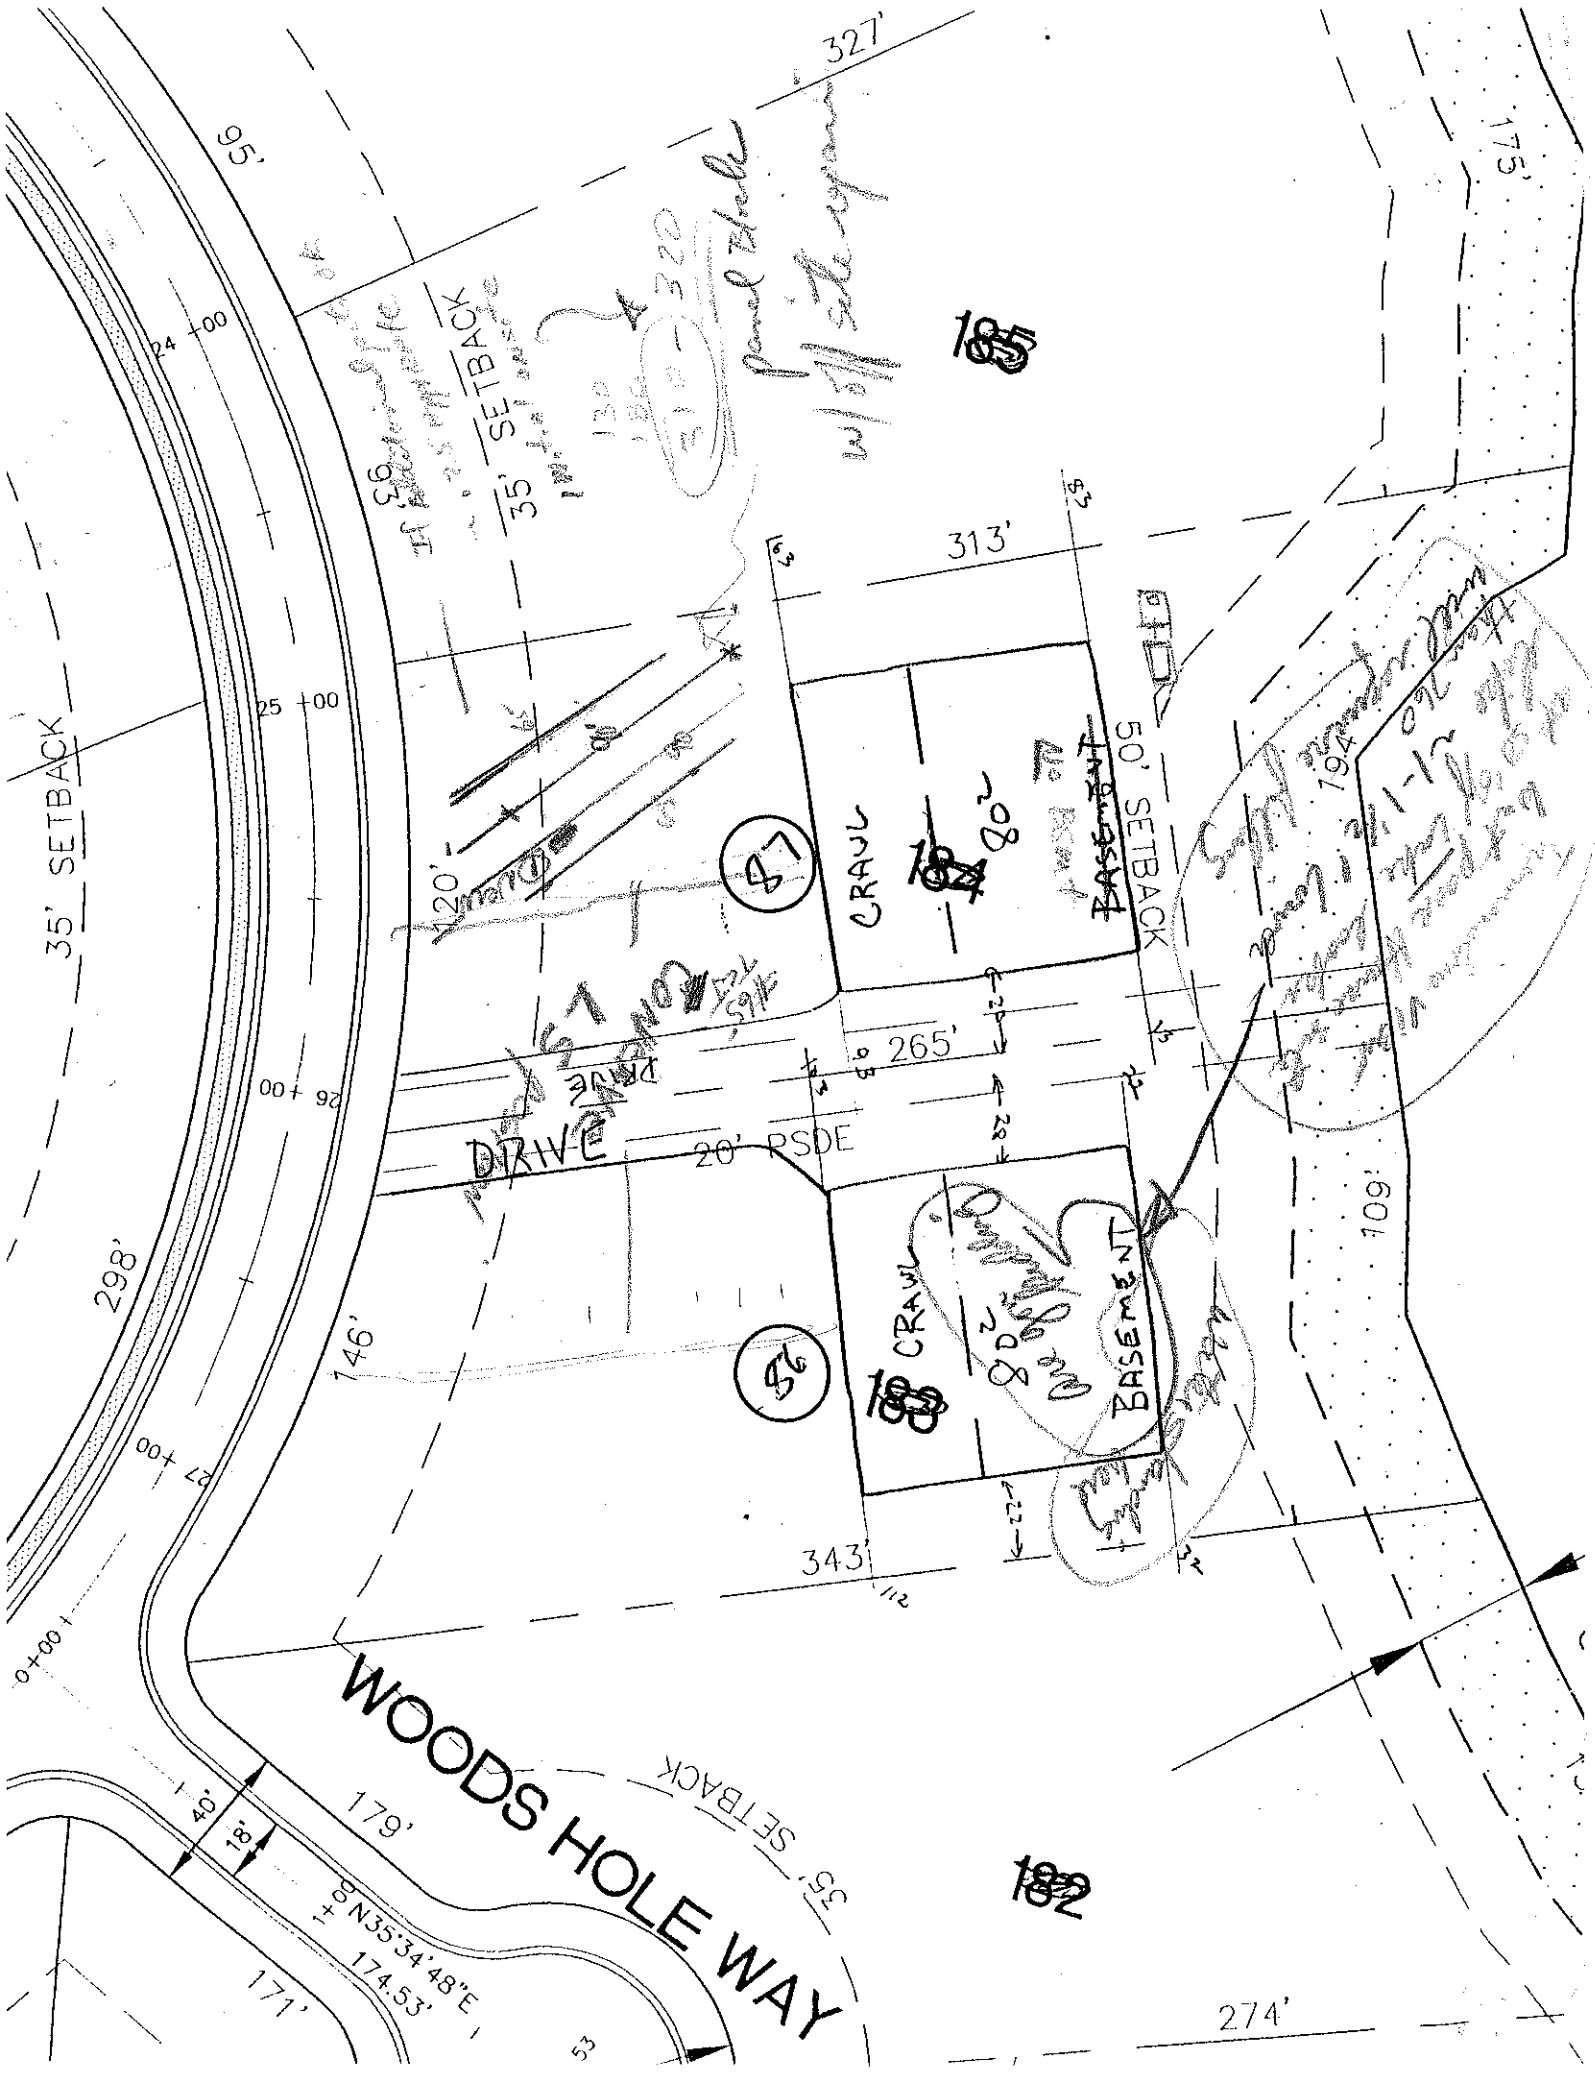
Now Lot 86

PROFILE #	1940 LAND SCAPE POSITION/ SLOPE %	HORIZON DEPTH (IN.)	SOIL MORPHOLOGY (1941) 1941 STRUCTURE/ TEXTURE	1941 CONSISTENCE/ MINERALOGY	OTHER PROFILE FACTORS 1942 SOIL WETNESS/ COLOR	1943 SOIL DEPTH	1956 SAPRO CLASS	1944 RESTR. HORIZ	PROFILE CLASS & LTAR
1	5 in %	0-10							
		10-32							
		32-52							
2	65	6							
3									
4

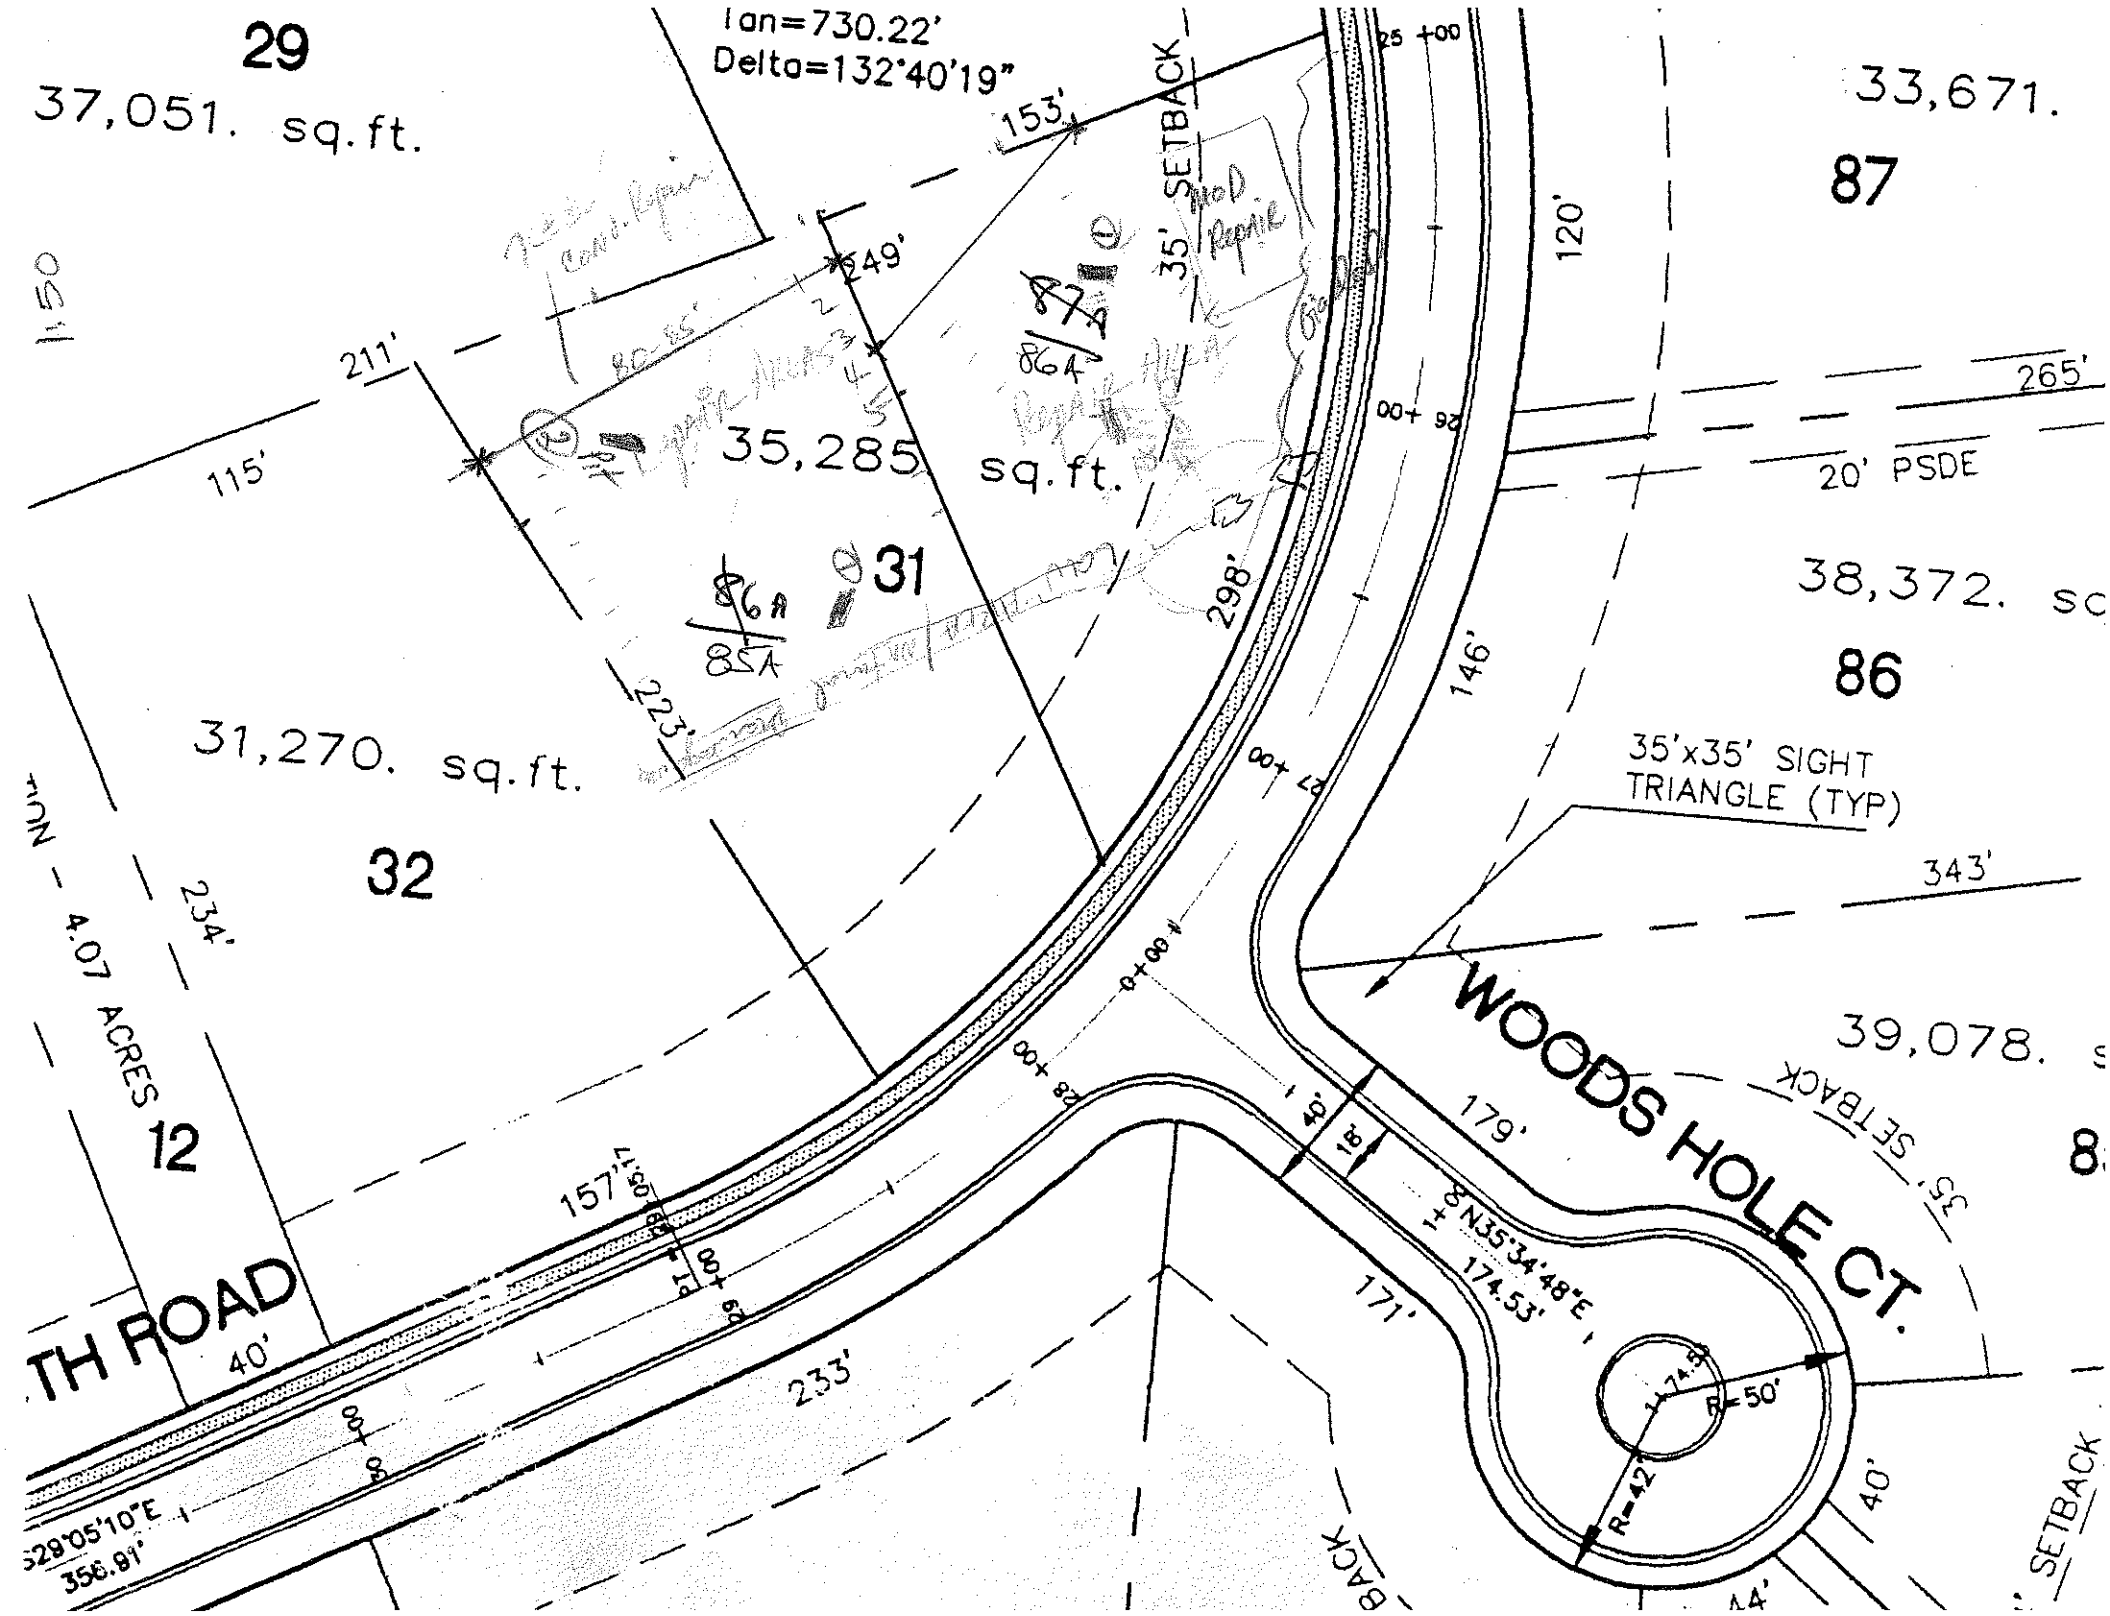
PROFILE #	.1940 LANDSCAPE POSITION/ SLOPE %	HORIZON DEPTH (IN.)	SOIL MORPHOLOGY (.1941) .1941 STRUCTURE/ TEXTURE	.1941 CONSISTENCE/ MINERALOGY	OTHER PROFILE FACTORS .1942 SOIL WETNESS/ COLOR	.1943 SOIL DEPTH	.1956 SAPRO CLASS	.1944 RESTR HORIZ	PROFILE CLASS & LTAR
1	Lot 20 shoulder ~30' from road	0-7	Sa brn sdy L	VFr					S .3
		7-34	MSBK R brn cl	Fr ss sp					
		34-62	(BC) MSBK CH/C	Fr ss sp					
			common med SAP						
2	~~SSA~~ D 86A	0-6	gr-SAB brn sdy L	Fr					S .3
		6-18	SAB R brn	Fr ss sp					
		18-36	mm-SAB red	Fr ss sp					
		36-60	WK SAB grey	Fr ss sp					
			common med SAP						
3	~~85A~~ ~~86A~~ D	0-10	gr-SAB brn sdy	Fr					S .3
		10-29	SAB R o	Fr					
		29-48	mod SAB R	Fr ss sp					
		48-59	WK SAB grey	Fr ss sp					
			few common med SAP						
4	~~85A~~ ~~86A~~ D	0-9	Sa brn sdy	Fr					S .3
		9-33	mSBK R org	Fr ss sp					
		33-59	mod WK SAB grey	Fr ss sp					
			common med SAP
