VISION OF ENVIRONMENTAL HEALTH
I-SITE WASTEWATER SECTION

SOIL/SITE EVALUATION
for ON-SITE WASTEWATER SYSTEM

OWNER: CTJ APPLICANT: _____
ADDRESS: _____ APPLICATION DATE: _____ DATE EVALUATED: 8-7-98
PROPOSED FACILITY: _____ PROPOSED DESIGN FLOW (.1949): _____ PROPERTY SIZE: _____
LOCATION OF SITE: Lot 11 phase 1 B Tuckaway PROPERTY RECORDED: _____
WATER SUPPLY: ☐ Private ☐ Public ☐ Well ☐ Spring ☐ Other _____
EVALUATION METHOD: ☐ Auger Boring ☐ Pit ☐ Cut
TYPE OF WASTEWATER: ☐ Sewage ☐ Industrial Process ☐ Mixed

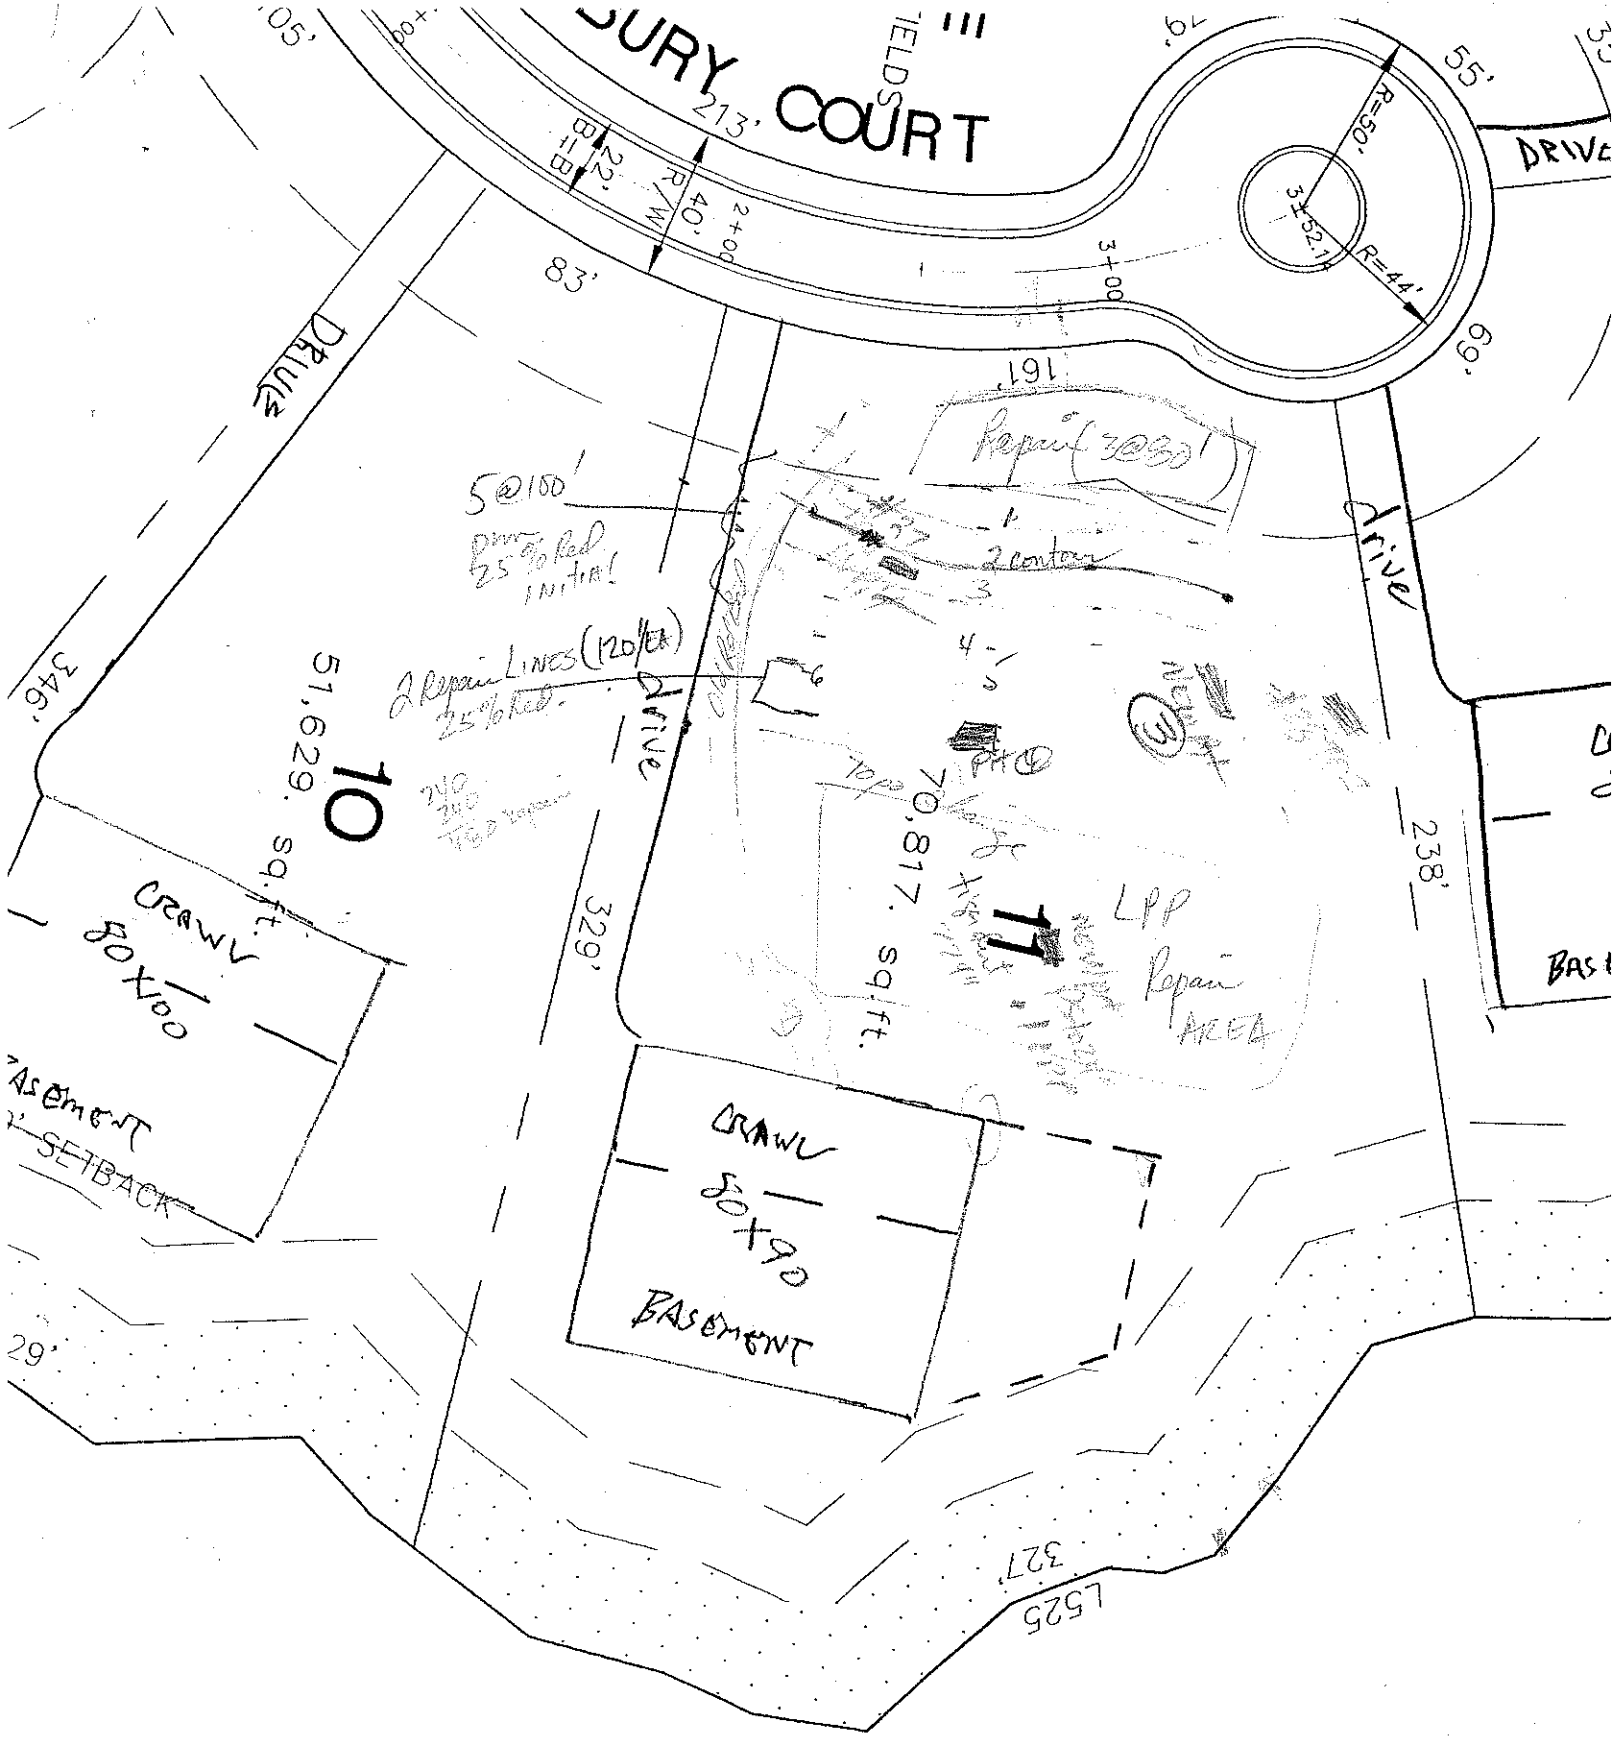
need another pit
