DEPARTMENT OF ENVIRONMENT, HEALTH, AND NATURAL RESOURCES
DIVISION OF ENVIRONMENTAL HEALTH
ON-SITE WASTEWATER SECTION

SOIL/SITE EVALUATION
for ON-SITE WASTEWATER SYSTEM

OWNER: MJ Fox — APPLICANT: _____
ADDRESS: _____ APPLICATION DATE: _____ DATE EVALUATED: 1-20-99
PROPOSED FACILITY: _____ PROPOSED DESIGN FLOW (.1949): _____ PROPERTY SIZE: _____
LOCATION OF SITE: Lot 13 Lakeview Heights — PROPERTY RECORDED: _____
WATER SUPPLY: ☐ Private ☐ Public ☐ Well ☐ Spring ☐ Other _____
EVALUATION METHOD: ☐ Auger Boring ☑ Pit ☐ Cut — Too much tree debris, brush from lots 13/14 than Lot 7
TYPE OF WASTEWATER: ☐ Sewage ☐ Industrial Process ☐ Mixed

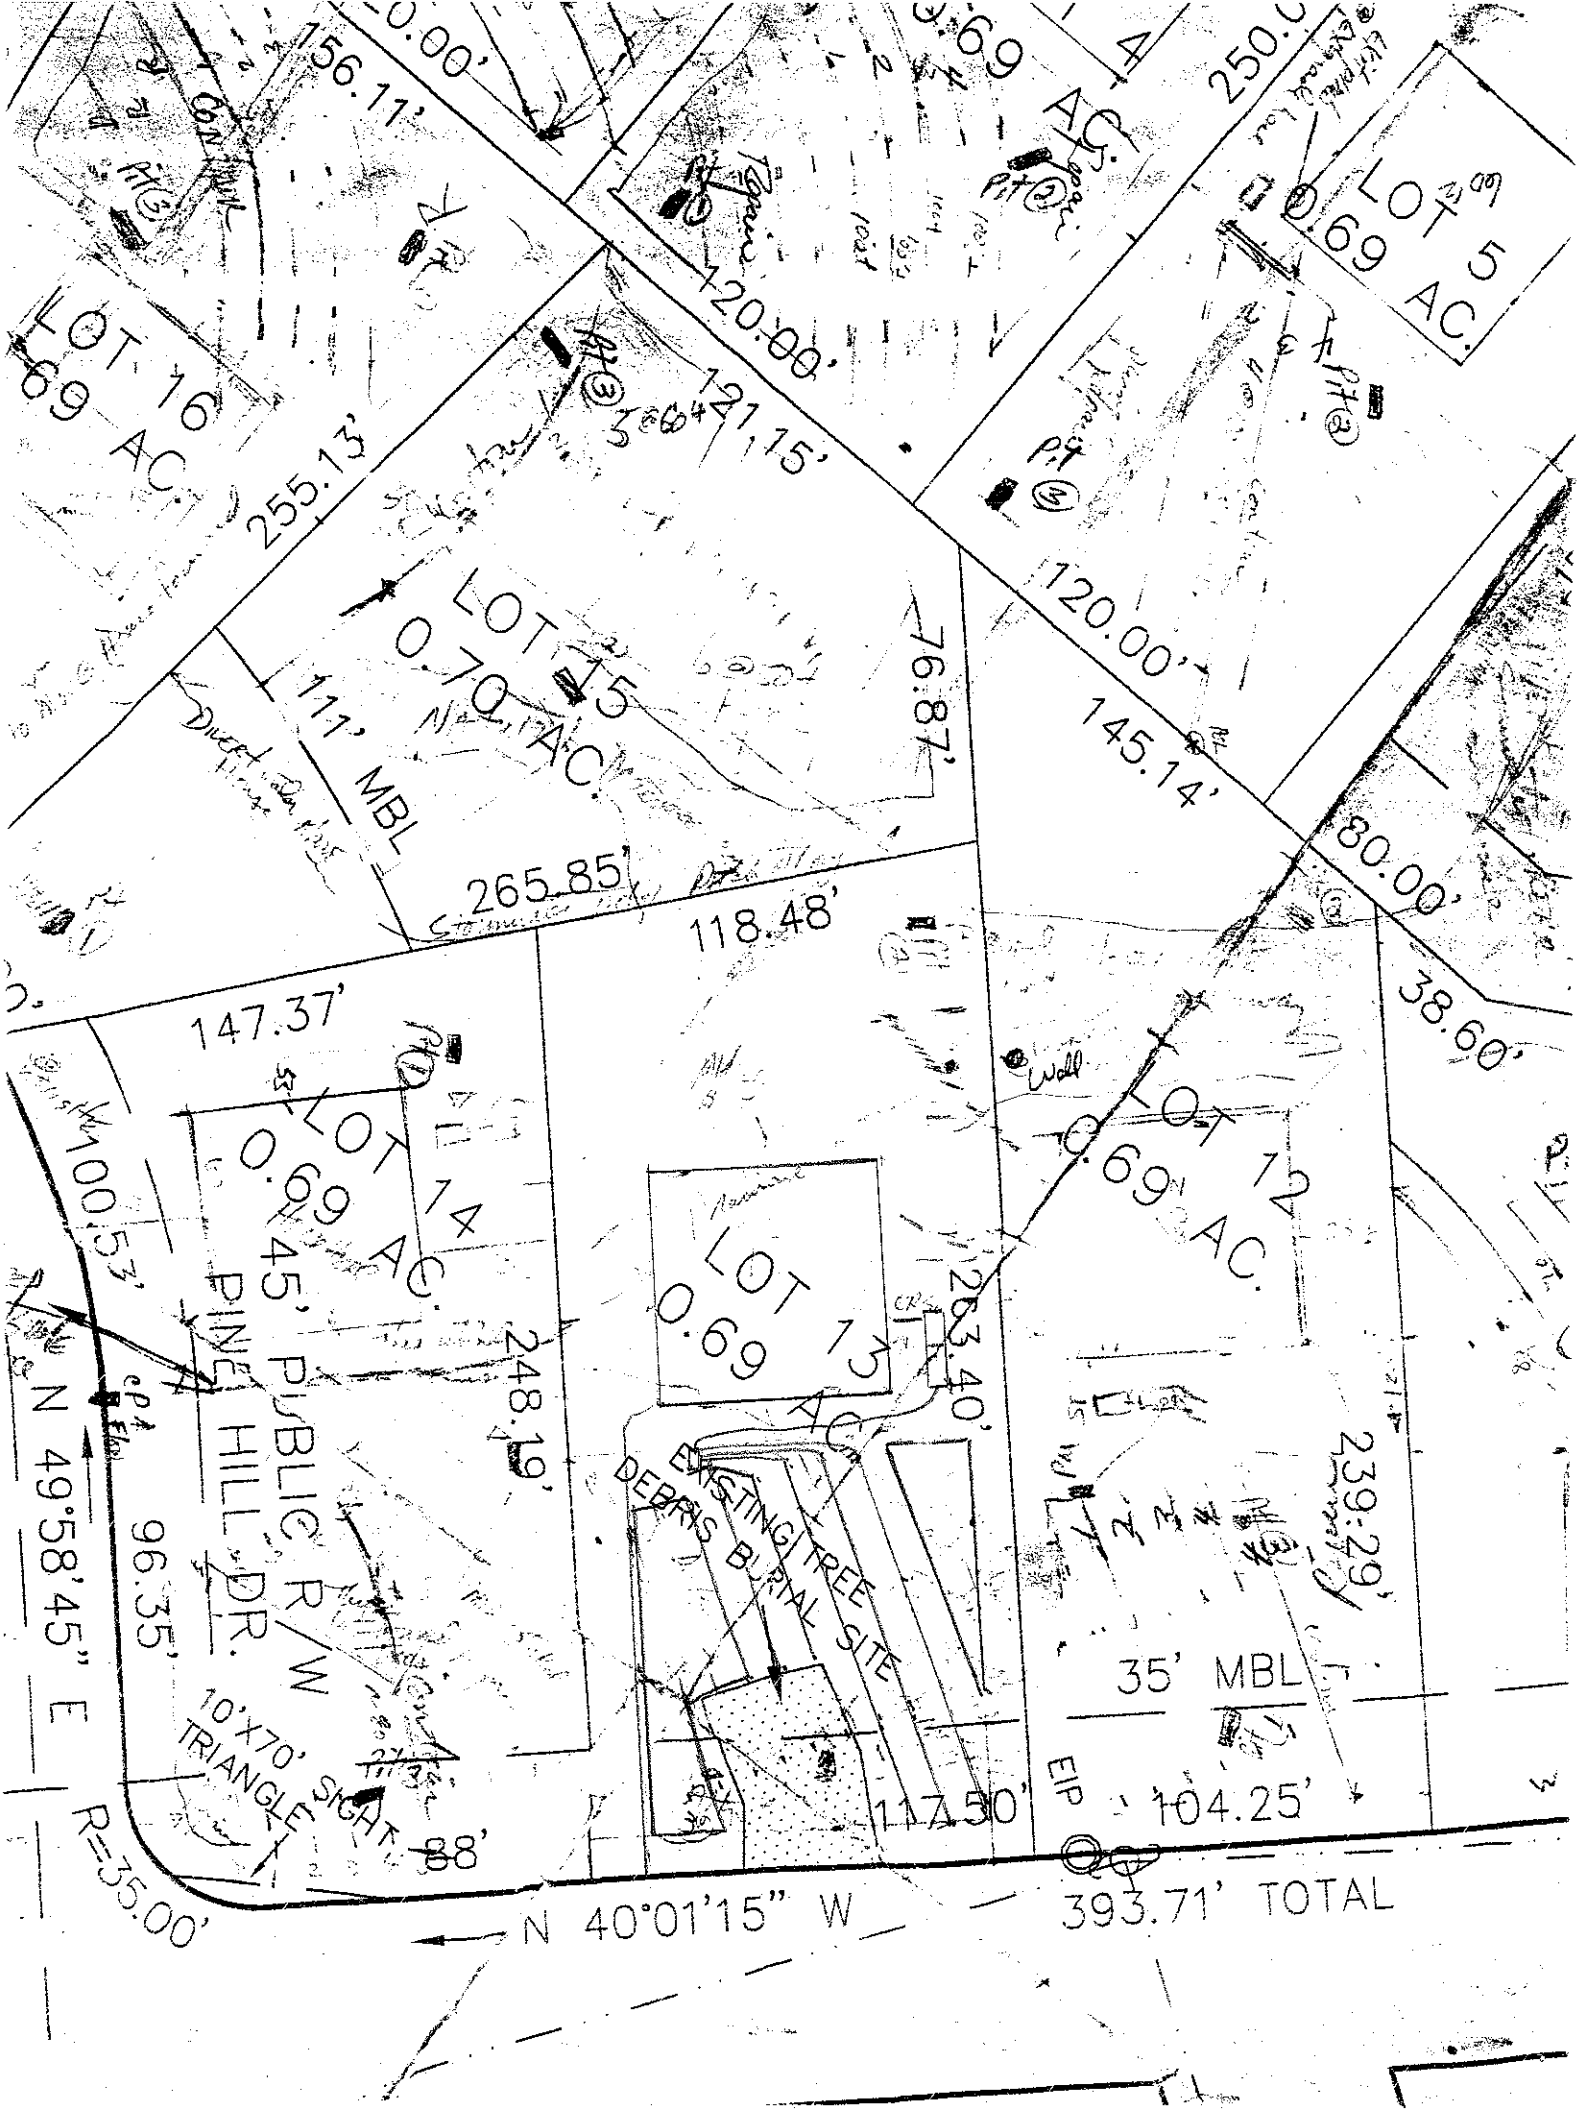
PROFILE #	1940 LANDSCAPE POSITION/ SLOPE %	HORIZON DEPTH (IN.)	SOIL MORPHOLOGY (.1941) .1941 STRUCTURE/ TEXTURE	.1941 CONSISTENCE/ MINERALOGY	OTHER PROFILE FACTORS .1942 SOIL WETNESS/ COLOR	.1943 SOIL DEPTH	.1956 SAPRO CLASS	.1944 RESTR HORIZ	PROFILE CLASS & LTAR
1		0-27	fill/tree debris						(4)
		27-38	SAB rc/cl						
		38-48+	water in pit						
2		0-20	SAB rc/cL	fr sp-ssg					
		20-32	(water in pit						
			(not stopping coinciding LS position)						
3	AH 2-16-99	0-6	wkmb brn sil	fr					PS @25-3
		6-25	SAB RC	fr sp ssg (SL impeded)					
		25-43	wkgr gr sch	fr ss sp ssg					
4		0-5	wkmb brn sil	fr					wet @0-5 mottled
		5-18	SAB rc/cl	fr-fi sp ssp					
		18-48	wkmb gr L	common wk/sp fr ss sp
