OF ENVIRONMENT, HEALTH, AND NATURAL RESOURCES
ENVIRONMENTAL HEALTH
WASTEWATER SECTION

SOIL/SITE EVALUATION
for ON-SITE WASTEWATER SYSTEM

OWNER: Lot 18 Village at Pine APPLICANT: Barnes & Dev.
ADDRESS: _____ APPLICATION DATE: _____ DATE EVALUATED: 5-31-05
PROPOSED FACILITY: House PROPOSED DESIGN FLOW (.1949): _____ PROPERTY SIZE: _____
LOCATION OF SITE: _____ PROPERTY RECORDED: _____
WATER SUPPLY: ☐ Private ☒ Public ☐ Well ☐ Spring ☐ Other _____
EVALUATION METHOD: ☐ Auger Boring ☒ Pit ☐ Cut
TYPE OF WASTEWATER: ☒ Sewage ☐ Industrial Process ☐ Mixed

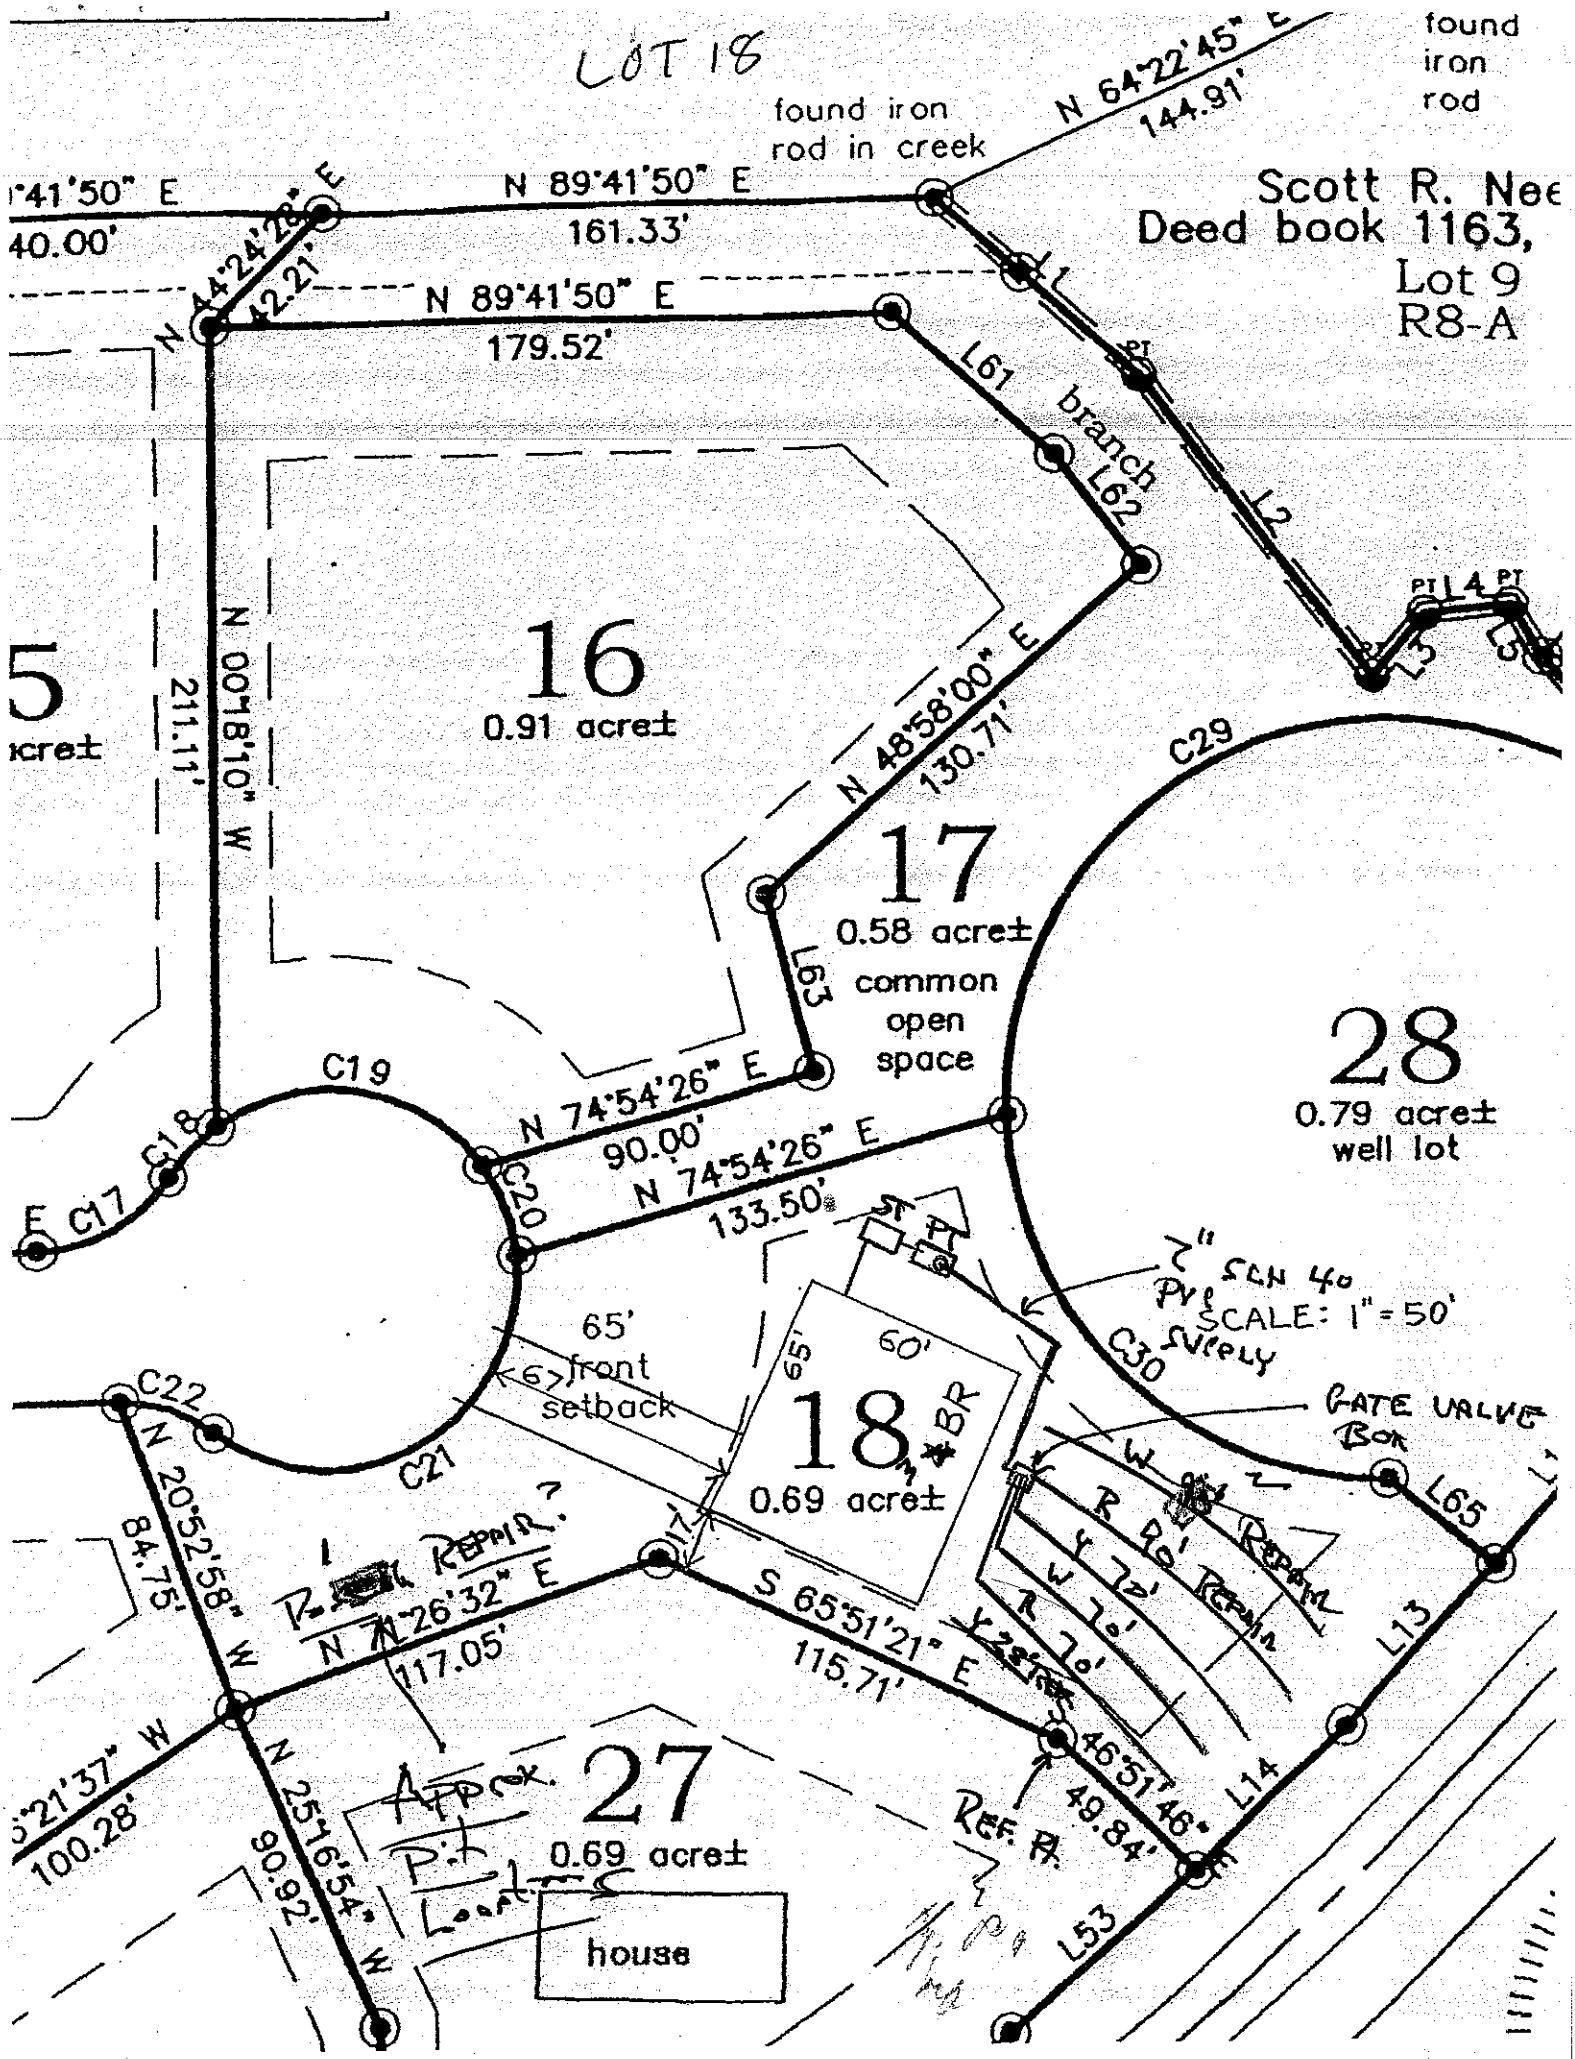
PROFILE #	.1940 LANDSCAPE POSITION/ SLOPE %	HORIZON DEPTH (IN.)	SOIL MORPHOLOGY (.1941) STRUCTURE/ TEXTURE	SOIL MORPHOLOGY (.1941) CONSISTENCE/ MINERALOGY	OTHER PROFILE FACTORS .1942 SOIL WETNESS/ COLOR	.1943 SOIL DEPTH	.1956 SAPRO CLASS	.1944 RESTR HORIZ	PROFILE CLASS & LTAR
1	L 4>2%	0-21	sr/wsbk sl	fr ss/sp	br Red	48L	Fc SN ind 21		PS .3
		21-48	msbk cl	fr ss/sp					
2	L 2 10%	0-20	msbk c	fr s/p	mot red gr 12 mot gr 11	29"	PS		PS .3
		20-29	wsbk scl	fr ss/sp					
		29-48	m cl	fr ss/sp					
3									
4

OTHER FACTORS (.1946): _____
SITE CLASSIFICATION (.1948): PS · 3
EVALUATED BY: REP
OTHER(S) PRESENT: _____

LOT 18
found iron rod in creek
N 64°22'45" E
144.91'
found iron rod
Scott R. Nee
Deed book 1163,
Lot 9
R8-A
N 89°41'50" E
161.33'
N 89°41'50" E
179.52'
42.21'
40.00'
L1
L2
L3
L4
L5
L61
L62
branch
PT
16
0.91 acre±
N 00°18'10" W
211.11'
N 48°58'00" E
130.71'
17
0.58 acre±
common open space
L63
C29
28
0.79 acre±
well lot
C19
C18
C17
C20
N 74°54'26" E
90.00'
N 74°54'26" E
133.50'
2" SCH 40 PVC SURVEY
SCALE: 1" = 50'
65' front setback
65'
60'
18
0.69 acre±
BR
C30
GATE VALVE BOX
W 8" WATER
R 20' REPAIR
W 12'
R 10'
L65
C22
C21
N 20°52'58" W
84.75'
N 71°26'32" E
117.05'
S 65°51'21" E
115.71'
S 46°51'46" E
49.84'
L13
L14
L53
REF. PT.
N 25°16'54" W
90.92'
27
0.69 acre±
Approx. Pit Location
house
