SOIL/SITE EVALUATION
for ON-SITE WASTEWATER SYSTEM

OWNER: Stumpy Creek LLC APPLICANT: _____

LOCATION OF SITE: Sect B Harborview Lot 5 PROPERTY RECORDED: _____

DAVIDSON TOWNSHIP **IREDELL COUNTY, N.C.**
DECEMBER 15, 1997 **SCALE: 1"= 60'**

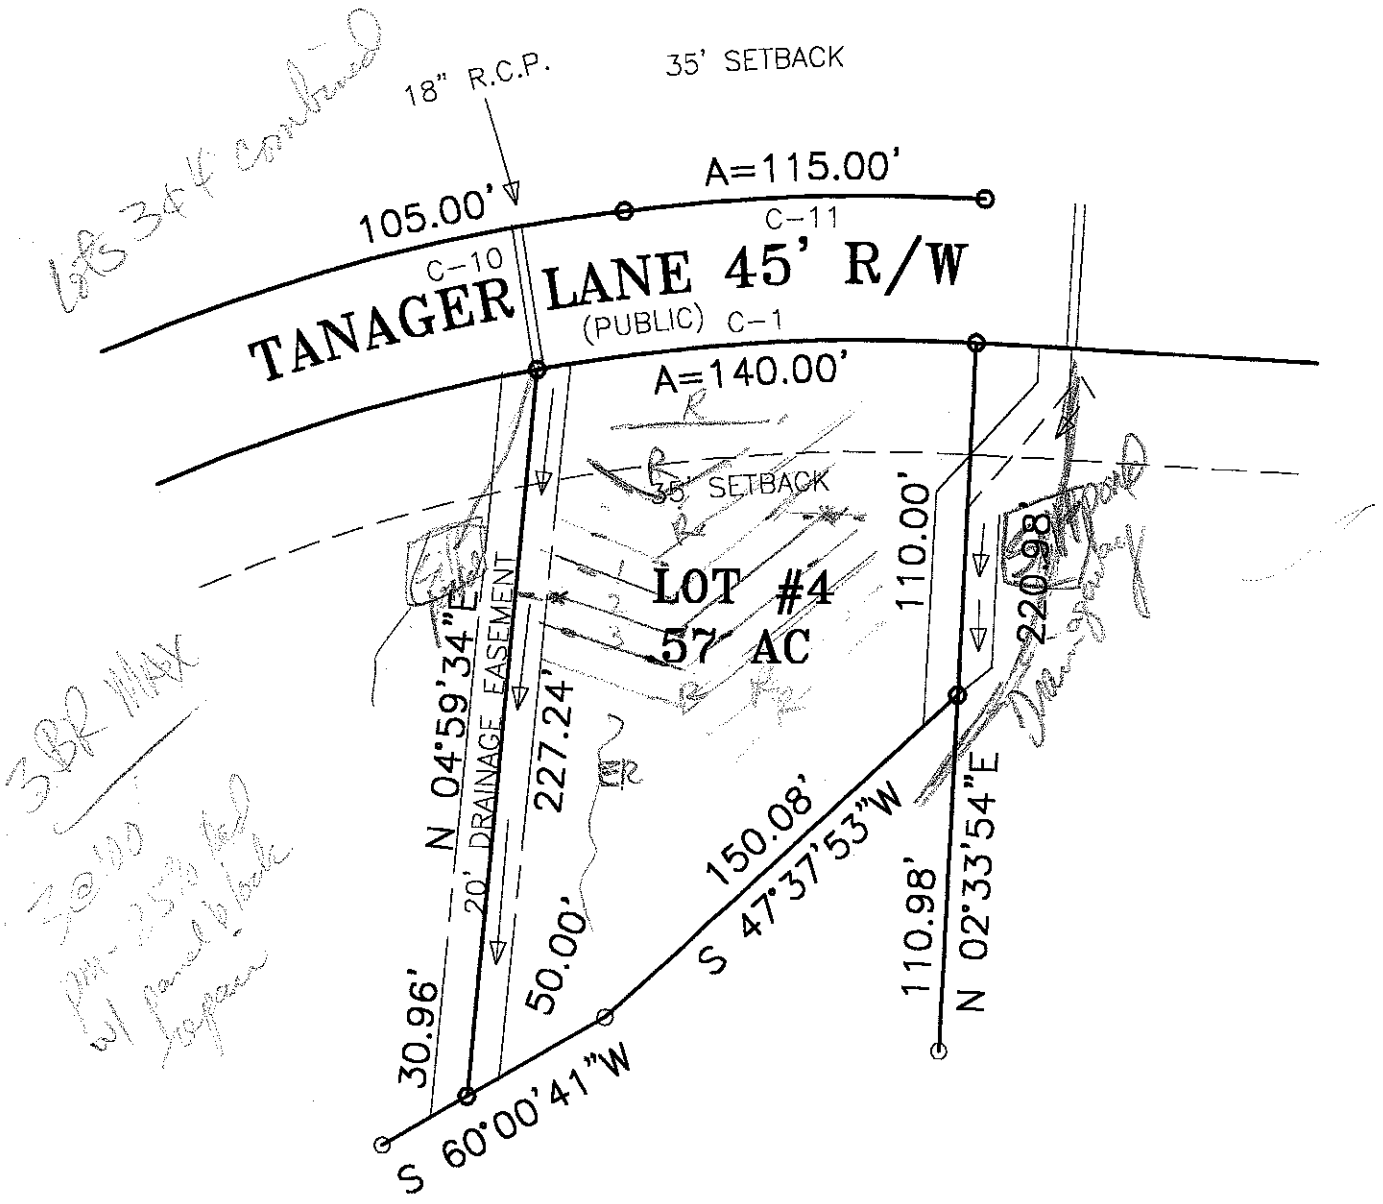
VERY poor SITE; complex topo to drainage except small area at rear
