SOIL/SITE EVALUATION
for ON-SITE WASTEWATER SYSTEM

ATION OF SITE: Lot 1 Wildwood Cove PROPERTY RECORDED: _____

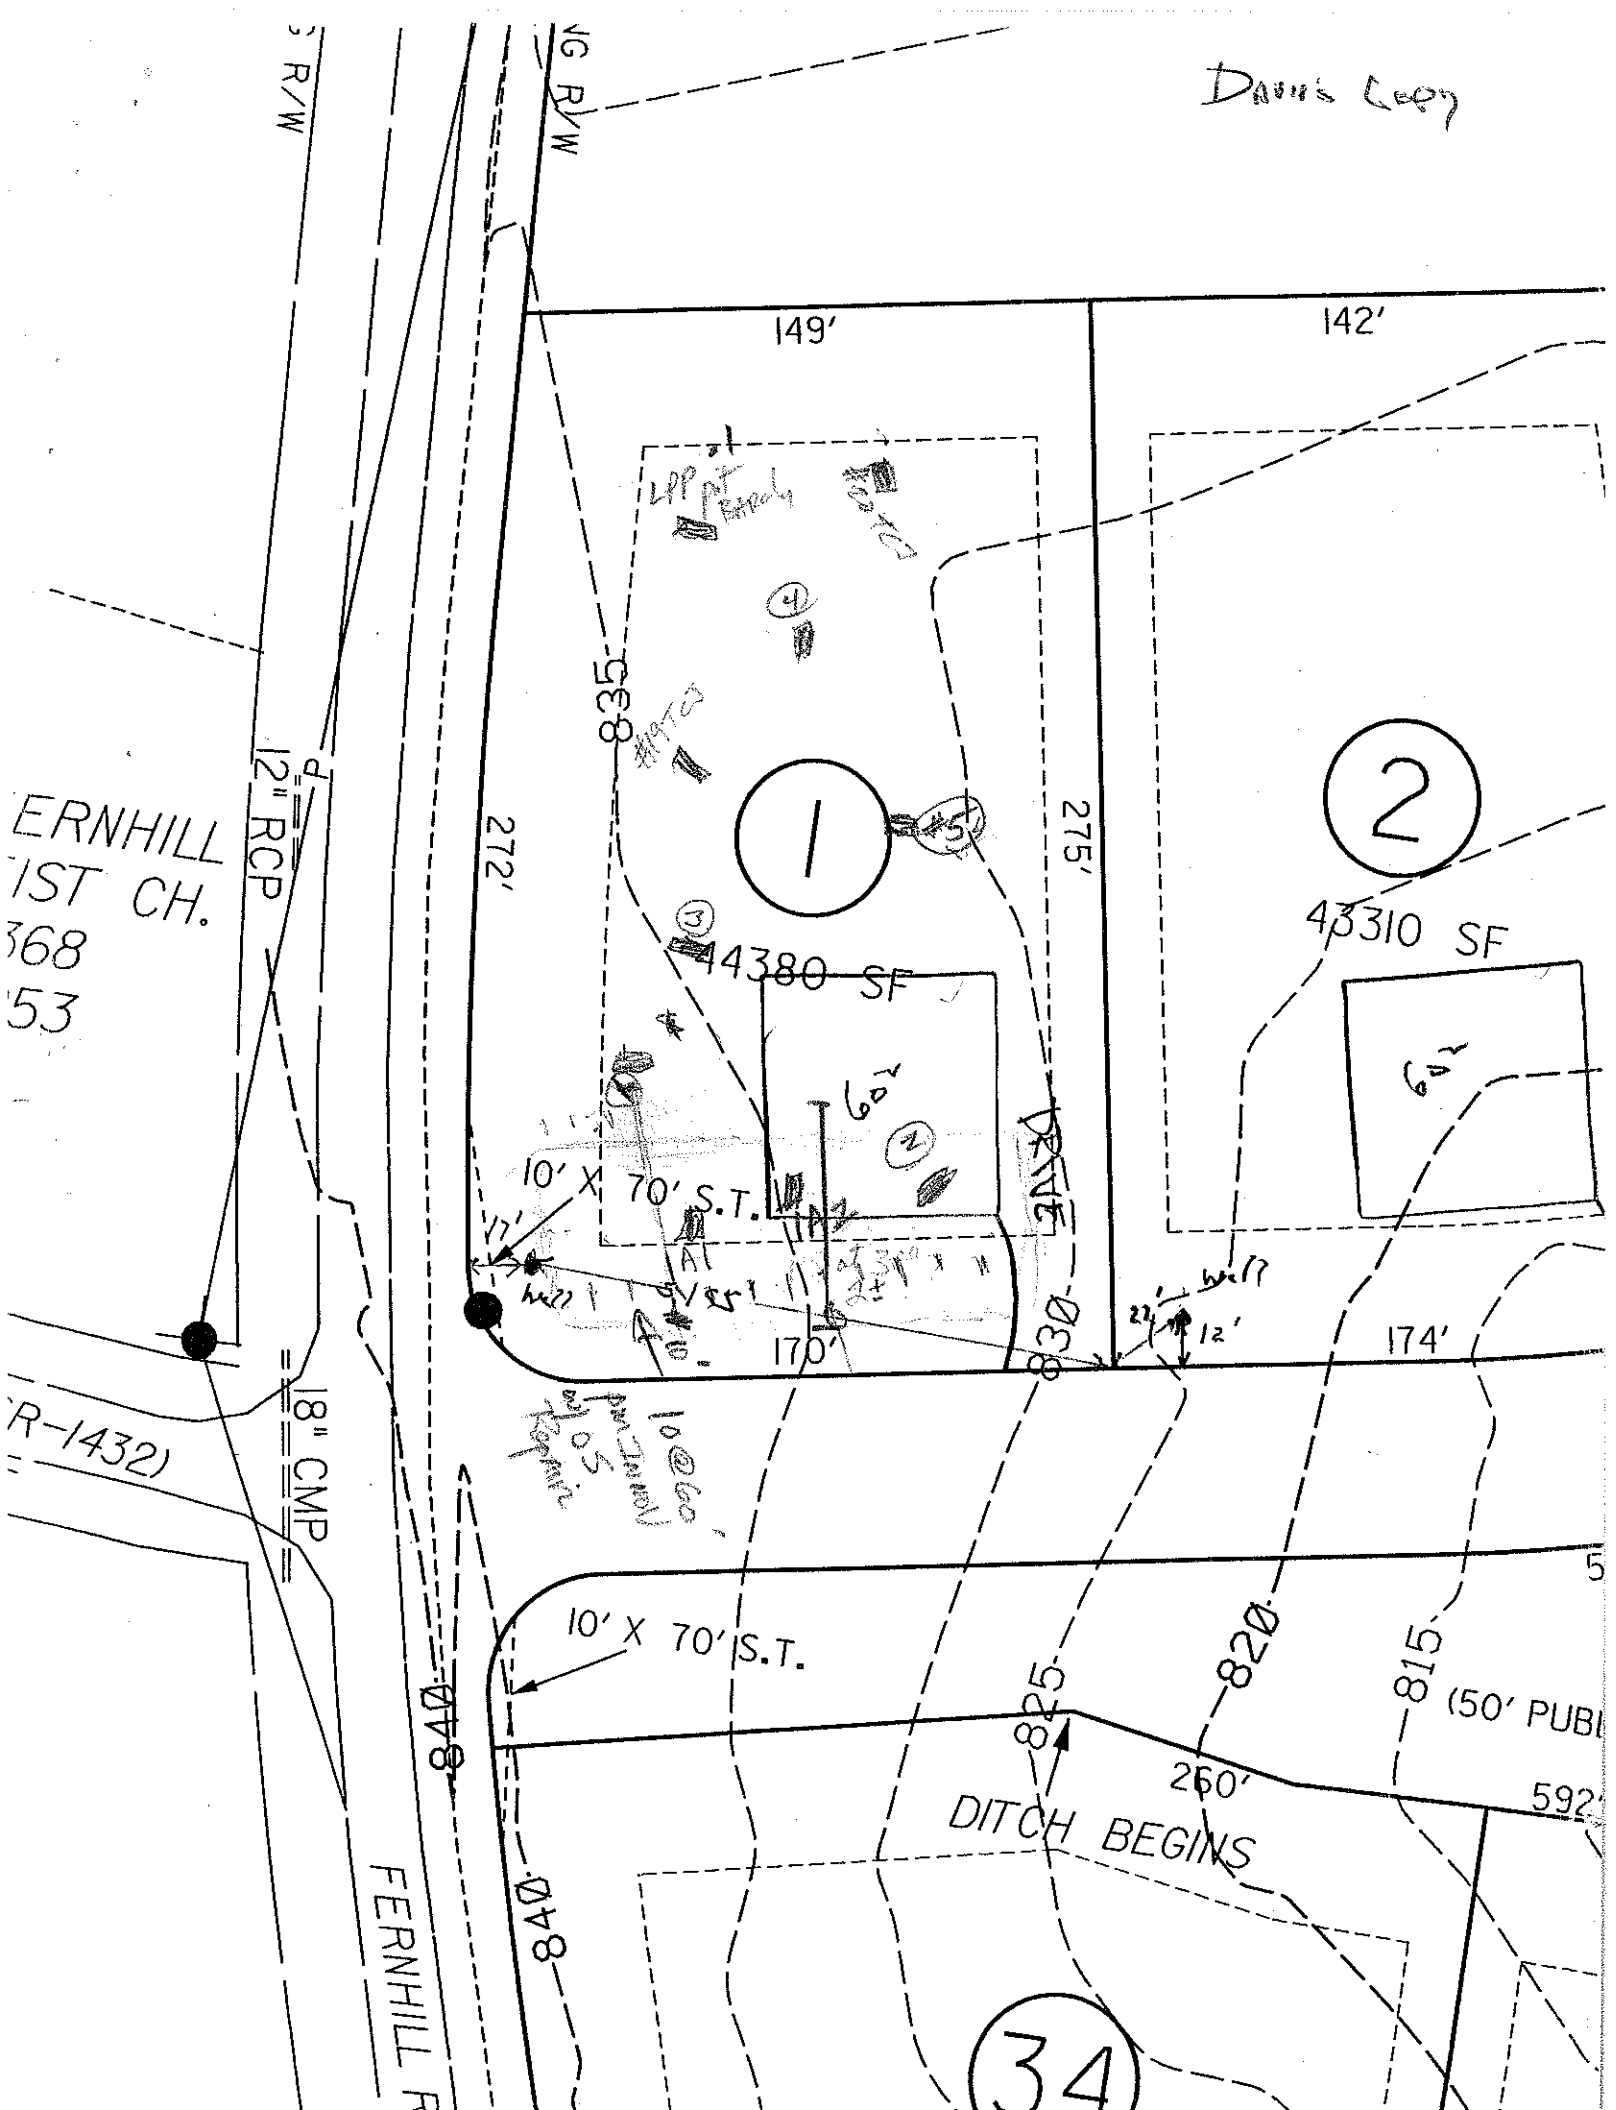
.1940 LANDSCAPE POSITION/ SLOPE %	HORIZON DEPTH (IN.)	SOIL MORPHOLOGY (.1941) STRUCTURE/ TEXTURE	.1941 CONSISTENCE/ MINERALOGY	OTHER PROFILE FACTORS .1942 SOIL WETNESS/ COLOR	.1943 SOIL DEPTH	.1956 SAPRO CLASS	.1944 RESTR HORIZ	PROFILE CLASS & LTAR
1A1	0-27	RCl	Common yellow clay mottles					e1
	27-48	wk sab RCl	fi-fr SSSp rare SAP 36-48					e3
	48-65	LSAp						.4
1A2	0-16	Somewhat compacted relict C fSAp		Common yellow mottles				PS e1
	16-53	wk sab m cbk heave of fSAp	fi-fr-SSSp few-common wkSAP					.225-.25
