ISION OF ENVIRONMENTAL HEALTH
-SITE WASTEWATER SECTION

SOIL/SITE EVALUATION
for ON-SITE WASTEWATER SYSTEM

OWNER: CRI — APPLICANT: _____
ADDRESS: _____ — APPLICATION DATE: _____ — DATE EVALUATED: 10-16-00
PROPOSED FACILITY: _____ — PROPOSED DESIGN FLOW (.1949): _____ — PROPERTY SIZE: _____
LOCATION OF SITE: Lot 5 Wildwood Court — PROPERTY RECORDED: _____
WATER SUPPLY: ☐ Private ☐ Public ☐ Well ☐ Spring ☐ Other _____
EVALUATION METHOD: ☐ Auger Boring ☐ Pit ☐ Cut — AH#5 — 0-16 wkgr Cl sl gravelly fine sandy loam mottles .2-.3 fi sssp — 16-32 gr wkstb fr sssp abrupt wsl sap .3+ — 32-46 wkstb fr sssp
TYPE OF WASTEWATER: ☐ Sewage ☐ Industrial Process ☐ Mixed — 10-31-00 — 36" Hb – System in boat yard

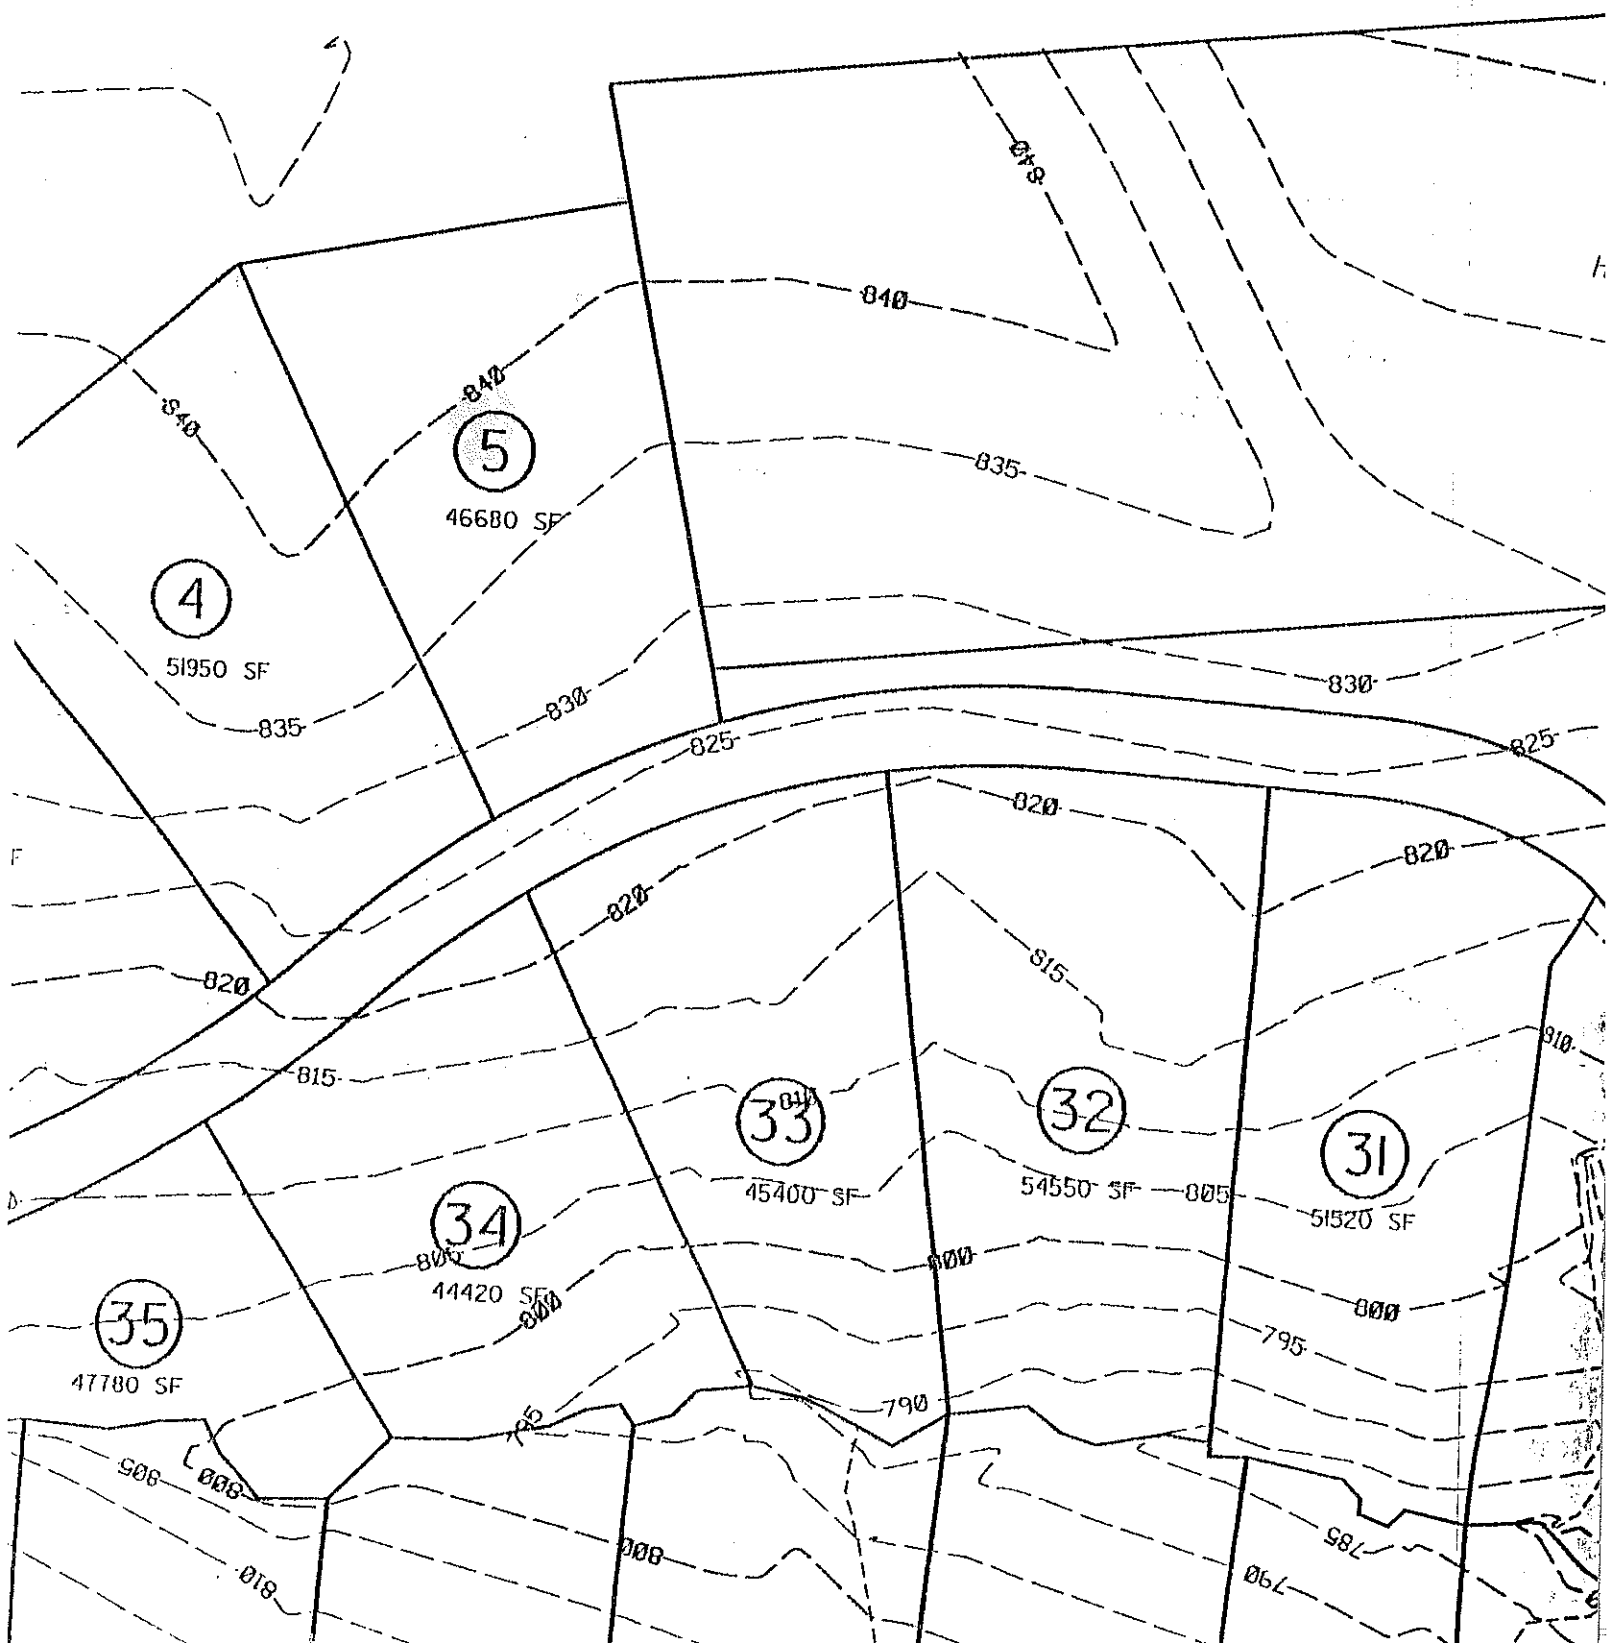
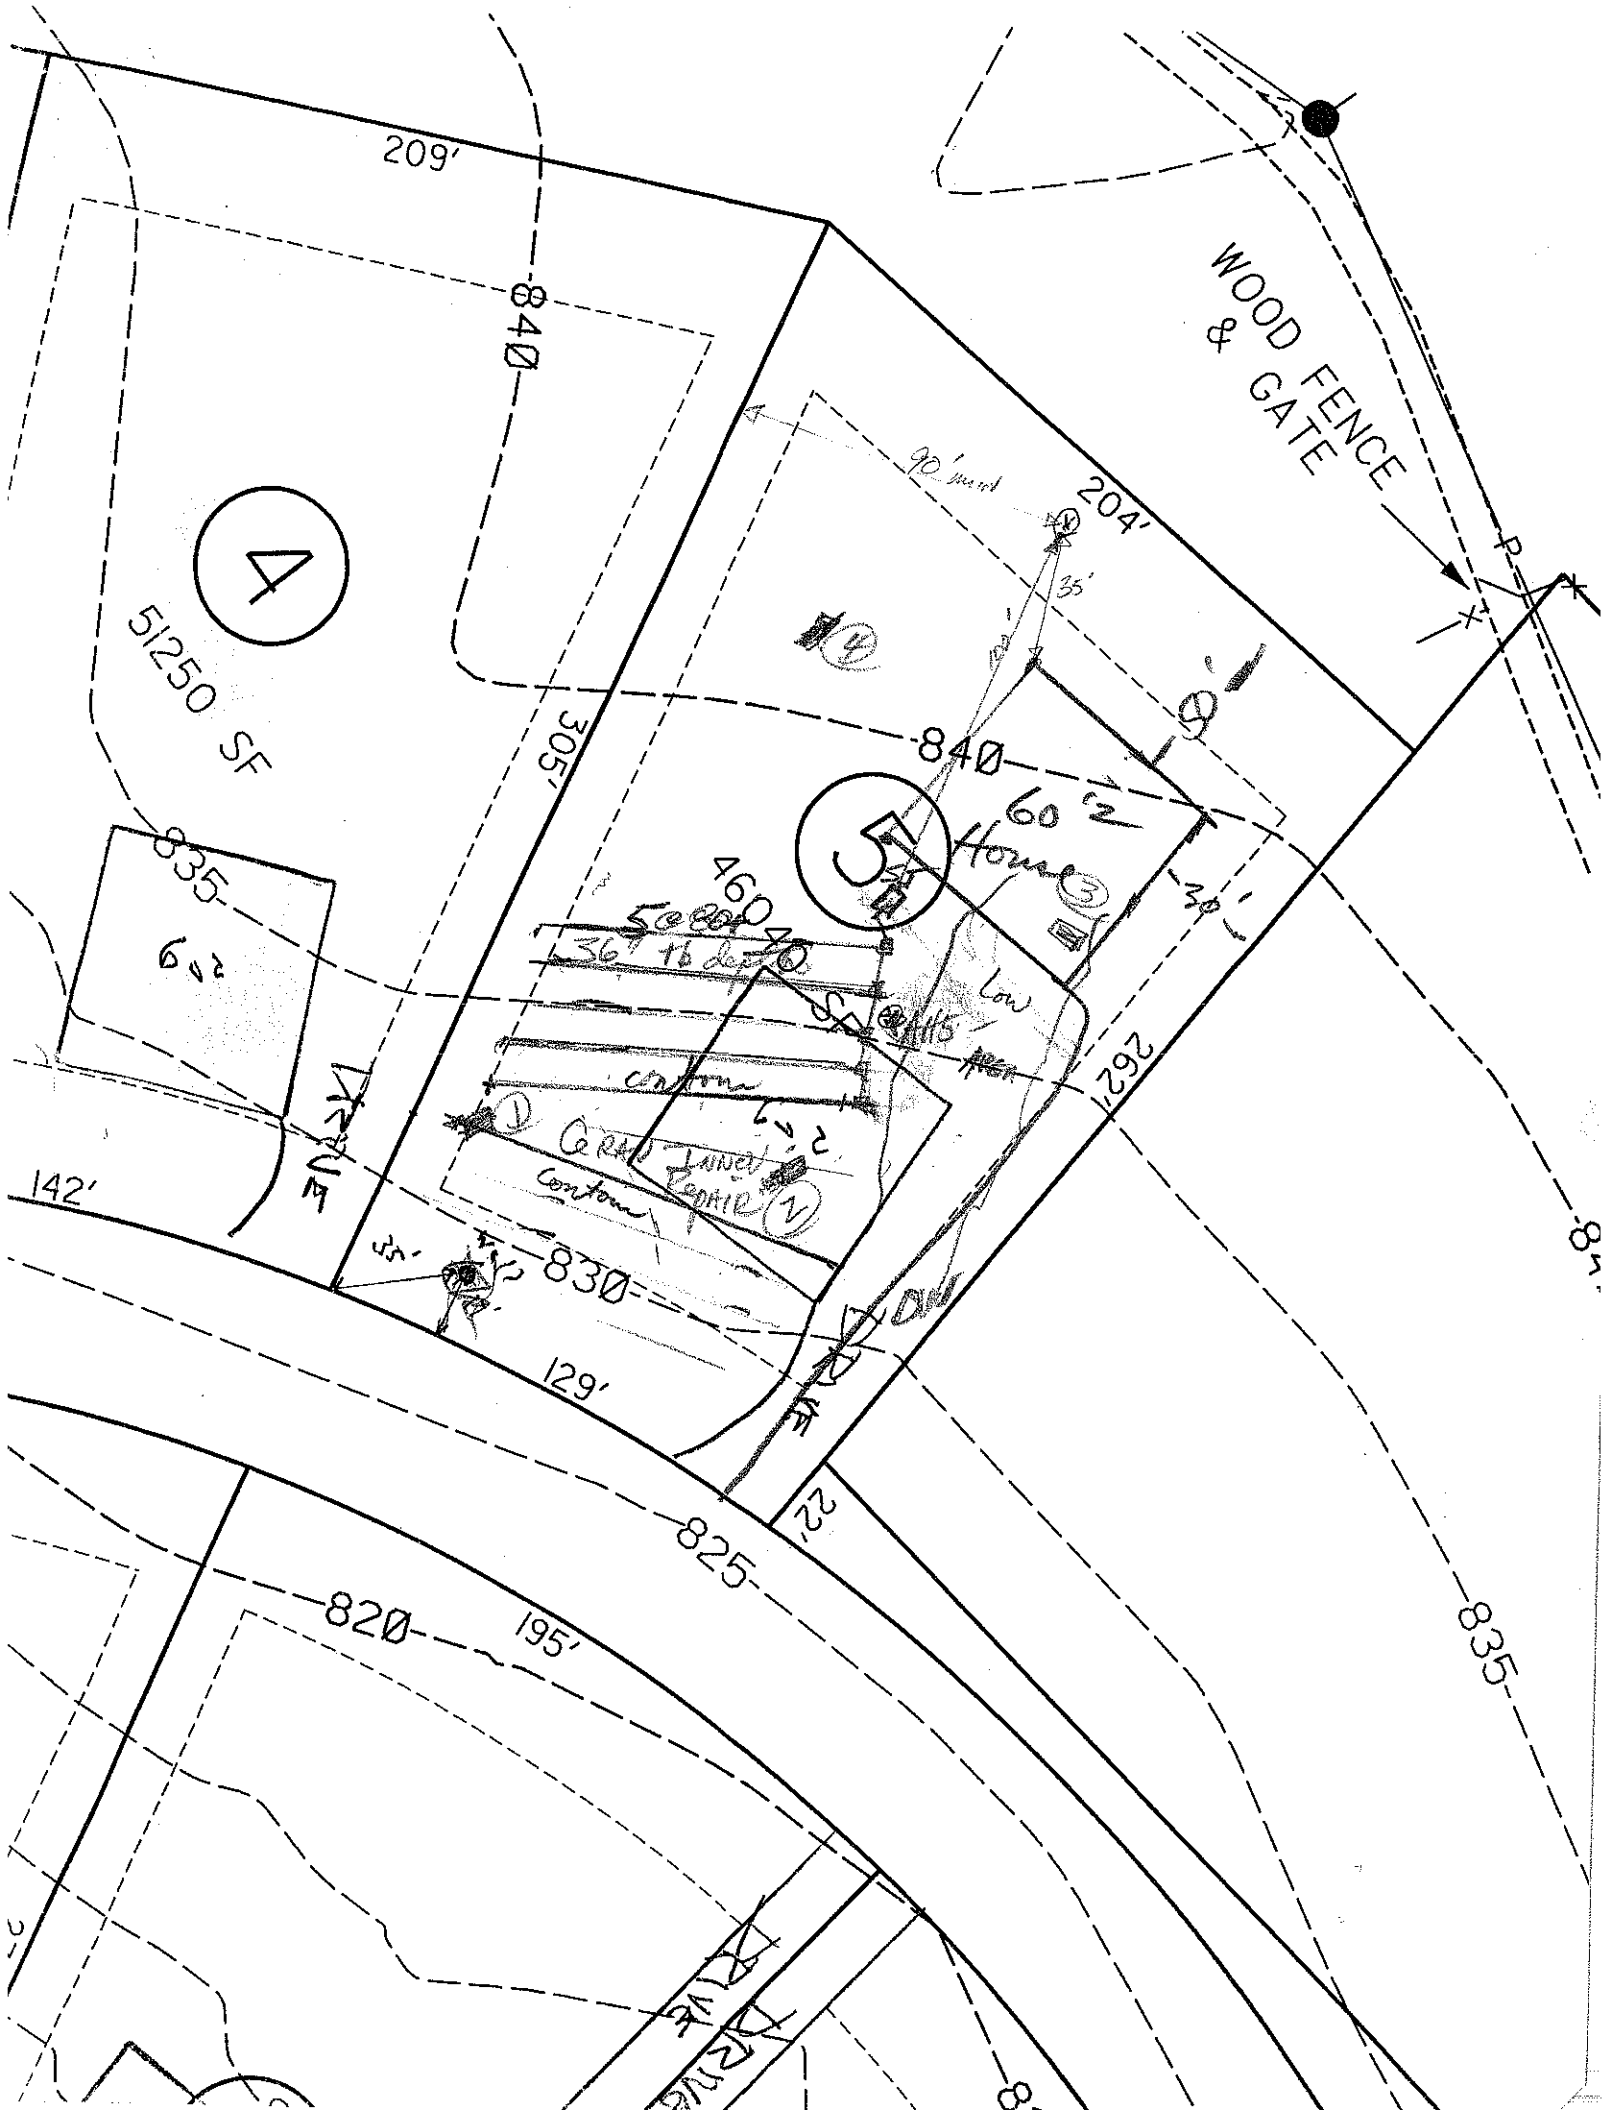
209'
840
WOOD FENCE & GATE
90' mark
204'
35'
4
51250 SF
305'
840
60' 2 Story House
5
835
460
36" to dec 40
Low
Contour
262'
142'
Cedar Tree
Contour
830
129'
825
820
195'
835
22'

.1940 LANDSCAPE POSITION/ SLOPE %	HORIZON DEPTH (IN.)	SOIL MORPHOLOGY (.1941) STRUCTURE/ TEXTURE	SOIL MORPHOLOGY (.1941) CONSISTENCE/ MINERALOGY	OTHER PROFILE FACTORS .1942 SOIL WETNESS/ COLOR	.1943 SOIL DEPTH	.1956 SAPRO CLASS	.1944 RESTR HORIZ	PROFILE CLASS & LTAR
	0-14	compacted sl/c l vfi						
	14-46	wkstb ybr/gr c l/l few common mod sap fr sss p sap						B .3 > 144
	0-5	gr brn sl/sk fri fr						
	5-17	wkstb-mod sbk c fi-vfi sssp						.1-.2 .3
	17-43	wk mod stb yr cl fr sss p few-common mi sap						
	0-23	wk gr mod sbk c/cl vfi few common fine roots						
	23-50	wk stb/massive yr cl fi mod sap fr sssp						(4) .25+
	0-18	gr brn sl/sk fi-fr						
	18-40	wk thin moderate platy cl/sicl fi-vfi sssp						.1-.2
