Sheet 1 of 1
PROPERTY ID #:
COUNTY:

SOIL/SITE EVALUATION
for ON-SITE WASTEWATER SYSTEM

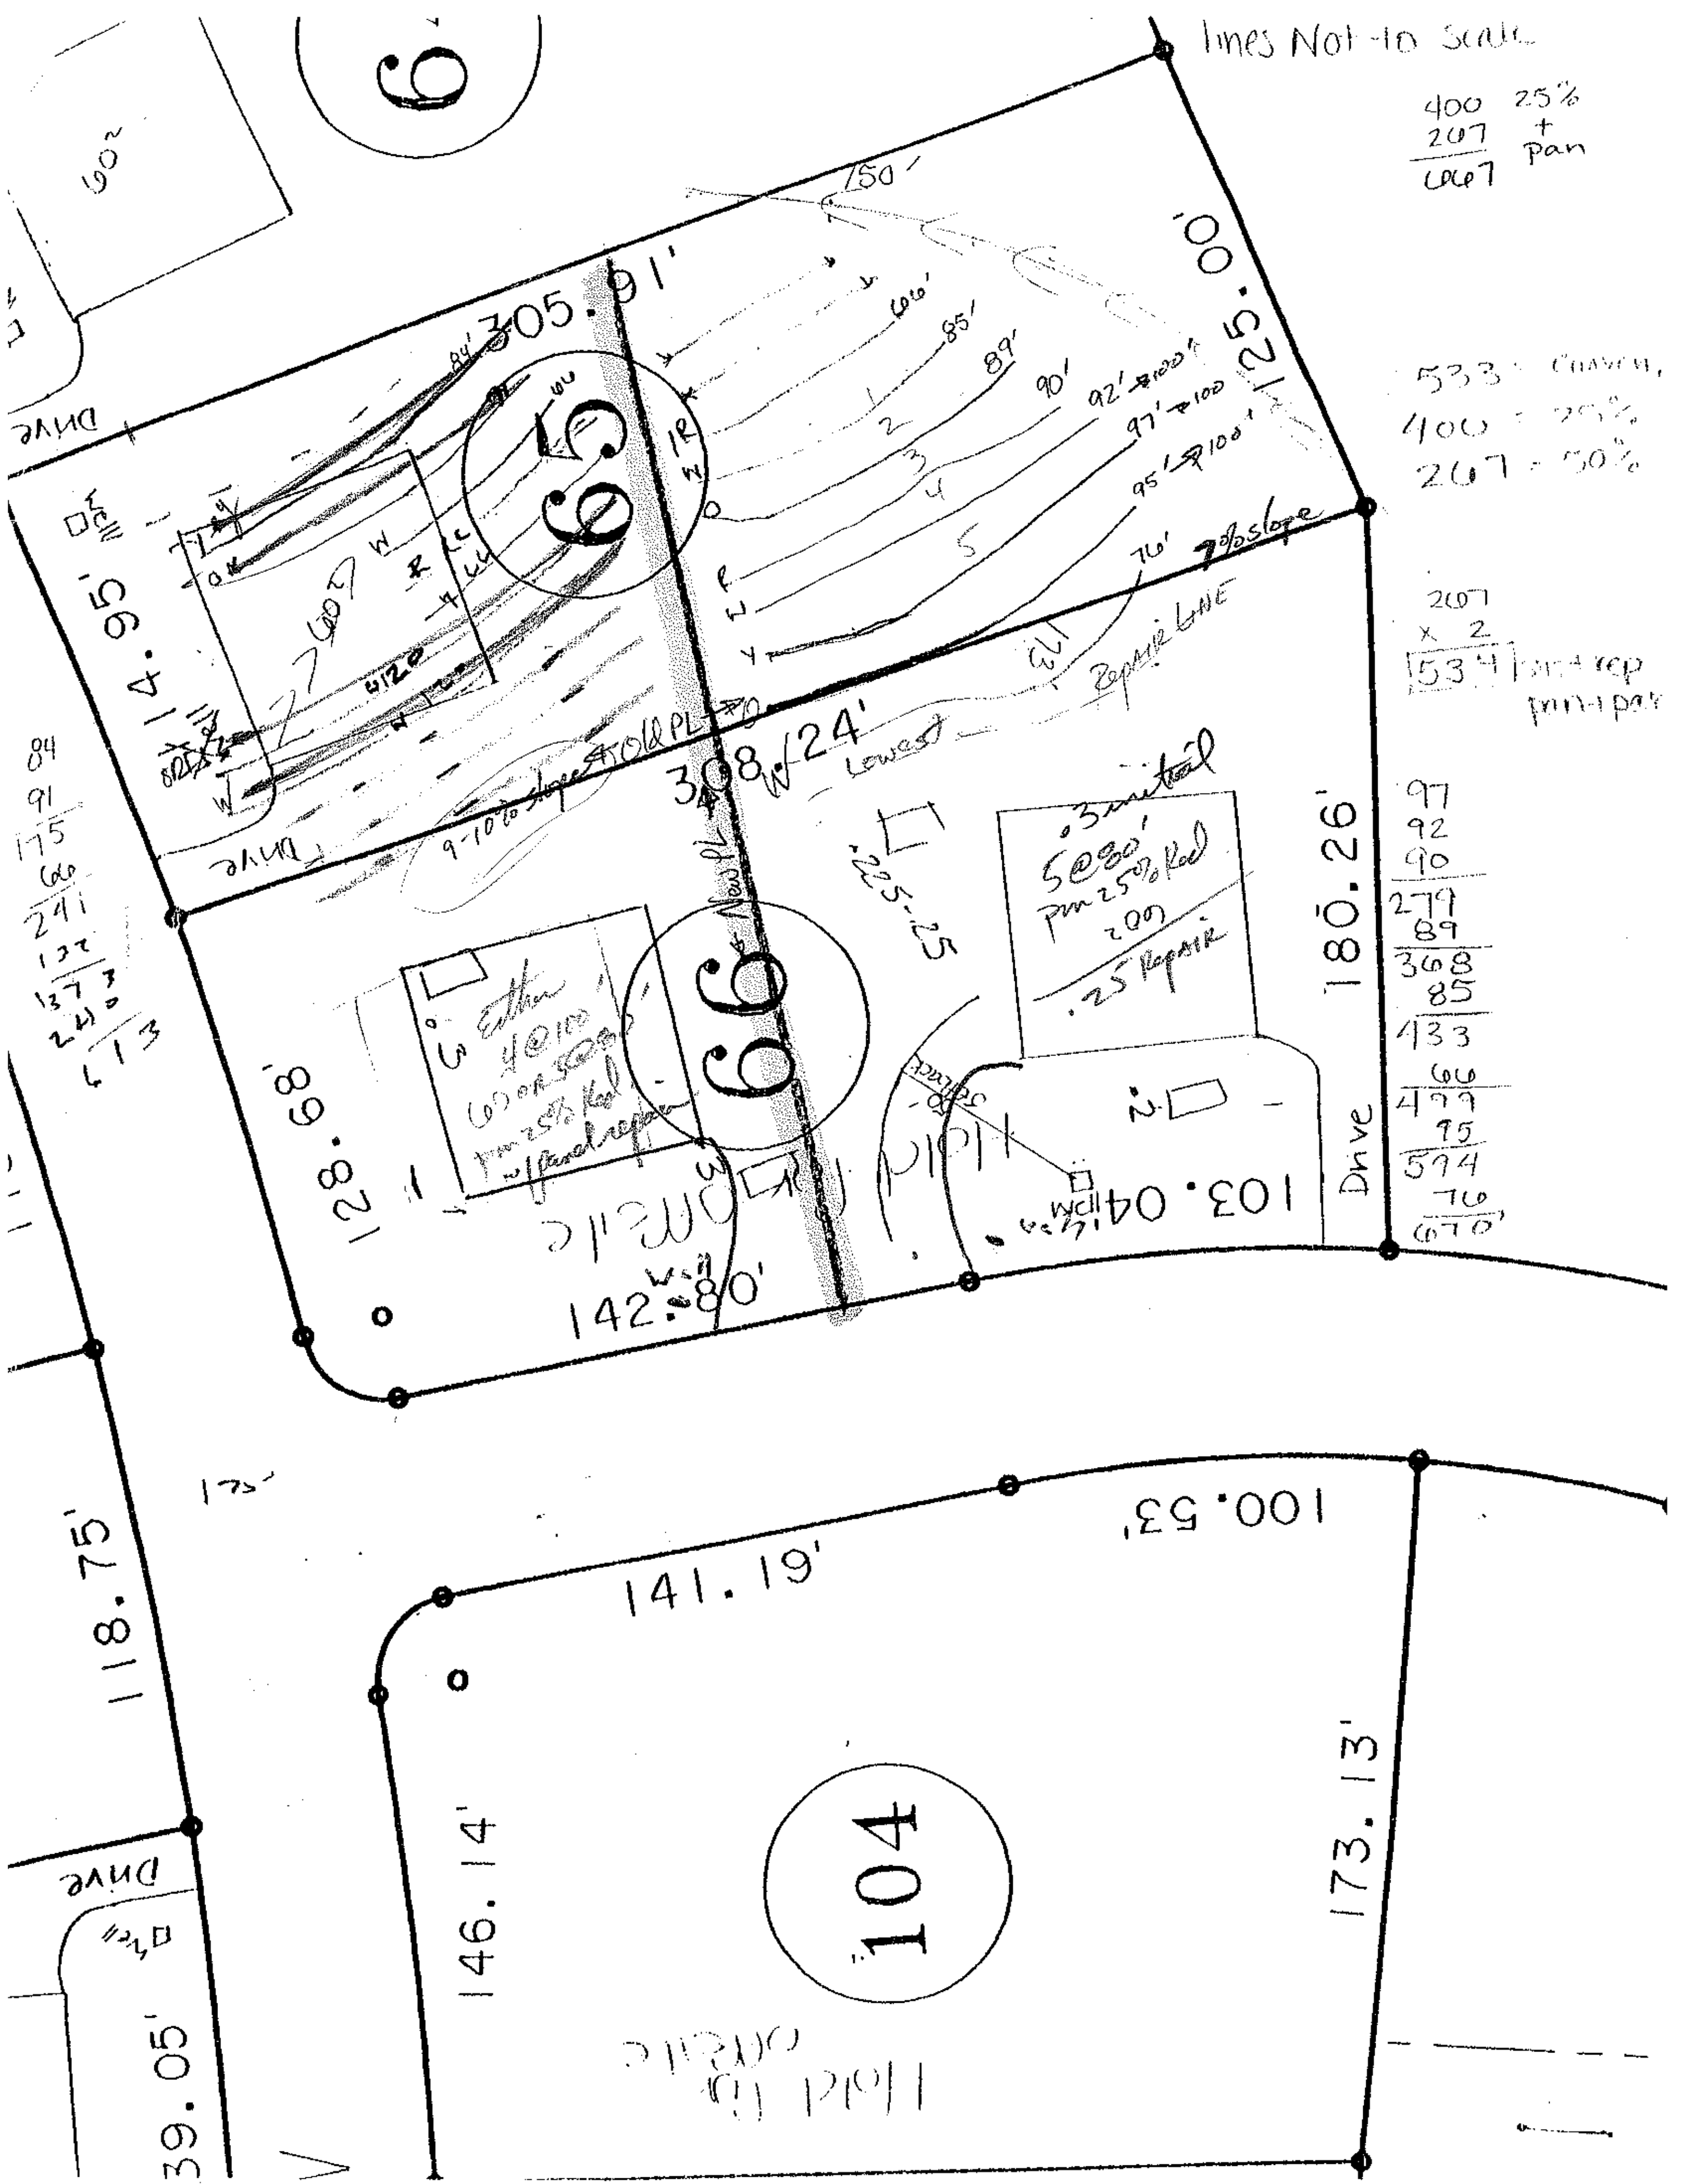
PROFILE #	.1940 LANDSCAPE POSITION/ SLOPE %	HORIZON DEPTH (IN.)	SOIL MORPHOLOGY (.1941) STRUCTURE/ TEXTURE	SOIL MORPHOLOGY (.1941) CONSISTENCE/ MINERALOGY	OTHER PROFILE FACTORS .1942 SOIL WETNESS/ COLOR	.1943 SOIL DEPTH	.1956 SAPRO CLASS	.1944 RESTR HORIZ	PROFILE CLASS & LTAR
1	NS 4% Initial Area	0-21	WK SBK brn SL	fr SS SP					.3
		21-45	ABK RC	fr SS SP					
		45-52	SBK RCL	fr SS SP					
2	Initial Area	0-11	WK SBK brn SL	fr SS SP					.3
		11-35	SBK RC	fr SS SP					
		35-48	WK SBK RCL	fr SS SP					
3									
4

lines Not to Scale
400 25%
207 + pan
607
305.91'
125.00'
65
114.95'
Drive
Old PL
308.24'
Lowest
Repair LINE
New PL
66
180.26'
128.68'
142.80'
103.04'
Drive
5@80'
pm 25% Red
207
.25 Repair
Either
4@100'
pm 25% Red
533 = Conven.
400 = 25%
207 = 50%
207
x 2
534
97
92
90
279
89
368
85
433
66
499
95
594
76
670
84
91
175
66
241
132
373
240
613
118.75'
141.19'
100.53'
104
146.14'
173.13'
39.05'
Drive
