VISION OF ENVIRONMENTAL HEALTH
N-SITE WASTEWATER SECTION

SOIL/SITE EVALUATION
for ON-SITE WASTEWATER SYSTEM

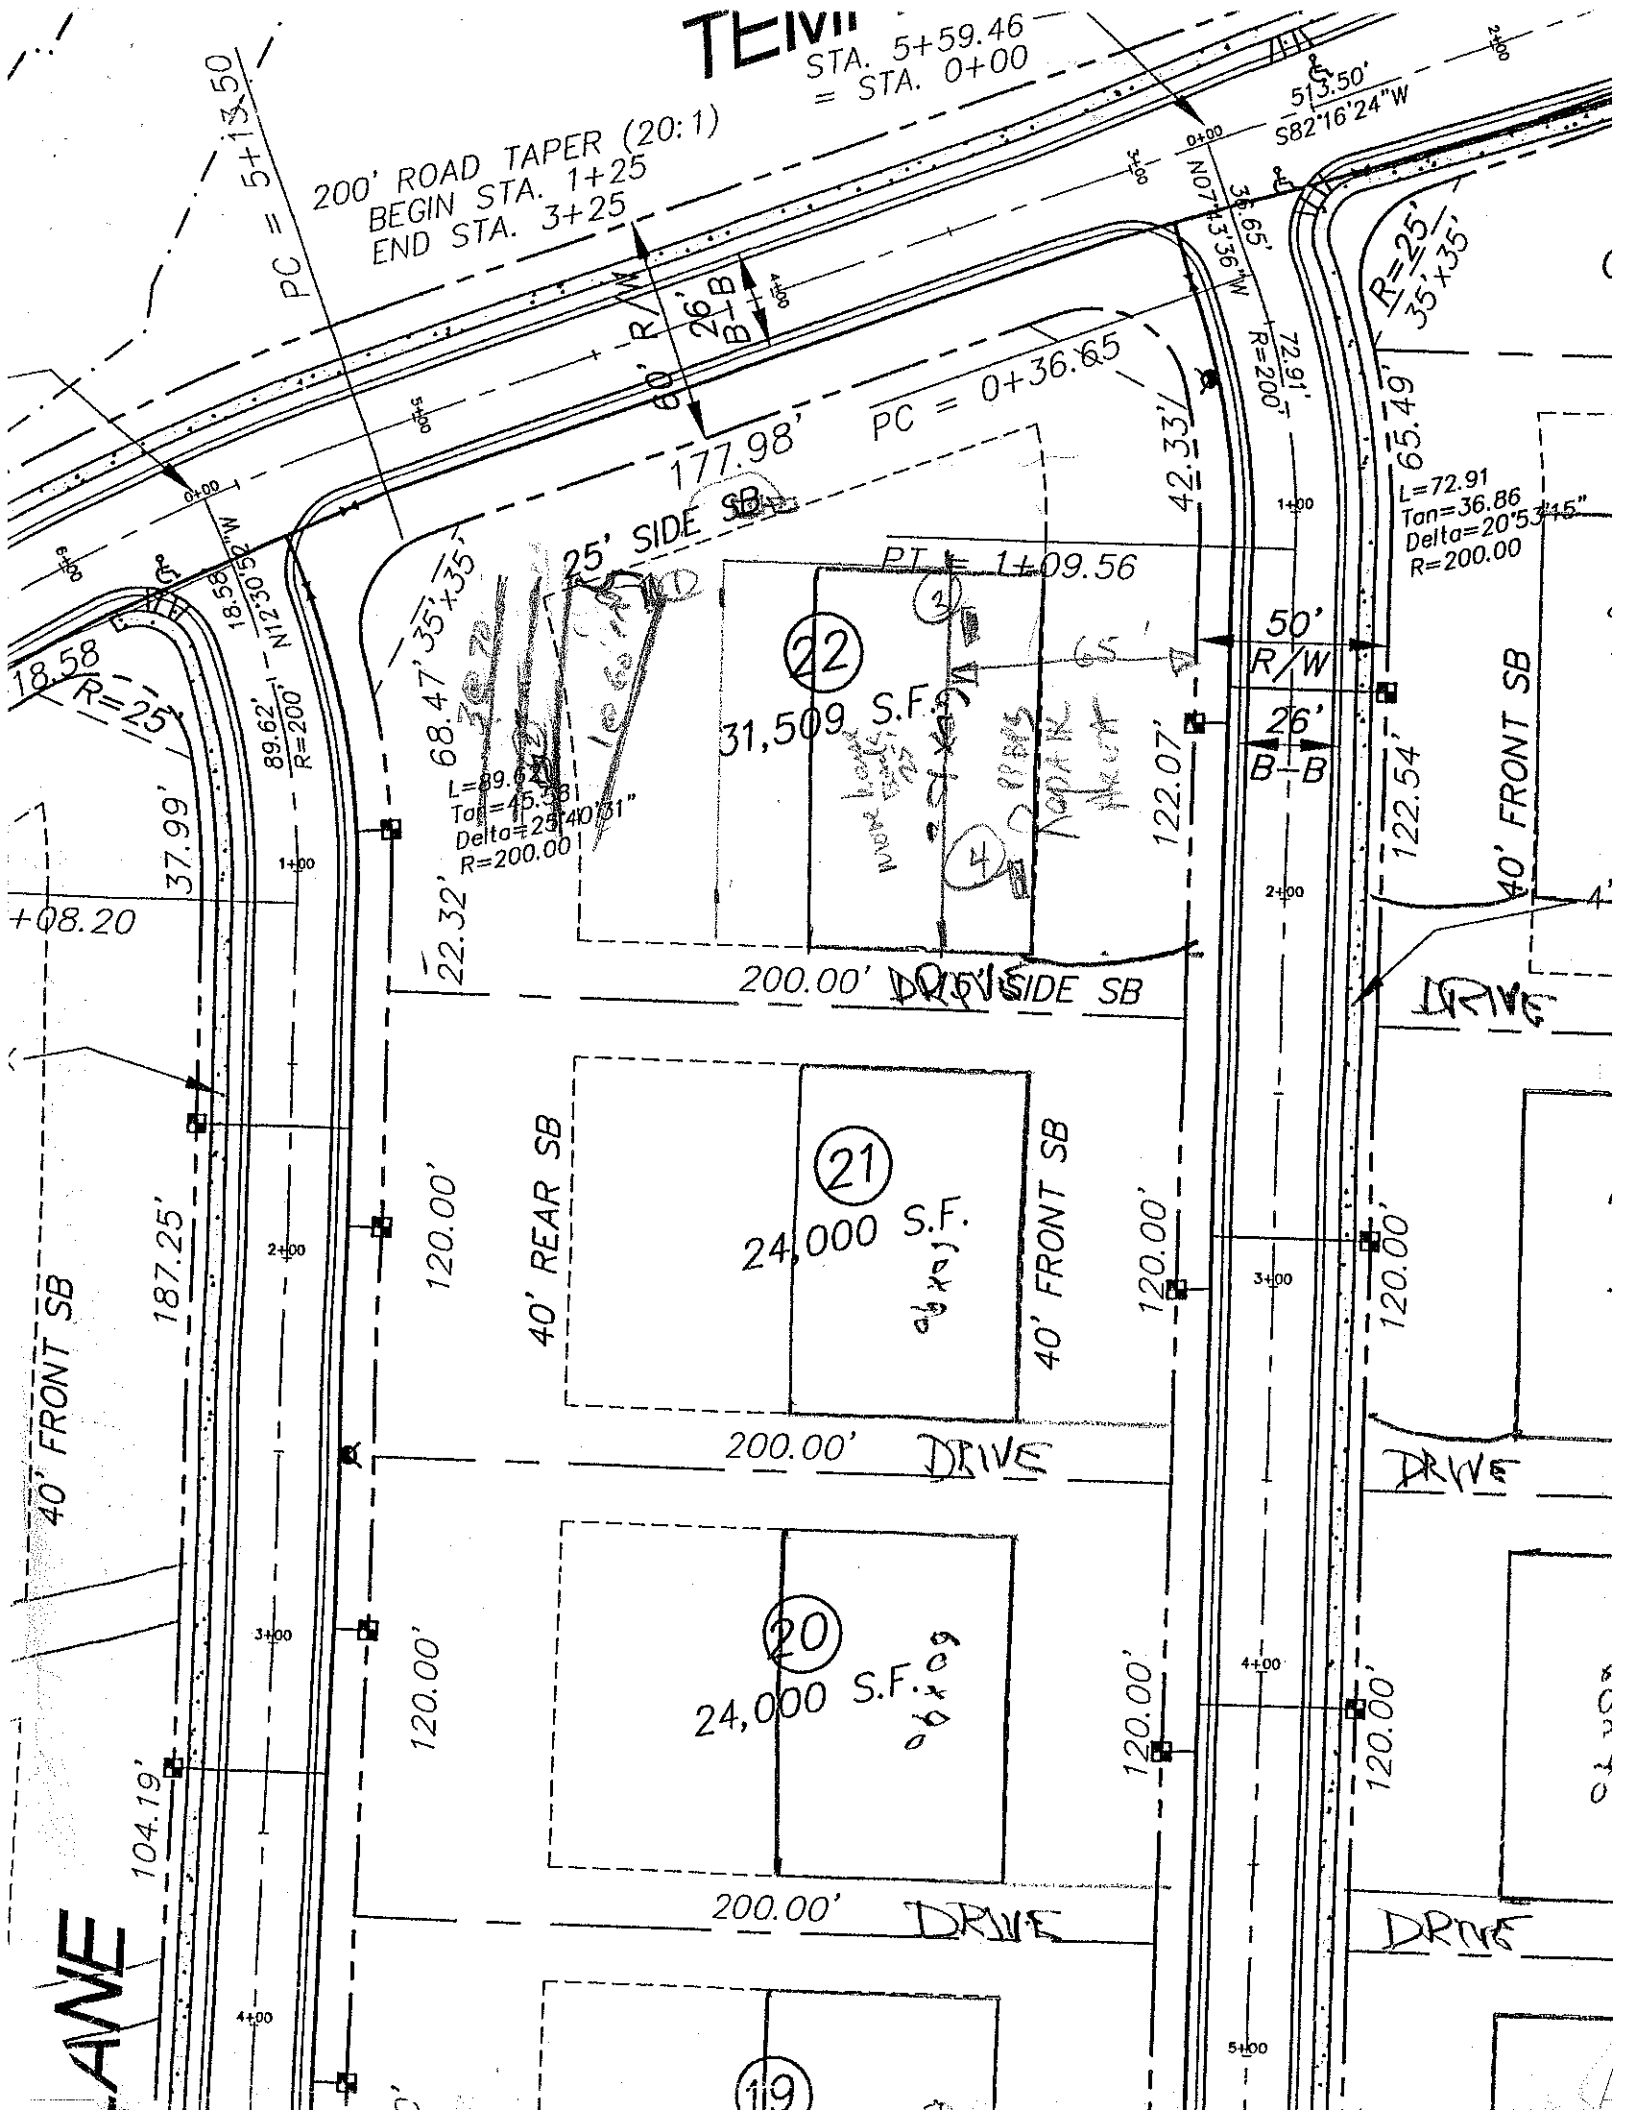
.1940 LANDSCAPE POSITION/ SLOPE %	HORIZON DEPTH (IN.)	SOIL MORPHOLOGY (.1941) .1941 STRUCTURE/ TEXTURE	SOIL MORPHOLOGY (.1941) .1941 CONSISTENCE/ MINERALOGY	OTHER PROFILE FACTORS .1942 SOIL WETNESS/ COLOR	.1943 SOIL DEPTH	.1956 SAPRO CLASS	.1944 RESTR HORIZ	PROFILE CLASS & LTAR
(1)	0-13	wksbk Rbrwd	frssso					.3
	13-56	m fmsbk RC	fi-frssso					
(2)	0-13	gr-wksbk brwn sil	frssso					.3
	13-36	sbk RC	fi-frssso					
	36-62	m-wksbk R-gr cl	frssso few mod sapr rx					
(3)	0-5	wksbk, Rbrwn cl	frssso					.25
	5-54	MSbk/ms Rcl/cl	fi sp sso					
		35-50 yb mottles on E wall of pit						
(4)	0-8	wksbk Rbrn sil/cl	frssso					.25
	8-56	wksbk/ms brwn c/c	fi sp sso					
			Common Mn concretions
