...ON OF ENVIRONMENTAL HEALTH:
...TE WASTEWATER SECTION

SOIL/SITE EVALUATION
for ON-SITE WASTEWATER SYSTEM

...ER: _____ APPLICANT: _____
...DDRESS: _____ APPLICATION DATE: _____ DATE EVALUATED: 9-6-01
...OPOSED FACILITY: _____ PROPOSED DESIGN FLOW (.1949): _____ PROPERTY SIZE: _____
...CATION OF SITE: 335 - Templeton Farms PROPERTY RECORDED: _____
...ATER SUPPLY: ☐ Private ☐ Public ☐ Well ☐ Spring ☐ Other _____
...ALUATION METHOD: ☐ Auger Boring ☐ Pit ☐ Cut
...PE OF WASTEWATER: ☐ Sewage ☐ Industrial Process ☐ Mixed

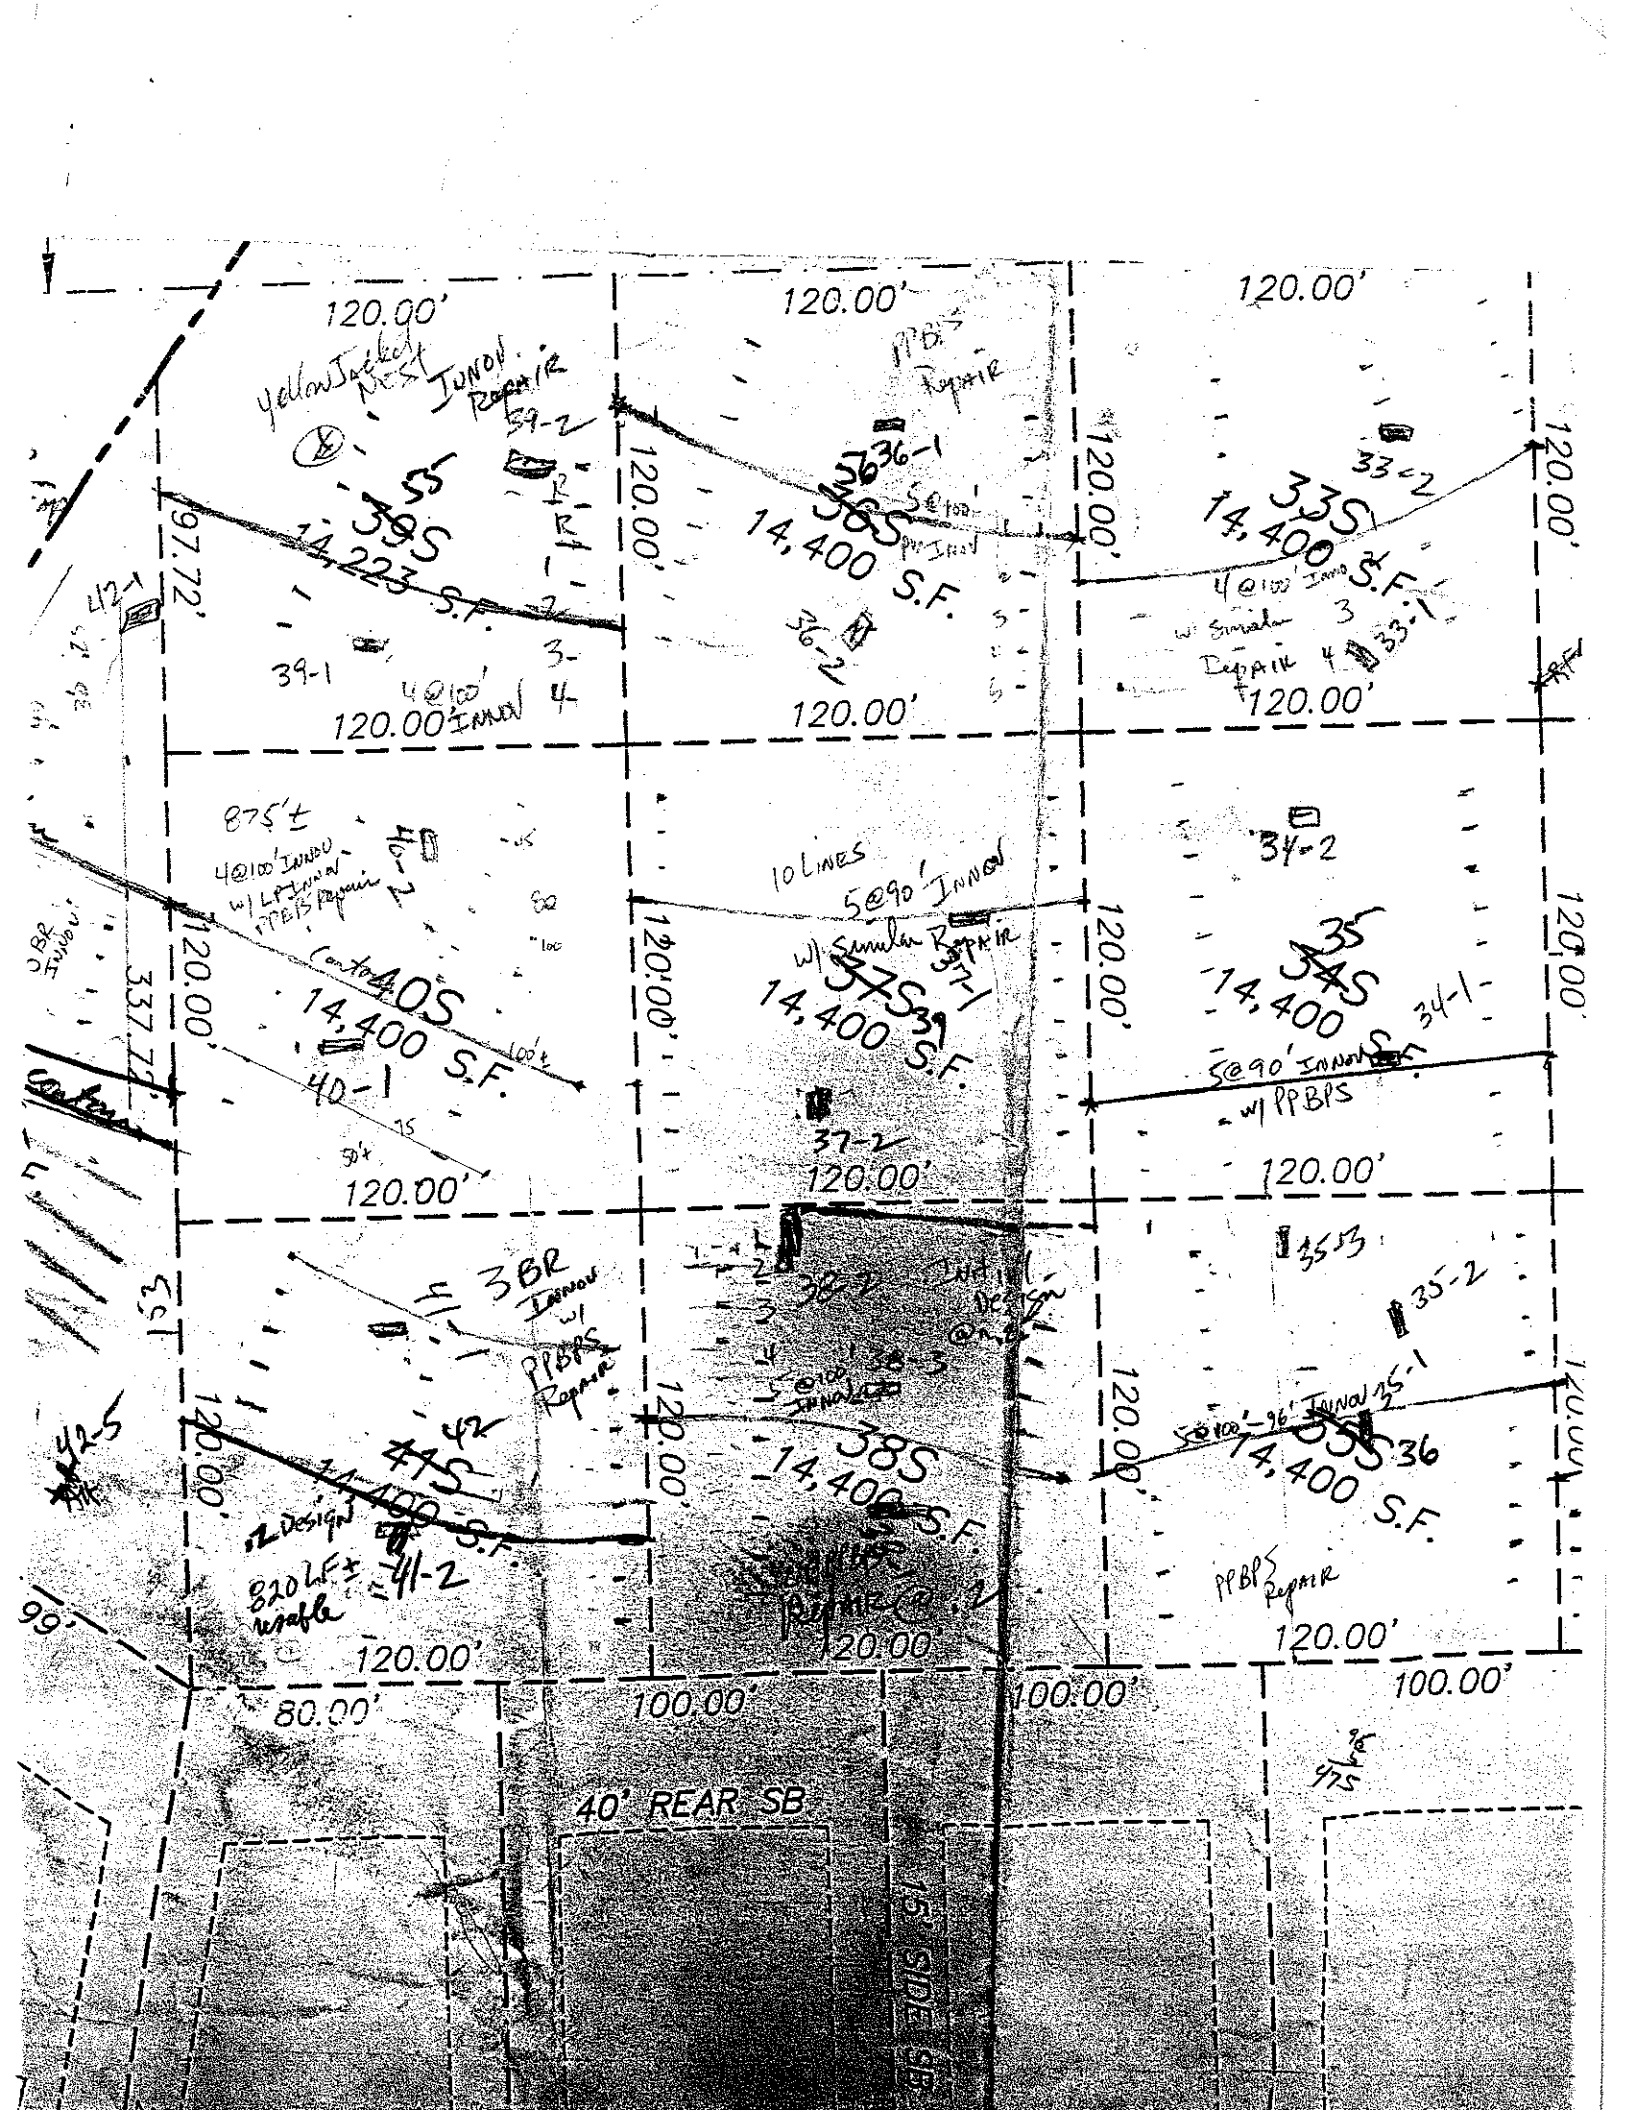
.1940 LANDSCAPE POSITION/ SLOPE %	HORIZON DEPTH (IN.)	SOIL MORPHOLOGY (.1941) .1941 STRUCTURE/ TEXTURE	SOIL MORPHOLOGY (.1941) .1941 CONSISTENCE/ MINERALOGY	OTHER PROFILE FACTORS .1942 SOIL WETNESS/ COLOR	OTHER PROFILE FACTORS .1943 SOIL DEPTH	OTHER PROFILE FACTORS .1956 SAPRO CLASS	OTHER PROFILE FACTORS .1944 RESTR HORIZ	PROFILE CLASS & LTAR
33-1	0-4	wksbk brn sl/sel fr						.3
	4-27	sbk rc	fi-fr sp sso					
	27-38	sbk yr cl	fw-md sbp fr ss sp					
	38-53	wksbk yr cl/l	common md sbp fr ss sp					
33-2	0-3	gr brn sl	fr ss sp					.3
	3-21	M fnb/sbk rc	fi sp					
	21-46	wksbk yr scl/cl	fr ss sp fw common md sbp

120.00'
Yellow Jacket Nest
Innov. Repair
39-2
39S
14,223 S.F.
39-1
4@100' Innov
120.00'
PPBS Repair
36-1
36S
14,400 S.F.
5@100' Innov
36-2
120.00'
33-2
33S
14,400 S.F.
4@100' Innov w/ Similar Repair
33-1
120.00'
875'±
4@100' Innov w/ PPBS Repair
40-2
Center
40S
14,400 S.F.
40-1
50'±
120.00'
10 Lines
5@90' Innov w/ Similar Repair
37S
14,400 S.F.
37-1
37-2
120.00'
34-2
35S
14,400 S.F.
5@90' Innov w/ PPBS
34-1
120.00'
3BR Innov w/ PPBS Repair
41-1
41S
14,400 S.F.
41-2
820 LF± Swale
38-2
38-3
5@100' Innov
38S
14,400 S.F.
PPBS Repair @ 2
35-3
35-2
5@100'-96' Innov
35-1
35S
14,400 S.F.
PPBS Repair
120.00'
80.00'
100.00'
40' REAR SB
15' SIDE SB
