IREDELL COUNTY HEALTH DEPARTMENT

IMPROVEMENT PERMIT / CERTIFICATE OF COMPLETION / OPERATION PERMIT / EXISTING SYSTEM INSPECTION

PROPERTY DESCRIPTION NO. 15560 DATE Sept 3, '93 TAX MAP NO. 2H-1-A-26

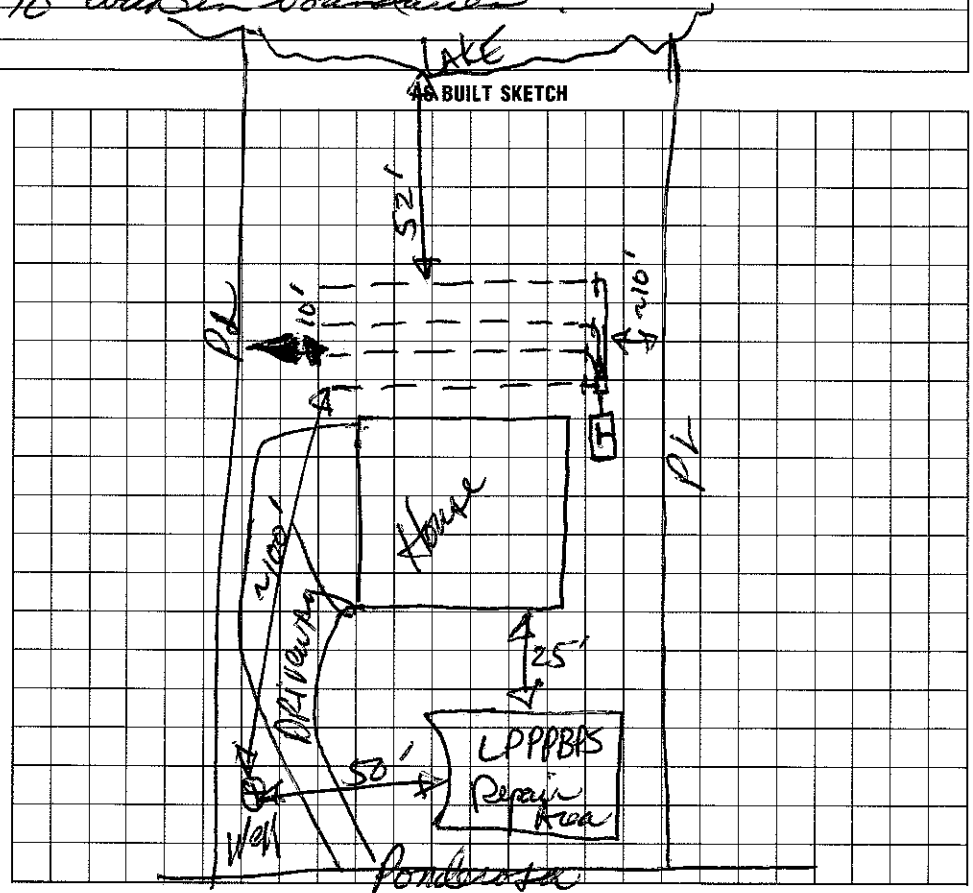
AS BUILT SKETCH

Comments Linear footage ~10' less than shown on IP in order to stay at least 10' within boundaries.
