for ON-SITE WASTEWATER SYSTEM

CATION OF SITE: Lot 44 Templeton Farms PROPERTY RECORDED: _____

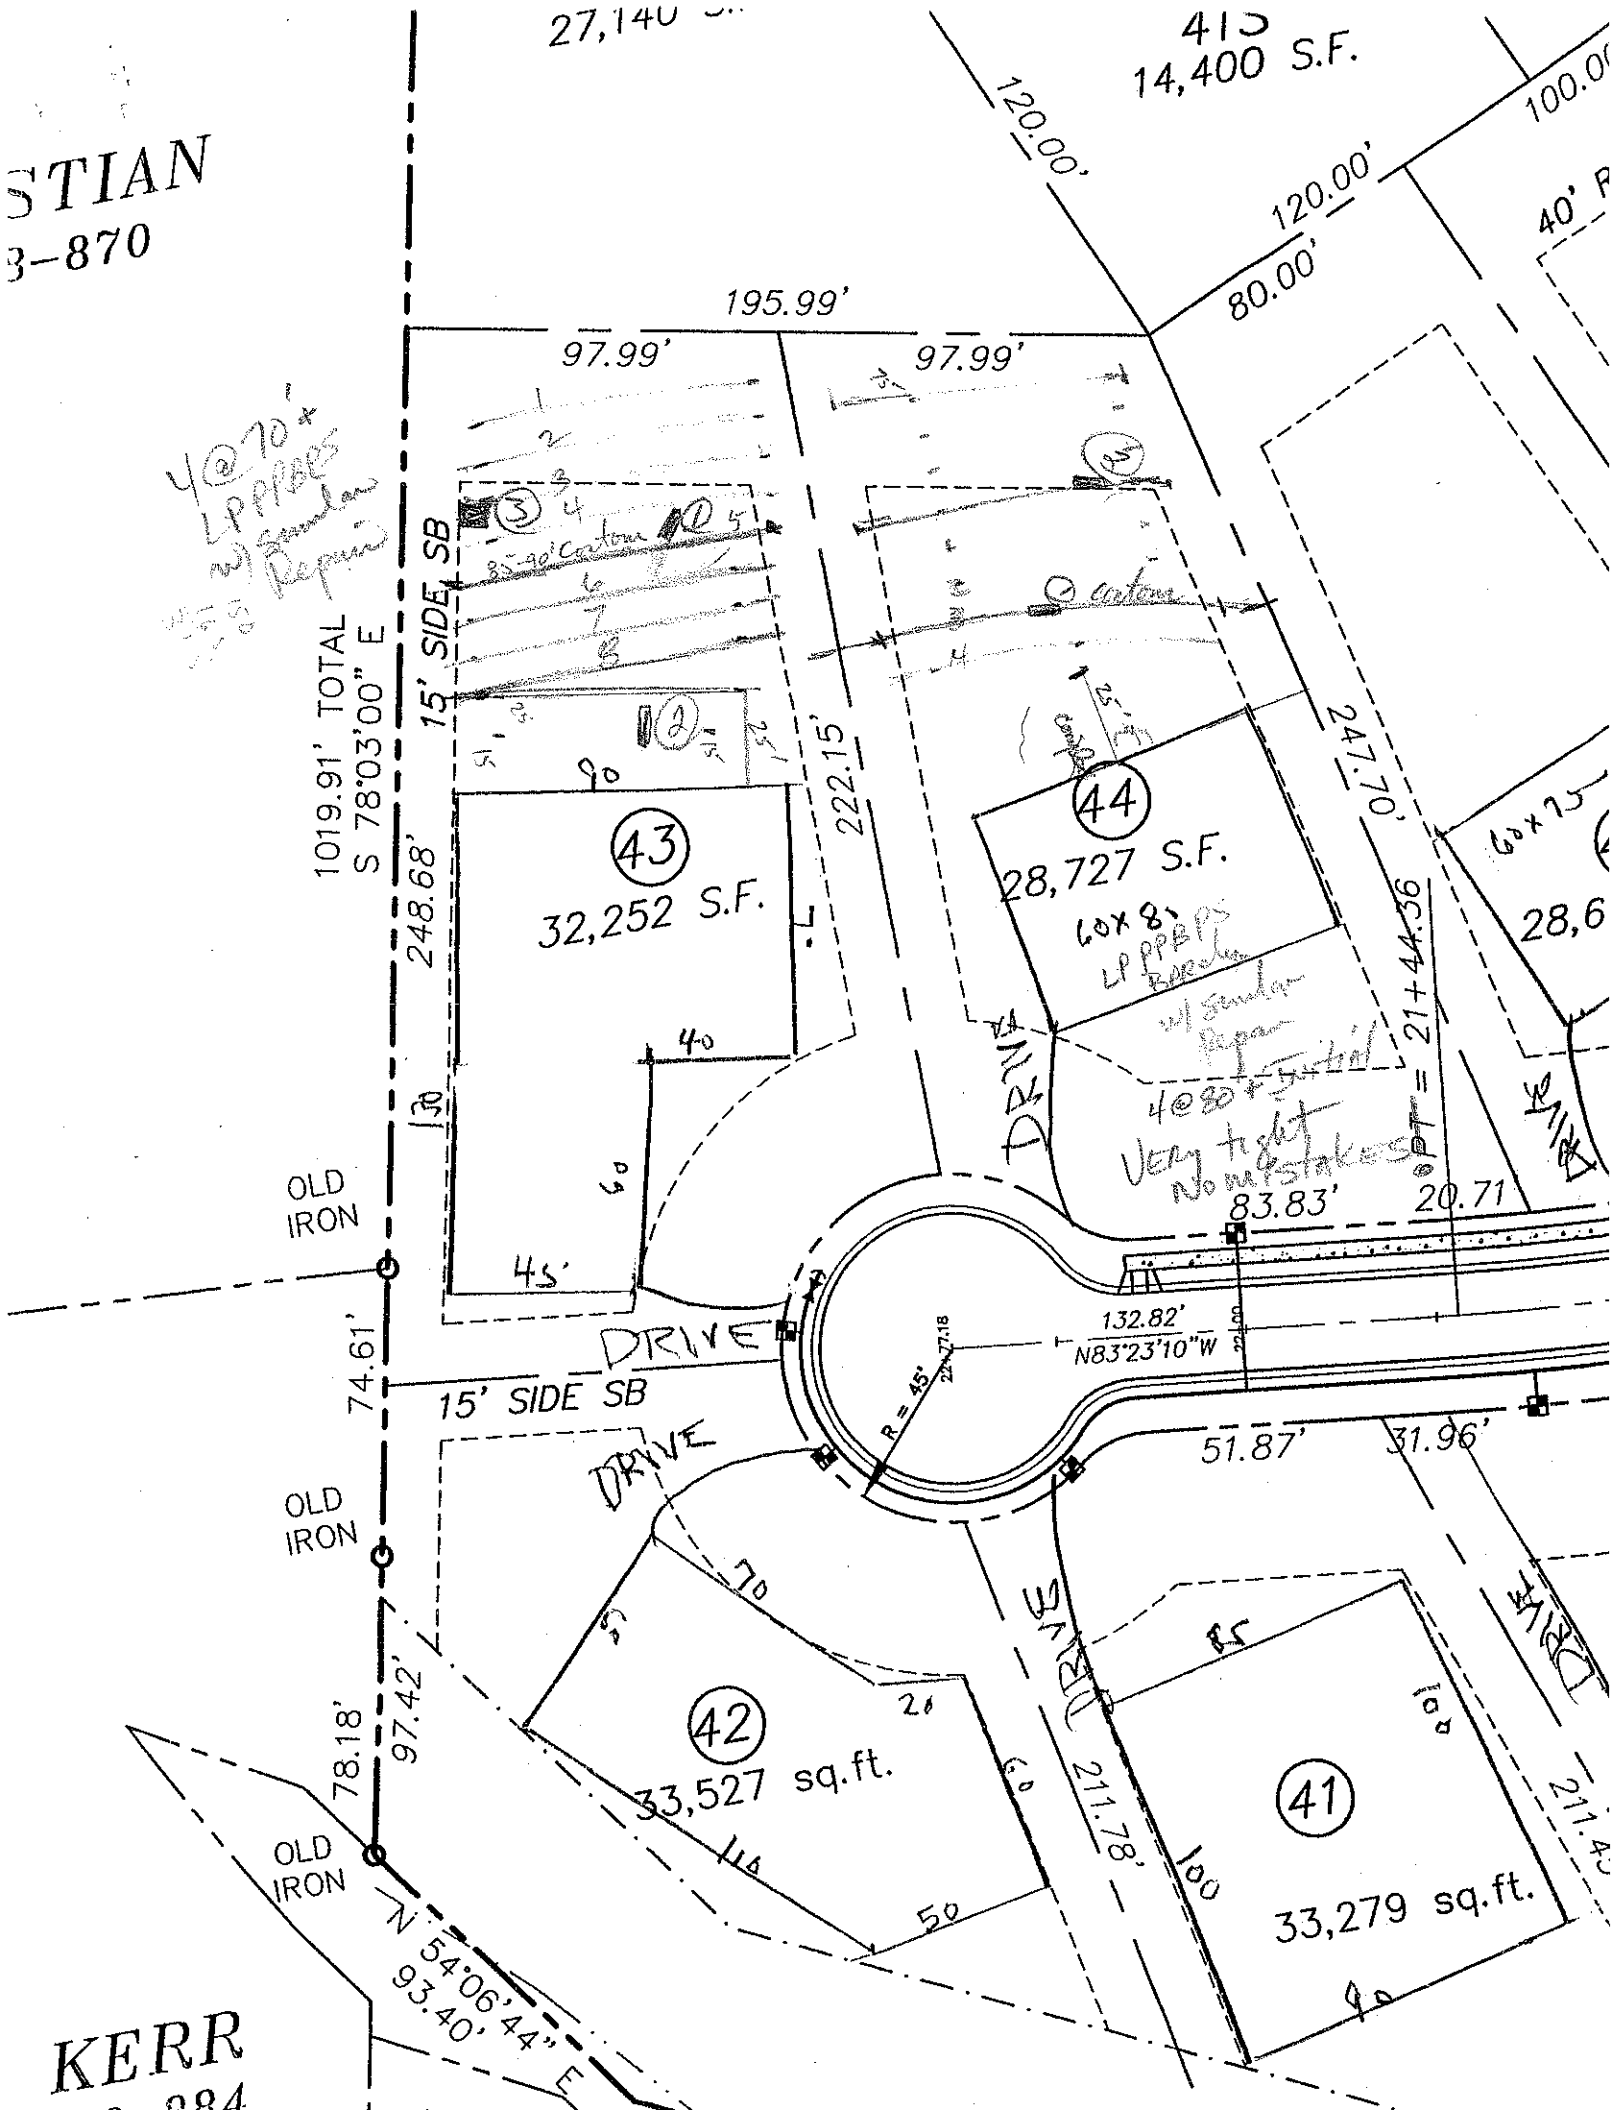
.1940 LANDSCAPE POSITION/ SLOPE %	HORIZON DEPTH (IN.)	SOIL MORPHOLOGY (.1941) .1941 STRUCTURE/ TEXTURE	SOIL MORPHOLOGY (.1941) .1941 CONSISTENCE/ MINERALOGY	OTHER PROFILE FACTORS .1942 SOIL WETNESS/ COLOR	OTHER PROFILE FACTORS .1943 SOIL DEPTH	OTHER PROFILE FACTORS .1956 SAPRO CLASS	OTHER PROFILE FACTORS .1944 RESTR HORIZ	PROFILE CLASS & LTAR
(1)	0-14	wksmb brad sbl	fssscp					.25
	14-41	Mfmb RC	fi sp	few brwn/blk few mn/gray				
(2)	0-9	gr brw sl/sbl	fssscp					.25
	9-15	Mwkmb RC	fi sp scp

27,140
415
14,400 S.F.
120.00'
120.00'
80.00'
100.0
40' R
STIAN
3-870
195.99'
97.99'
97.99'
4@70+
LPPPBPs
w/ Similar
Repair
15' SIDE SB
1019.91' TOTAL
S 78°03'00" E
248.68'
222.15'
247.70'
43
32,252 S.F.
44
28,727 S.F.
60x8
LPPPBP
w/ similar
Repair
4@80+ Survival
Very tight
No marks stakes
21+44.36
83.83'
20.71
28,6
OLD
IRON
40
30
60
45'
74.61'
DRIVE
15' SIDE SB
132.82'
N83°23'10"W
R = 45'
51.87'
31.96'
OLD
IRON
DRIVE
70
42
33,527 sq.ft.
211.78'
41
33,279 sq.ft.
211.4
78.18'
97.42'
OLD
IRON
N 54°06'44" E
93.40'
KERR
