date:
property description: Mills forest II weather: lot 23
topography: excavation:

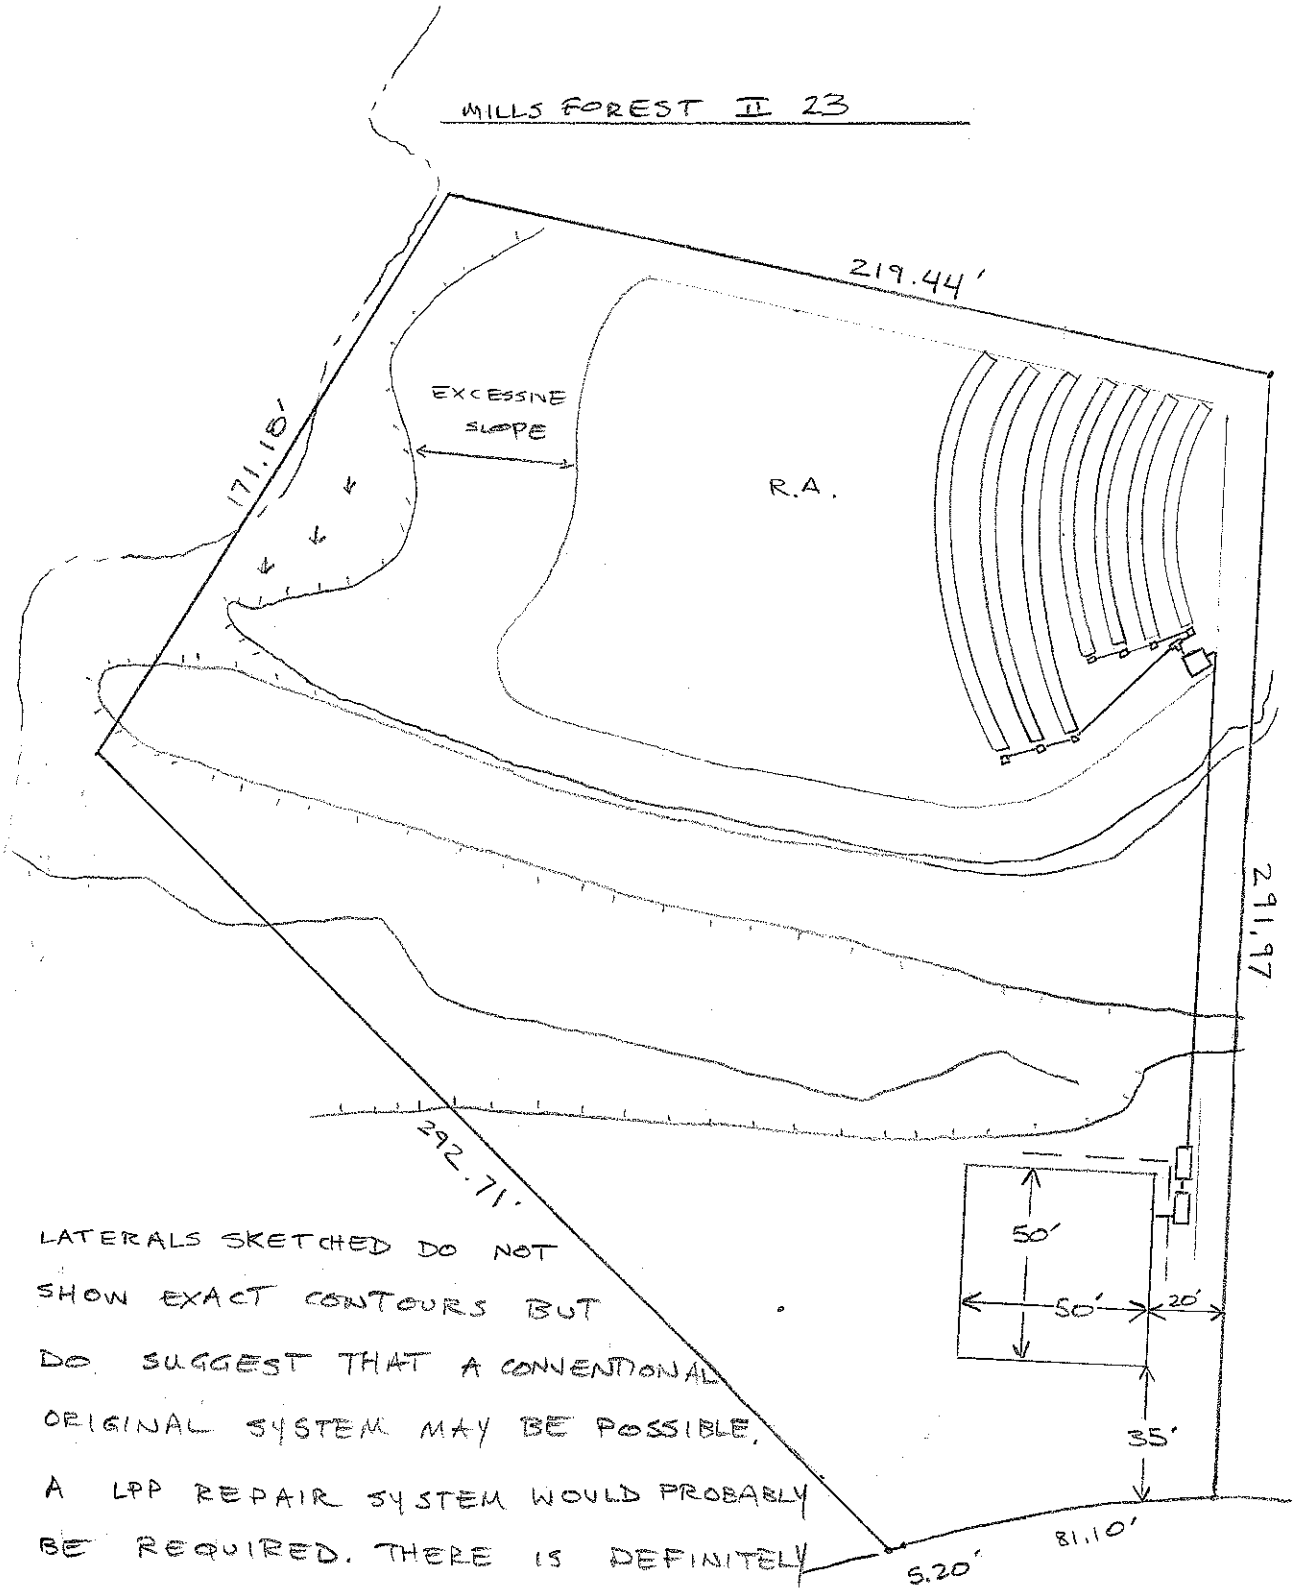
LATERALS SKETCHED DO NOT SHOW EXACT CONTOURS BUT DO SUGGEST THAT A CONVENTIONAL ORIGINAL SYSTEM MAY BE POSSIBLE. A LPP REPAIR SYSTEM WOULD PROBABLY BE REQUIRED. THERE IS DEFINITELY AREA FOR A LPP ORIGINAL AND REPAIR. WELL LOCATION IS HIGHLY VARIABLE. THE SUPPLY LINE MUST BE PROPERLY REINFORCED/SLEEVED/BACKFILLED TO PREVENT SAGGING, SETTLING, AND SEPARATION OF THE SUPPLY LINE.
