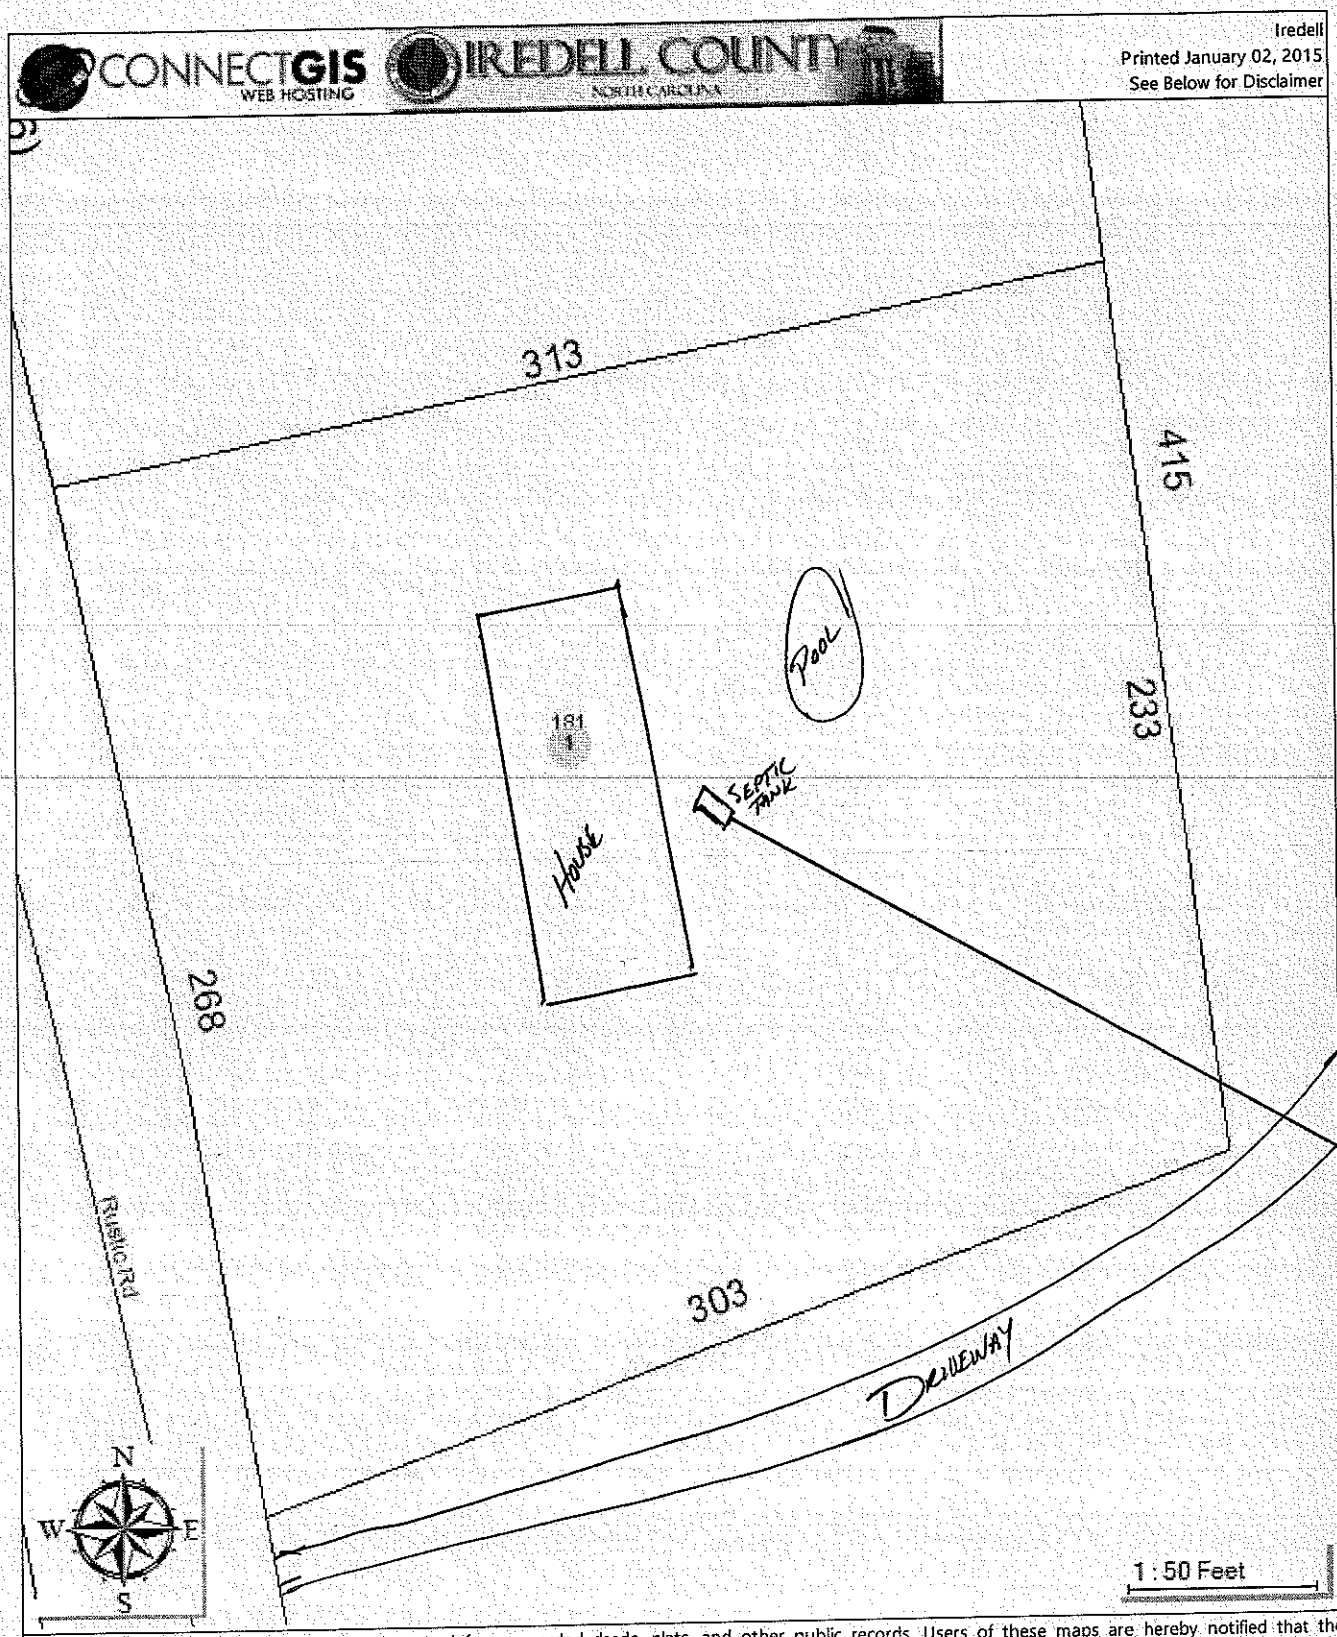
DOUBLE WHITE FLAGS END OF DRAINFIELD.

DRAINFIELD DRY

COLLAPSED D-BOX. LIKELY

MARKED SUSPECTED CLEANOUT.

TANK IS 6' DEEP
BASEMENT PLUMBING.

DRAINFIELD IS ON ANOTHER LOT. ~180' FROM TANK.
