* Repair

ON-SITE WASTEWATER SECTION

# SOIL/SITE EVALUATION
## *for* ON-SITE WASTEWATER SYSTEM

OWNER: Joel Gene Bost — APPLICATION DATE: _____
ADDRESS: 430 Lucky Farm rd. Statesville — DATE EVALUATED: 5 March 10
PROPOSED FACILITY: 4BR Home — PROPOSED DESIGN FLOW (.1949): 480 gpd — PROPERTY SIZE: 1 Ac.
LOCATION OF SITE: Hwy 90W to E Lucky Farm rd. - 6th House on left. — PROPERTY RECORDED: _____
WATER SUPPLY: • Private • Public • Well • Spring • Other _____
EVALUATION METHOD: • Auger Boring • Pit • Cut — TYPE OF WASTEWATER: • Sewage • Industrial Process • Mixed

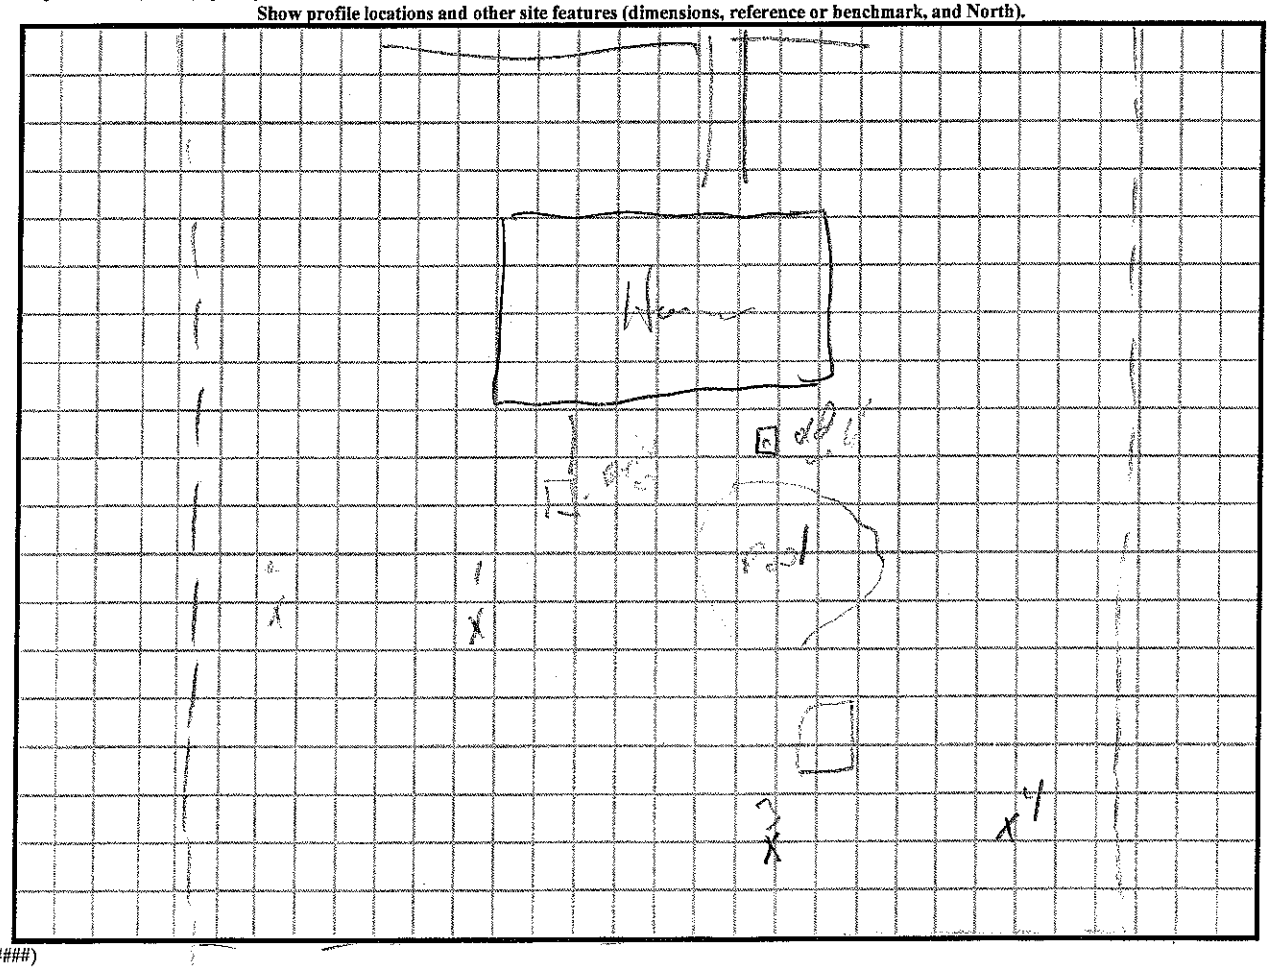
**Show profile locations and other site features (dimensions, reference or benchmark, and North).**
