DEPARTMENT OF ENVIRONMENT AND NATURAL RESOURCES
DIVISION OF ENVIRONMENTAL HEALTH
ON-SITE WASTEWATER SECTION

4730327920

# SOIL/SITE EVALUATION
## *for* ON-SITE WASTEWATER SYSTEM

OWNER: DAVID E. BRODGAN
ADDRESS: 132 HIGH SAIL CT, MRVL, NC 28117
PROPOSED FACILITY: 3BR H
PROPOSED DESIGN FLOW (.1949): 360
LOCATION OF SITE: STATE PARK TO HONEYCUTT TR HWY BRANCH, AT CURVE
WATER SUPPLY: ☑ Private ☐ Public ☑ Well ☐ Spring ☐ Other
EVALUATION METHOD: ☑ Auger Boring ☐ Pit ☐ Cut
TYPE OF WASTEWATER: ☑ Sewage ☐ Industrial Process ☐ Mixed

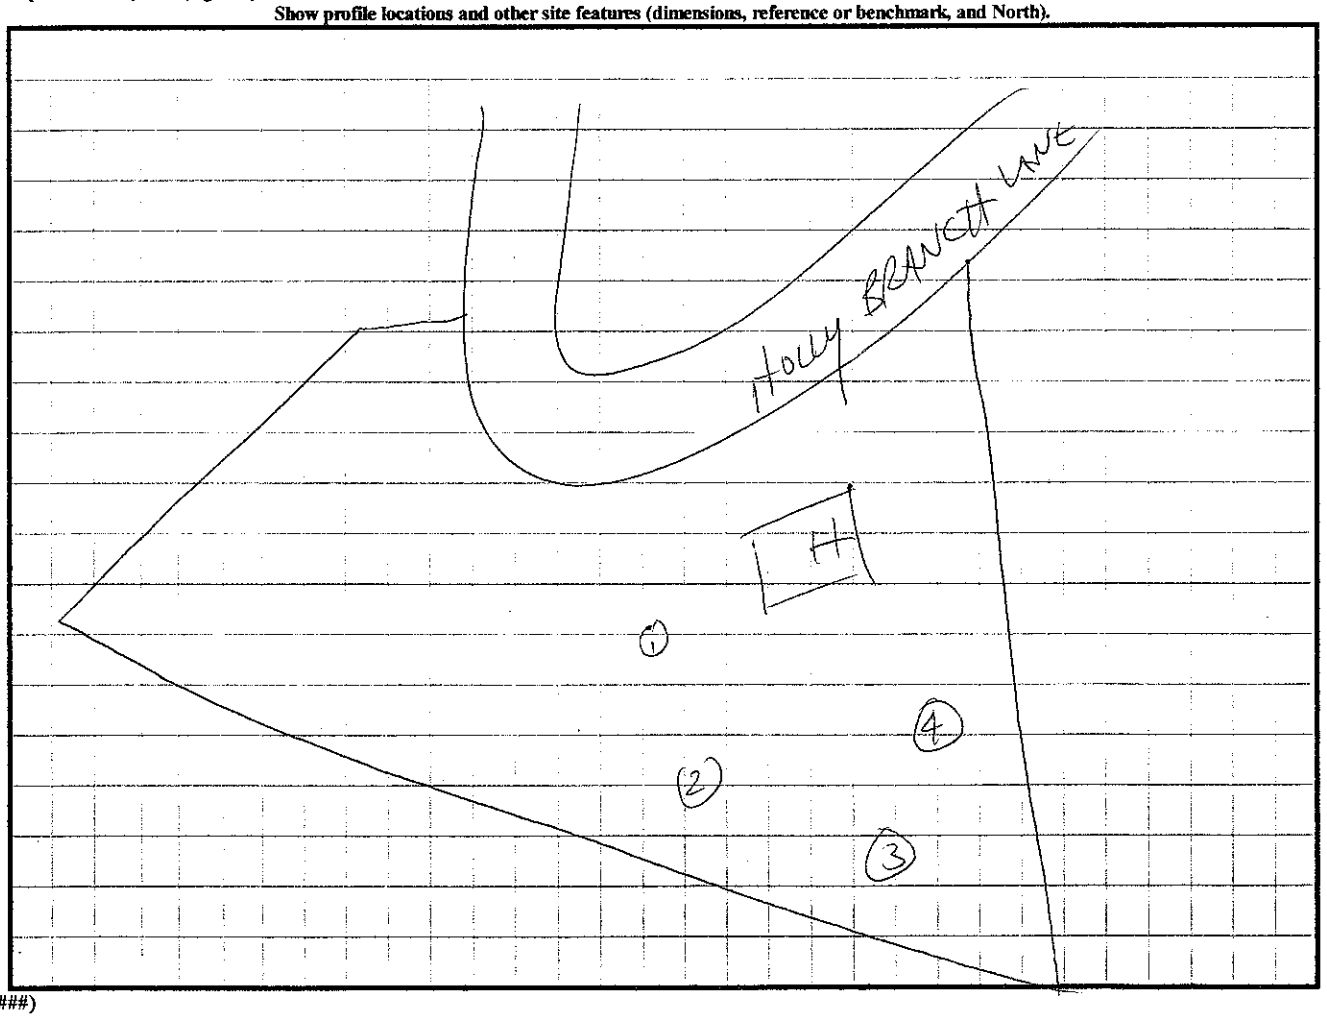
**Show profile locations and other site features (dimensions, reference or benchmark, and North).**
