IREDELL COUNTY HEALTH DEPARTMENT

IMPROVEMENT PERMIT / CERTIFICATE OF COMPLETION / OPERATION PERMIT / EXISTING SYSTEM INSPECTION

PROPERTY DESCRIPTION NO. 17035 DATE 9-29-93 TAX MAP NO. 3F-8-A-8

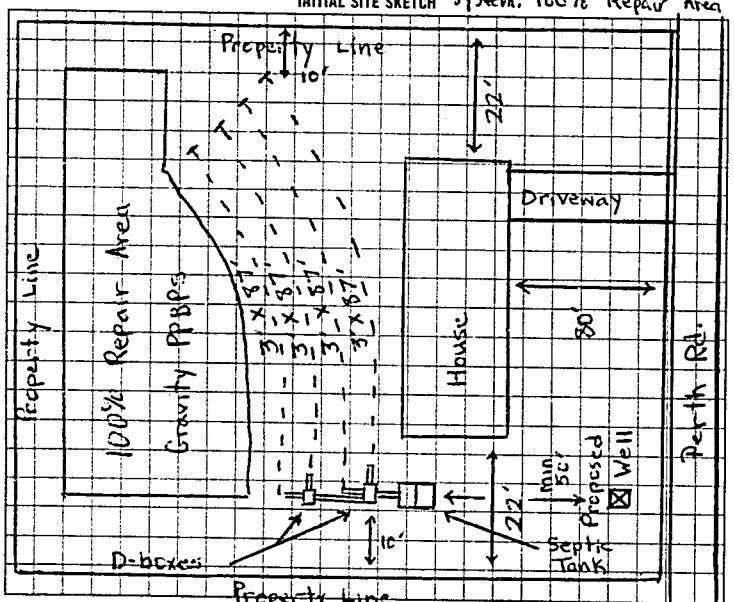
INITIAL SITE SKETCH

Comments INSTALL SYSTEM SHALLOW (no deeper than 30" to trench bottom) Add cover over d-boxes and lines (start of lines) to keep same amount of cover over system. Keep Nitrification lines on or as close to contour as possible. Keep system 5' from foundation of home, 10' from all property lines, and keep well min. 50' from any septic system. 100% Repair Area below initial system (gravity PPBPS).

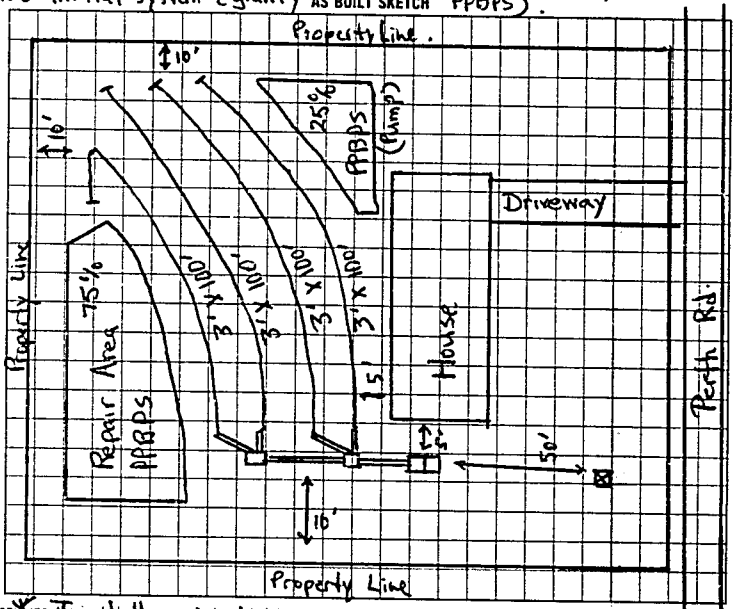
AS BUILT SKETCH

✓Trench falls as installed 400' instead of 345' Repair Area may not be quite 100%.
