DEPARTMENT OF ENVIRONMENT AND NATURAL RESOURCES
DIVISION OF ENVIRONMENTAL HEALTH
ON-SITE WASTEWATER SECTION

515 Tally Rd.

SOIL/SITE EVALUATION
for ON-SITE WASTEWATER SYSTEM

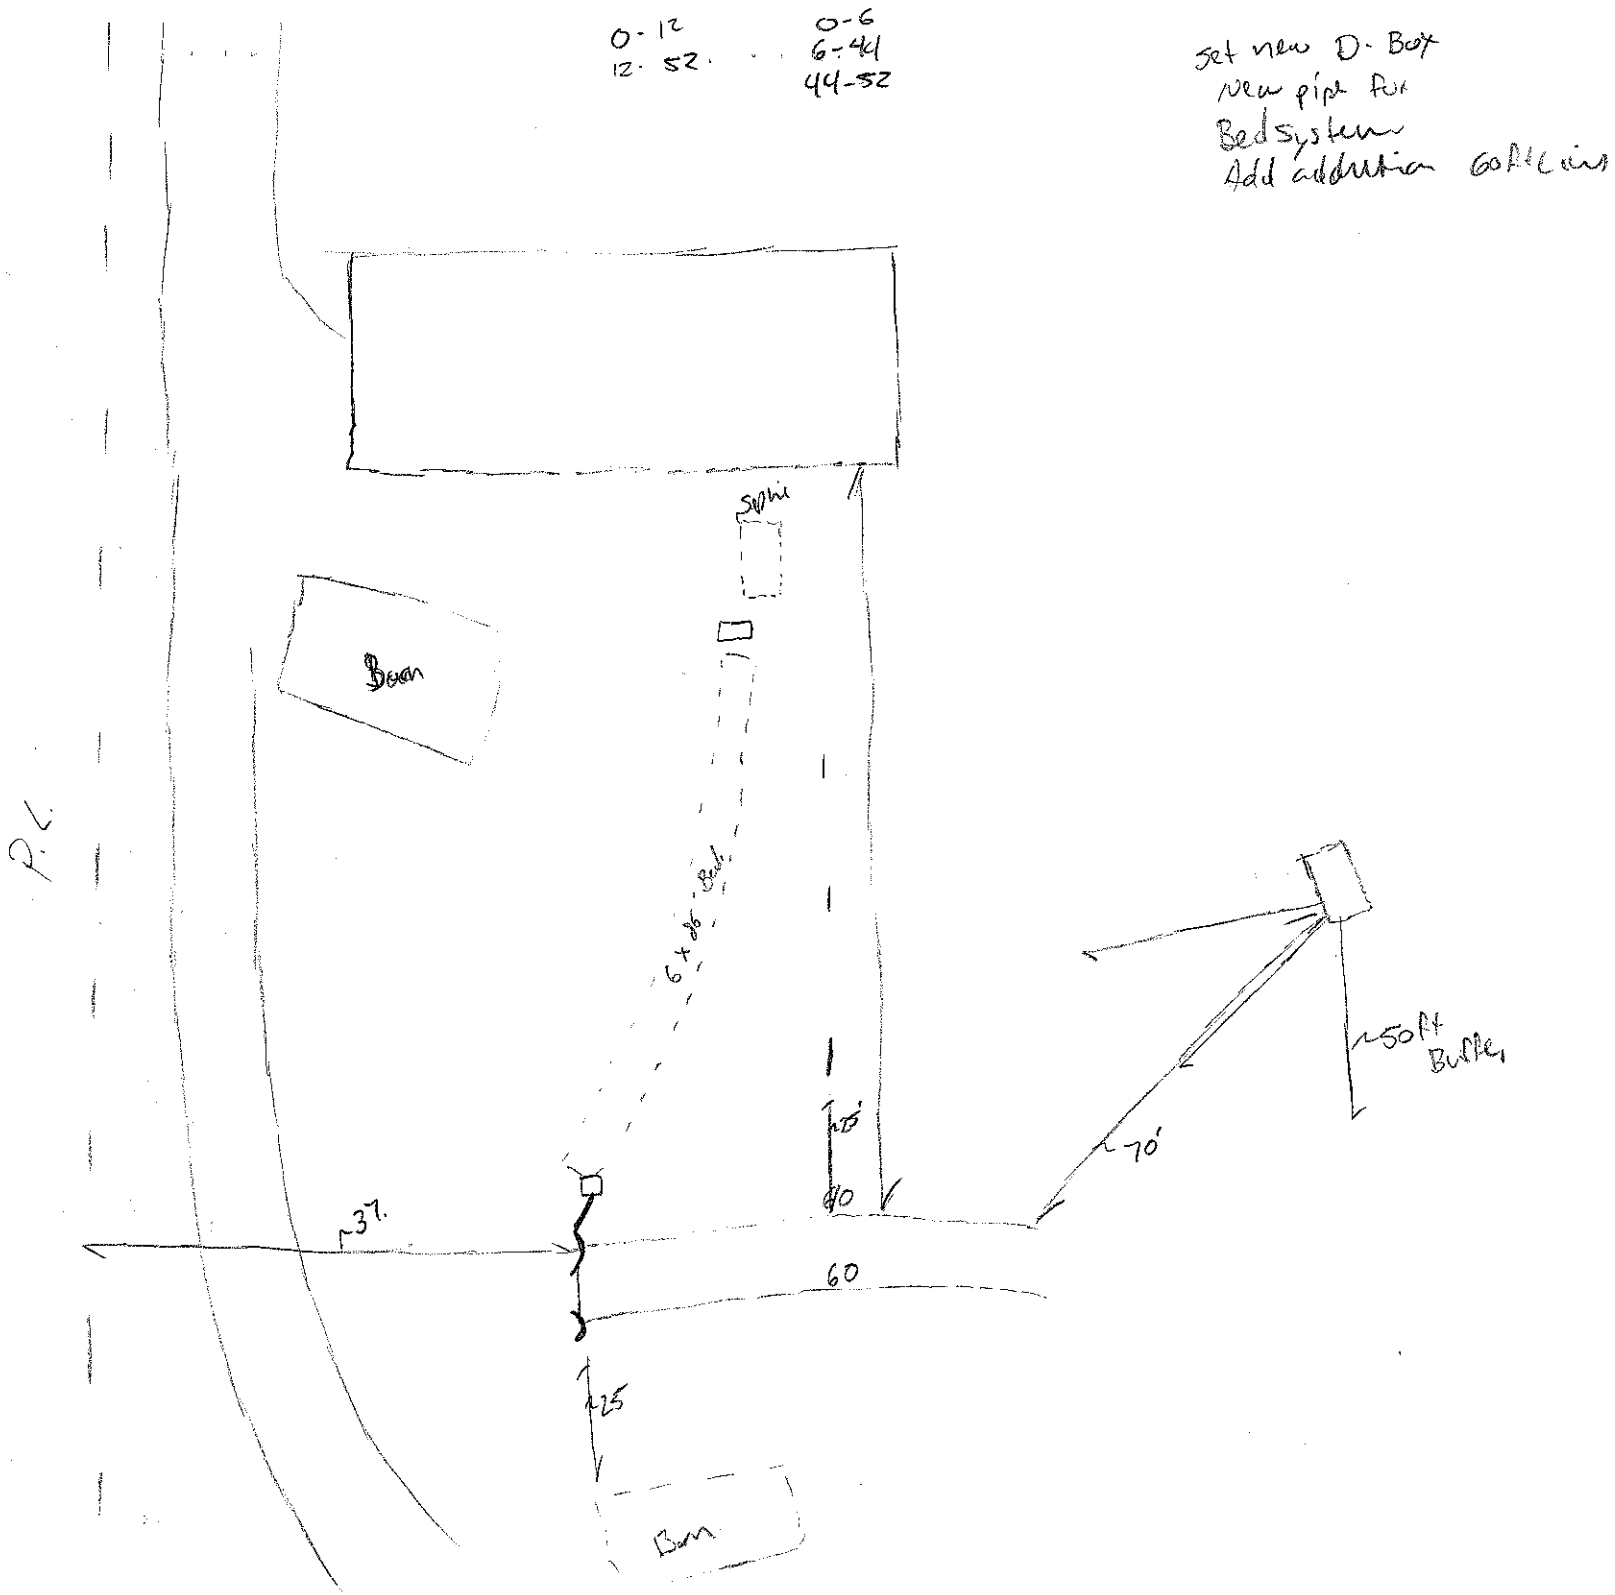
0-12
12-52
0-6
6-44
44-52
set new D-Box
new pipe for
Bed system
Add addition
Septic
Barn
6" x 86' Bed
P.L.
37'
60
25'
40'
70'
50ft
Buffer
125
Barn
