DEPARTMENT OF ENVIRONMENT AND NATURAL RESOURCES
DIVISION OF ENVIRONMENTAL HEALTH
ON-SITE WASTEWATER SECTION

SOIL/SITE EVALUATION
for ON-SITE WASTEWATER SYSTEM

OWNER: GA Mills
ADDRESS: _____
PROPOSED FACILITY: House
LOCATION OF SITE: Lot 9

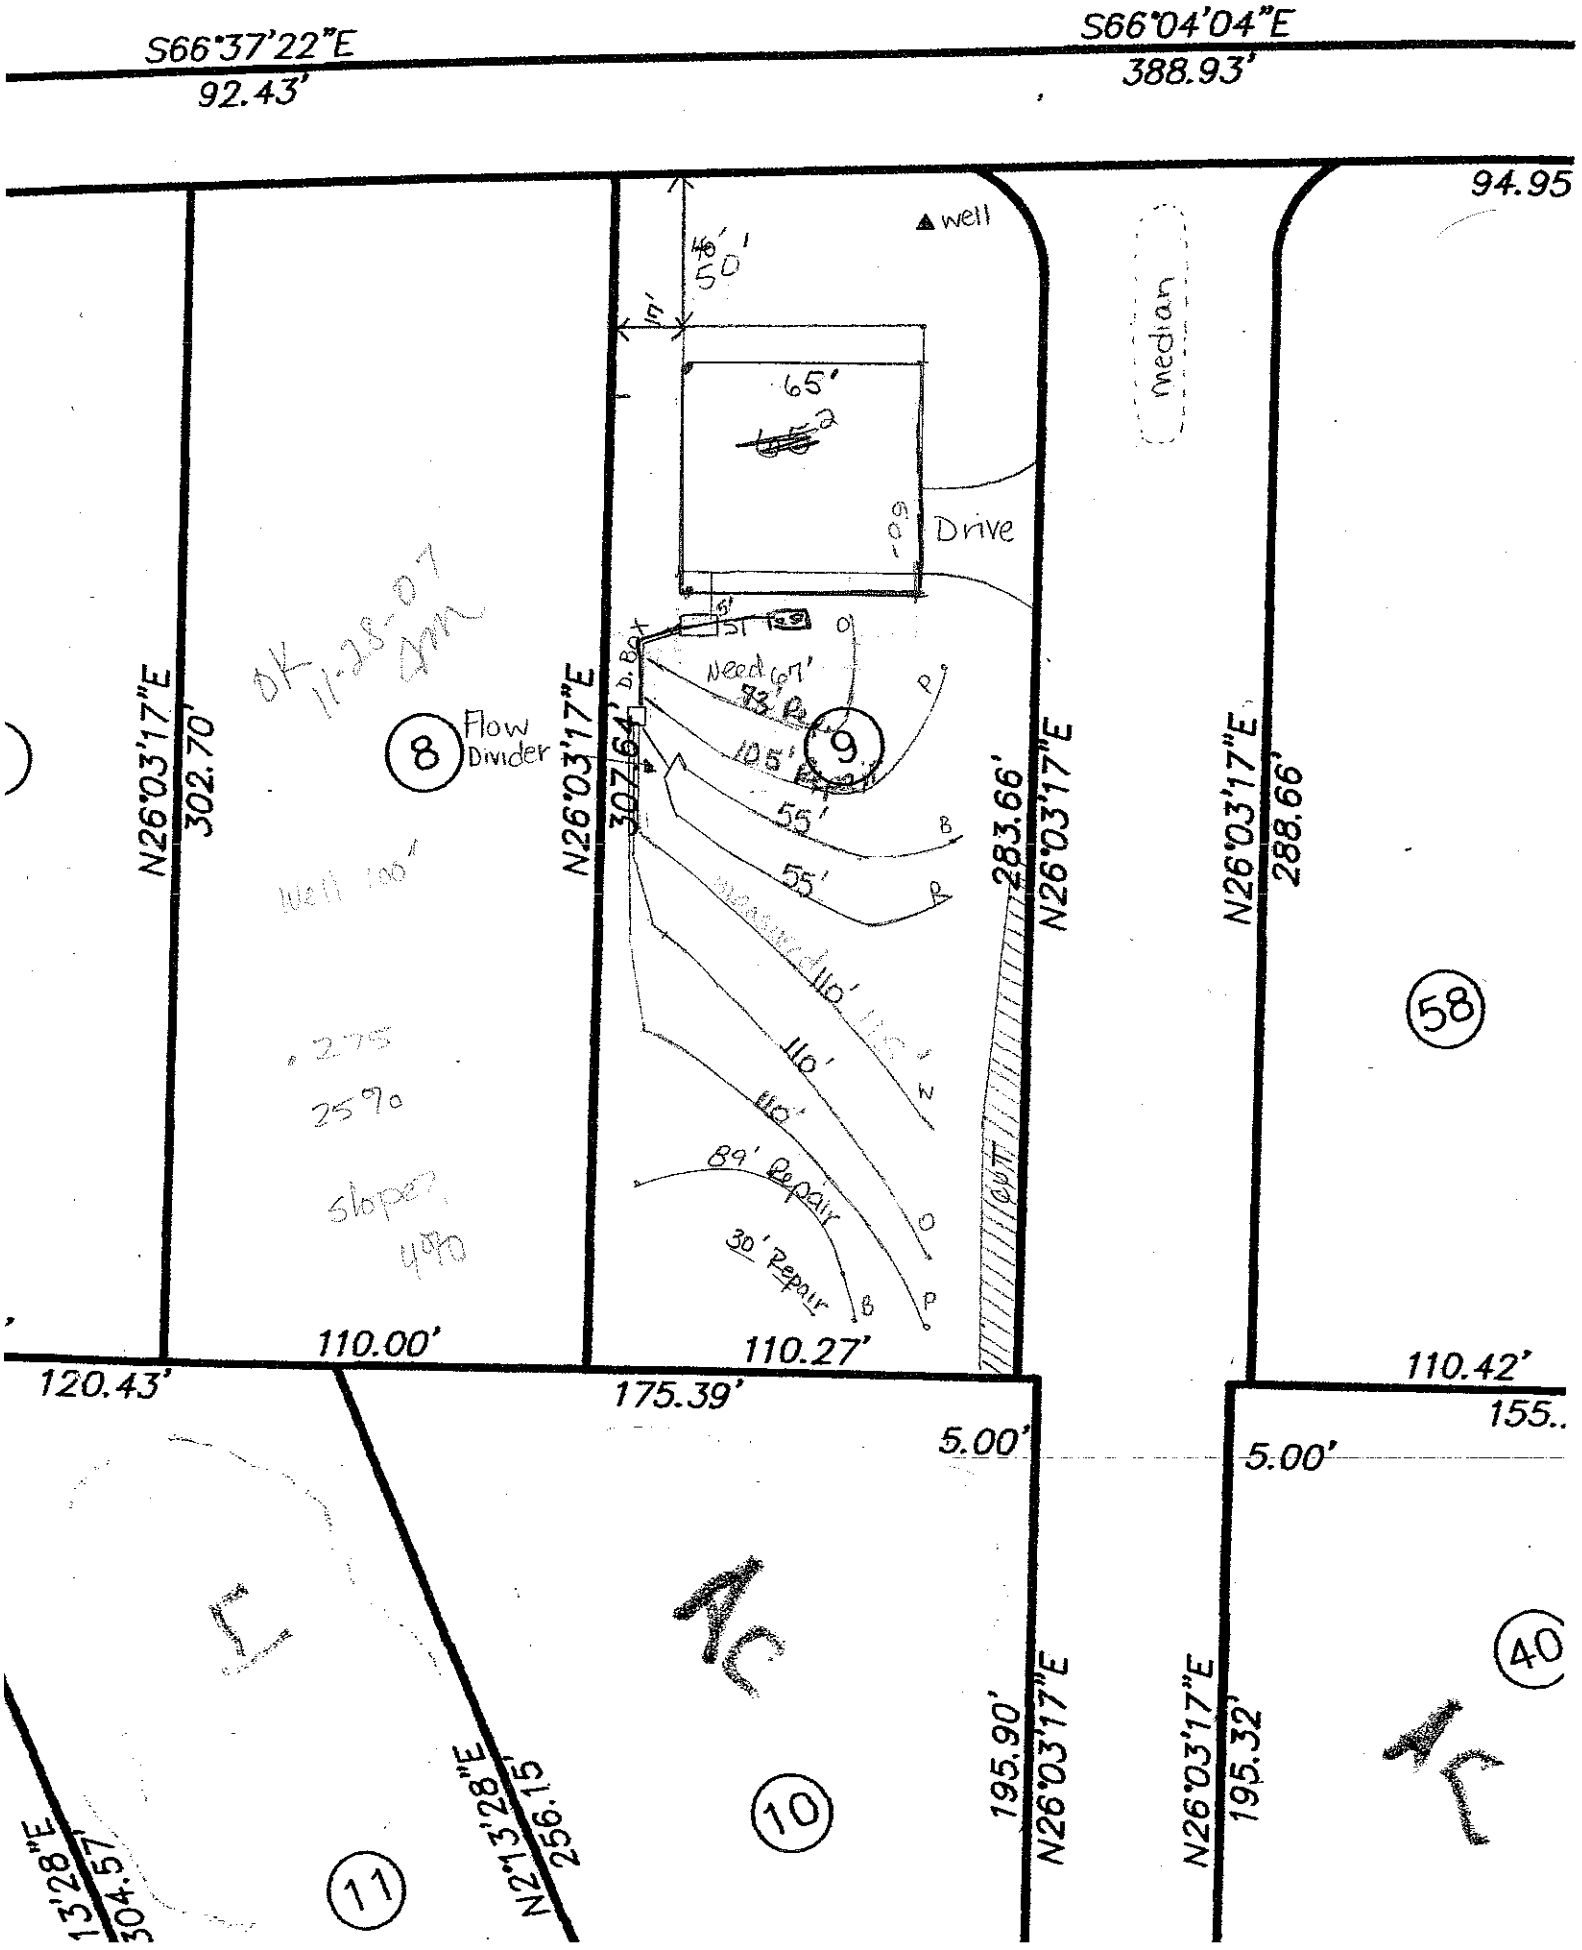
S66°37'22"E
92.43'
S66°04'04"E
388.93'
94.95
well
50'
15'
65'
Drive
median
N26°03'17"E
302.70'
307.64'
283.66'
288.66'
D. Box
Need 60'
33' Repair
105' Repair
55'
55'
110'
110'
89' Repair
30' Repair
Flow Divider
8
9
58
40
10
11
OK 11-25-07
110.00'
110.27'
110.42'
120.43'
175.39'
155..
5.00'
5.00'
195.90'
195.32'
256.15'
304.57'
13'28"E
N21°13'28"E
.275
25%
Slope 4%
