MICHAEL ATHANAS & ASSOCIATES
LICENSED SOIL SCIENTIST
561 Ennis Rd.
Weddington, NC 28173
(704) 576-3887

Reference: Data Sheet for 104 Redwood Ln., Cedar Hills SD Lot 19
House Footprint: See attached plan
Building Setbacks: 35' front/rear, 15' side
Water Source: City water
Number of Bedrooms: 3/360 GPD
Proposed LTAR: N/A (Existing system)
Existing System Type: Conventional
Proposed Repair System Type: N/A (1973 Deed)
Distribution: Distribution box
Septic Tank Size: Existing
Proposed Trench Bottom: N/A

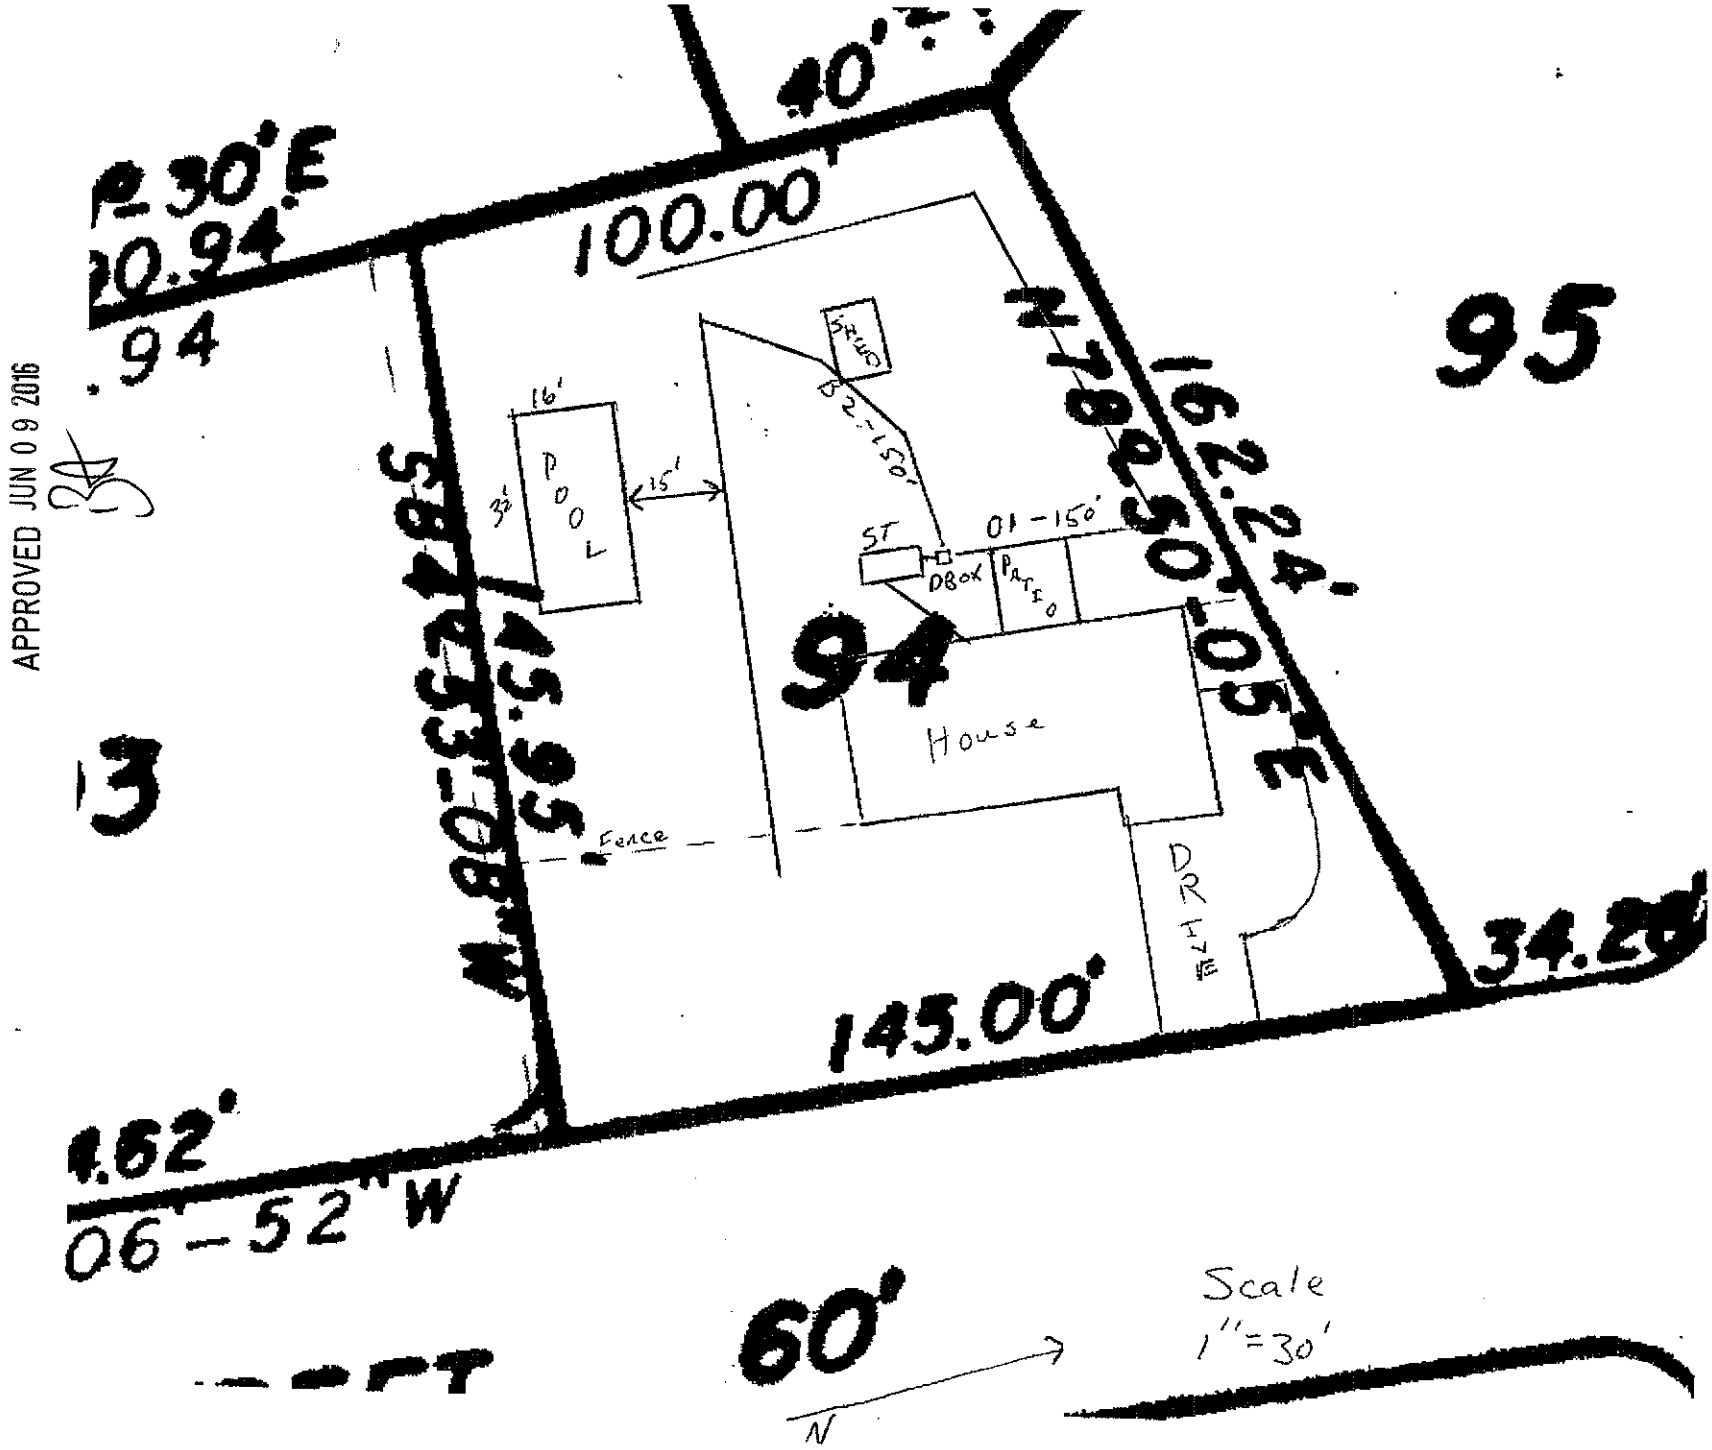
Comments:
This is an existing system inspection for a pool. The actual installation and the existing permit differ slightly. MA&A's site plan shows the actual lay out for the septic tank and lines. The fences lay along the property lines. The plat we are working from is the original plat recorded with the Register of Deeds in 1973. The scale of this plat seems to be off slightly. The side lines are the right lengths on the plat but the front and rear lines are off.

APPROVED JUN 0 9 2016
40'
N 30° E
20.94'
100.00'
94
95
N 78° 50' 05" E
162.24'
N 80° 33' 48" W
145.95'
13
94
House
POOL
16'
15'
32'
SHED
32 - 150'
ST
01 - 150'
DBOX
PATIO
Fence
DRIVEWAY
145.00'
34.28'
4.62'
06 - 52" W
60'
Scale
1" = 30'
N
