BLDR-2023-22257

ICHD - ENVIRONMENTAL HEALTH DIVISION

PERMIT # OSWP-2022-12446

SEPTIC: IMPROVEMENT PERMIT / AUTHORIZATION TO CONSTRUCT / OPERATION PERMIT / EXISTING SYSTEM

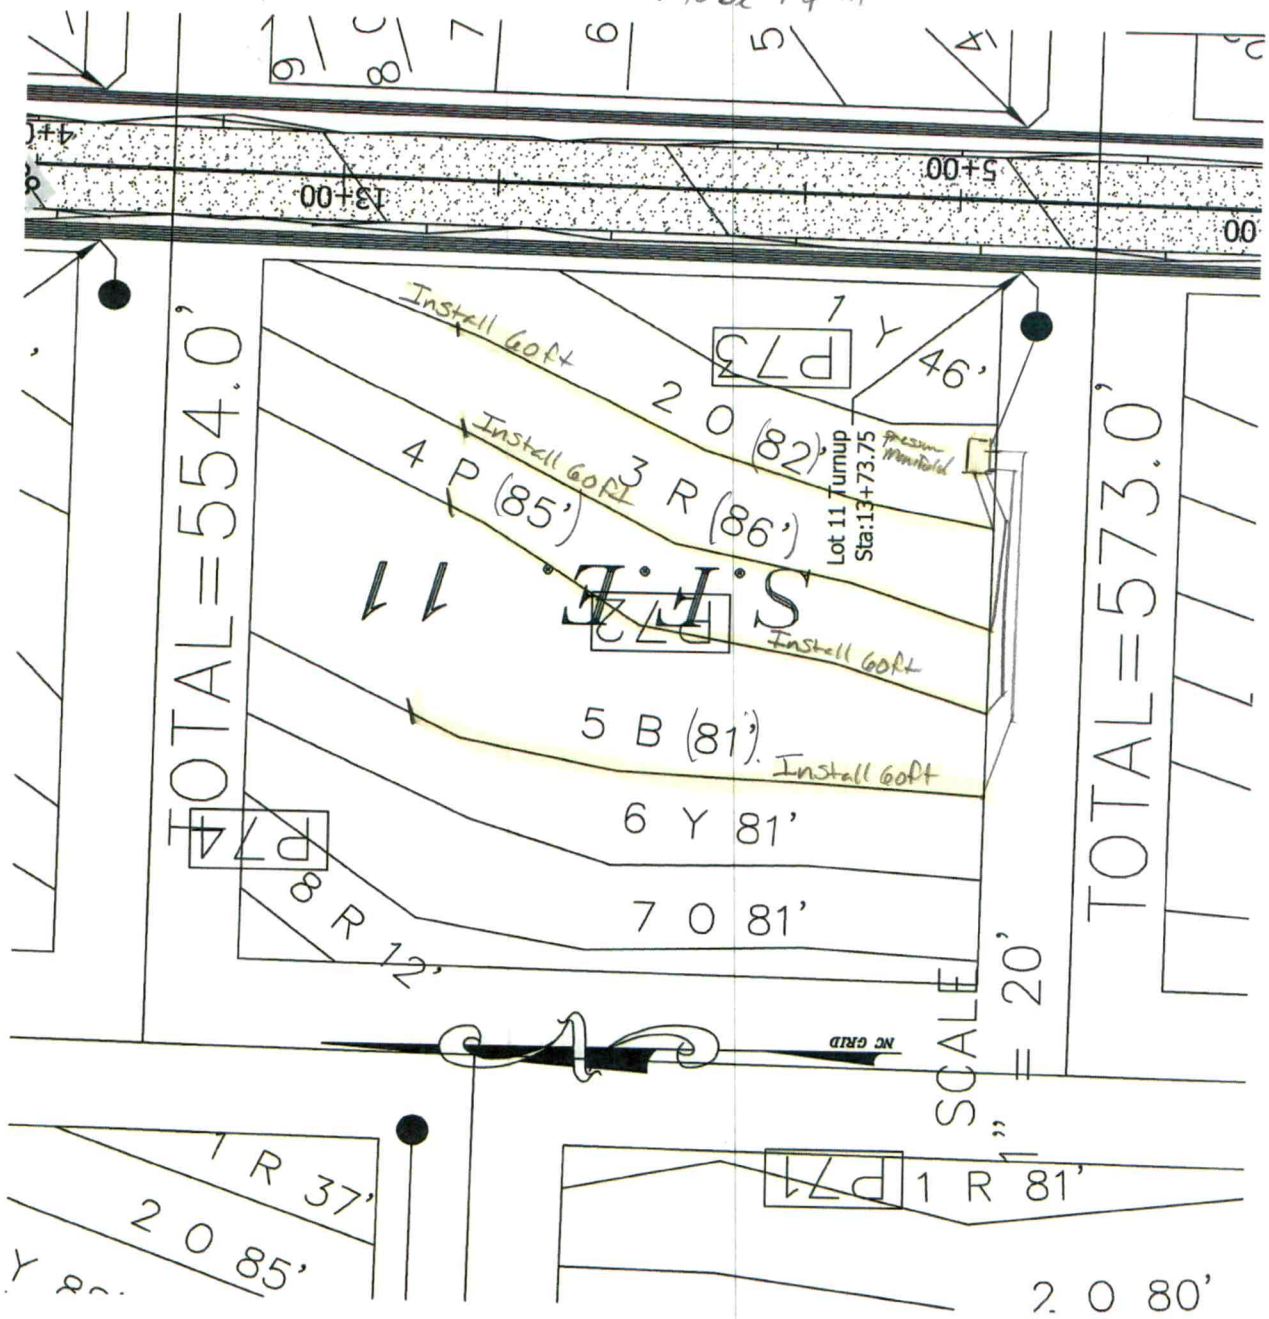
AS BUILT SKETCH

7-14-23 - Trench checked

9-27-23 - Cmu + Manifold checked

10/3/23 - Floats - needs to be sealed on electrical.

10/4/23 - Electrical - pressure Head
